# **REPORT ON THE DANVILLE MEETING HOUSE DANVILLE, NEW HAMPSHIRE**

**JAMES L. GARVIN**  
**DECEMBER 8, 2012**

The following report derives from an inspection of the Danville Meeting House on December 4, 2012. The principal purpose of the report is to assess the condition of the building and to make recommendations to the Olde Meeting House Association of Danville for the future stewardship and maintenance of the property. Second, the report refines and corrects statements that were made in the National Register nomination of the property in 1982 (listed April 19, 1982; see Appendix 1). The report includes a second appendix that provides a transcript of “Notes on the Date of Construction of the Danville Meeting House” of October 7, 1995, which revised the date of erection of the body of the building from 1760, as stated in the National Register nomination, to 1755. Third, the report explores in greater depth the physical evidence of changes that occurred to the building in the early nineteenth century.

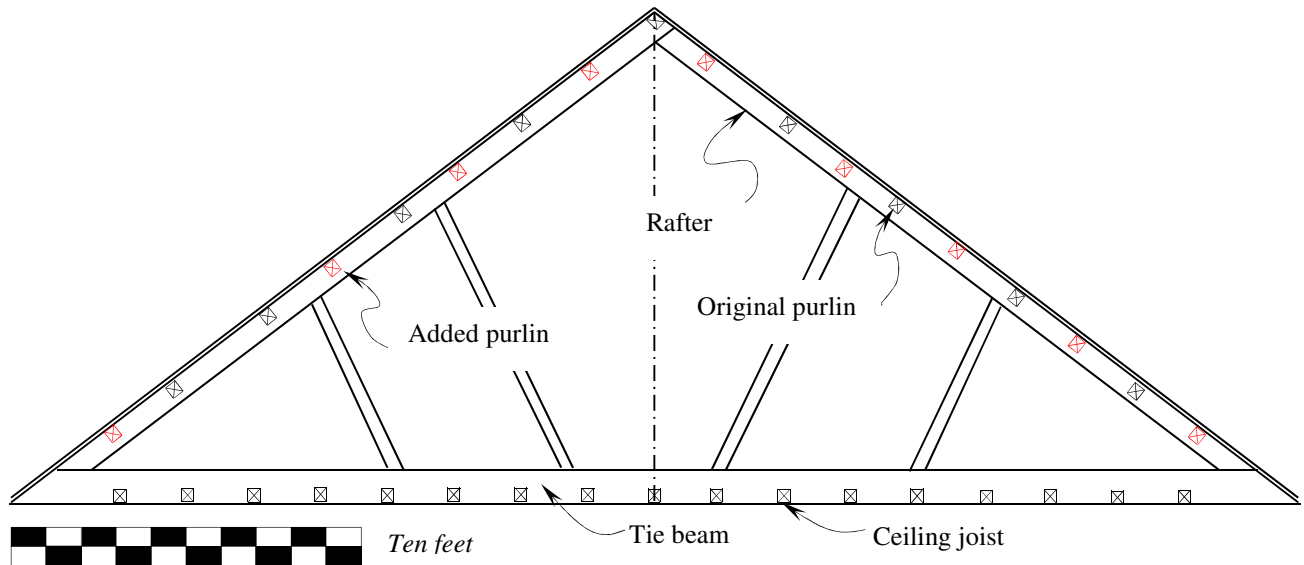
It appears that the roof frame was originally composed of rafters and purlins alone. Unlike most meeting house roofs, the rafters (or “spars” as they would originally have been termed) at Danville are single hewn members; in later and larger meeting houses, the rafters are typically doubled, and the parallel members are connected to one another by a series of short struts, as shown in the drawings on the following page.

The diagonal struts seen in the drawing above are not symmetrically placed, and appear to have been added after the original construction. Likewise, the purlins shown in red, also not symmetrically arranged from one slope of the roof to the other, were added later, presumably as the roof sheathing began to bow under its own unsupported weight and the weight of snow.

Unlike most meeting house roofs, the Danville frame does not have longitudinal trusses (usually either kingpost or queen post trusses) running through the attic from one end of the building to the other to stiffen the roof against racking or leaning, and to support the long tie beams that span the full depth of the meeting room. This lack of support from above was compensated for by the unusually long and prominent curved braces that rise from the four inner posts of the building’s frame to support the tie beams from below, as seen in the photographs on the preceding page. The tie beams at Danville are heavy members, measuring 11 inches broad and 12 inches deep, and the support provided by the exposed braces below the meeting room ceiling seems to have been sufficient to prevent these massive members from sagging appreciably under their own weight and that of the ceiling plaster. (In a room measuring some 37 by 49 feet, the total weight of the one-coat plaster ceiling, calculated at an average weight of between 5.5 and 6.0 pounds per square foot, is some 10,000 pounds.)

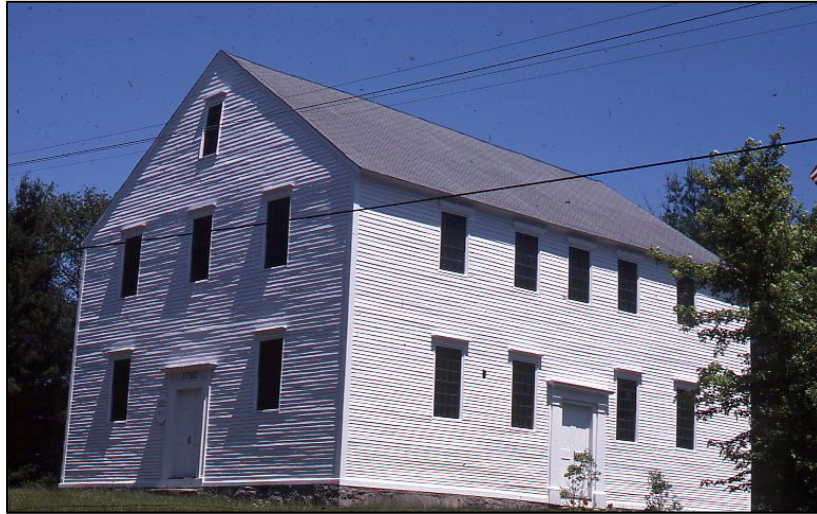
Perhaps because of the relative lightness of the Danville roof frame, there is some visible distortion in the building above the wall plates. The western gable, facing the road, is not plumb. Based on measurements made on December 4, 2012, it appears that the peak of the western gable is some twelve inches out of plumb, leaning toward the east. This distortion is normally not visible, but can be seen when the sun provides a raking light across the gable end, as shown in the photograph below.

*Danville Meeting House, photograph taken July 1982 by James L. Garvin*

Without further measurement, it is not clear whether this distortion applies to the entire roof structure. For the moment, it appears that the lean is confined to the western gable, and that the remainder of the roof structure is relatively plumb. It also appears that this condition is of long standing, and perhaps original to the building's construction. In the photograph below, probably dating from the 1950s, the tilt of the attic window is as visible as in the 1982 photograph above.

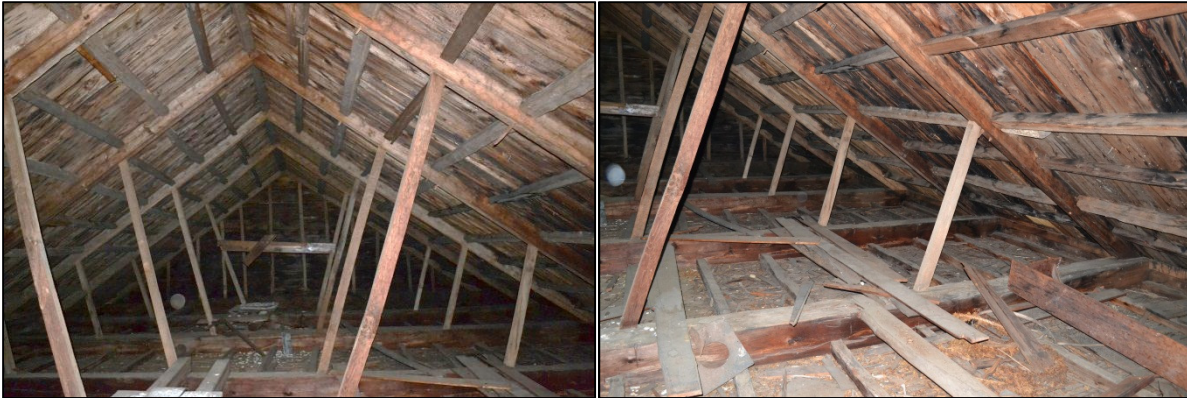
Despite its relatively light design and its supplementary reinforcement in the years after its construction, the roof frame of the Danville Meeting House is impressive and appears to be in good condition, as seen in the photographs below.

*Left: Longitudinal view, looking east. Platforms for two former brick chimneys rest on tie beams at the left of center.*

*Right: View looking southeast, showing original and supplementary purlins, and ceiling joists supporting lath and plaster.*

Because sheets of plywood are too thin to offer adequate support and are too large to fit through the small trap door that provides access to the attic, the catwalk might best be constructed of two-inch planks, laid parallel and adjacent to one another down the length of the attic and attached to wooden cleats on each side of the tie beams in order to do no damage to the original beams.

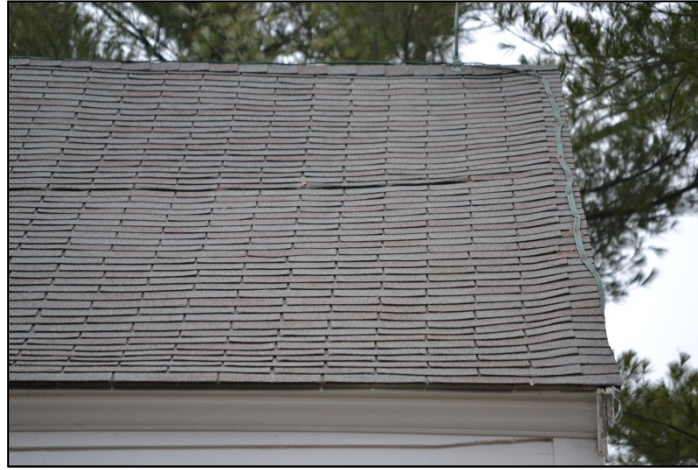
The first aspect occurs on the south (front) slope of the roof. As may be seen in the photograph below, there is an unexplained longitudinal lifting at the butts of a course of shingles along most of the length of the roof, just above the halfway point of the slope.

*Southeast corner of roof, showing separation of butts at one course of shingles.*

The cause of this lifting is unexplained, especially inasmuch as the roof sheathing boards run vertically, from ridge to eaves, as seen in the photographs on the preceding page. Mr. Collins explained that no plywood was installed over the original sheathing, and none can be seen from the attic through joints in the sheathing boards. The lifting may be the result of a shifting of a single roof purlin, or possibly from the upward bowing of the rafters caused by a strut or prop, but the photograph above shows that the roof surfaces typically sag between points of support rather than bowing upward. Rows of shingle nails used in lapped rolls of roofing felt, or other aspects of the shingle underlayment, could be the cause. The separation of the shingle butts does not appear to be serious, but could invite water penetration during a driving rain from the south. The condition should be monitored from the ground and also from the attic if a catwalk is constructed to permit safe and careful study of the roof from beneath.

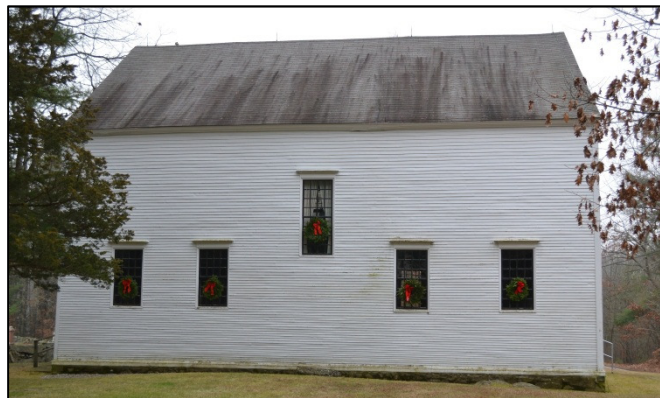
A second aspect of the roof attracts attention and invites concern. This is the staining of the shingles on the rear (north) slope of the roof, as seen in the photograph below.

This type of stain, radiating downward from multiple points high on the roof and merging into a pronounced and generalized blackening of the lower shingles, is commonplace on modern asphalt shingle roofs. Shingles with fiberglass felts impregnated with calcium carbonate, or those that use limestone granules to impart light colors to the shingle surface, are especially prone to this condition. Algae identified as *Gloeocapsa magma* are the usual cause of shingle staining; some authorities assert that *Gloeocapsa magma* is a cyanobacterium rather than an alga. Because of the widespread nature of this staining—today almost universal on newer asphalt shingle roofs after a few years of exposure to the elements—many products and treatments have been introduced to remove the algae stains. There is also one traditional method of preventing the recurrence of the staining.

Shingle manufacturers and roofers almost universally state that algae staining does not diminish the life of an asphalt roof shingle; the problem is a cosmetic or aesthetic one, not a symptom of imminent shingle failure. As seen on the Danville Meeting House, algae staining occurs most commonly on the northern slopes of roofs, where lack of direct sunlight encourages chronic dampness and reduces the ultraviolet light that inhibits the growth of algae. To combat this behavior of modern roof shingles, several manufacturers add copper or zinc granules to the aggregate that covers the shingles and protects their felts against destructive ultraviolet light.

Since specialists assert that the stains seen on the north slope of the roof of the Danville Meeting House are not indicative of a reduction in the service life of the shingles, the Association may choose to do nothing about the stains. If the Association wishes to address the issue, the first and least expensive approach would be to install a copper wire or a copper or zinc strip at or near the ridge, then monitor the roof to see if this removes the stain. If the stain is too entrenched to be dissolved by the ions from such a metallic inhibitor, it may be necessary to wash the roof with one of the commercial preparations that are marketed to clean algae-stained shingles. If this is done, it will be important to choose a product that needs only to be sprayed gently on the roof, then rinsed with clean water. It is crucial that the shingles not be washed with high-pressure spray or with harsh chemicals that could shorten their life or kill the grass beneath the eaves.

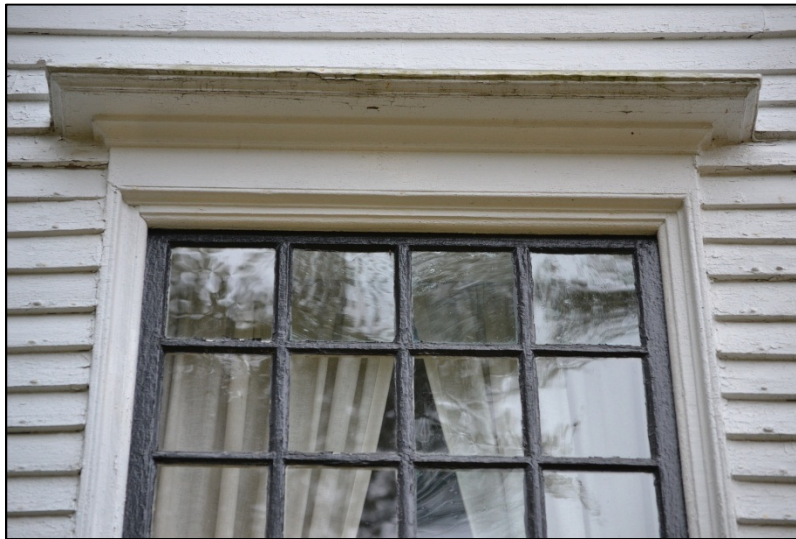
*Clapboards:* Most of the walls of the Danville Meeting House retain very old clapboards, probably original. These are hand-split (rived) and hand-shaved, and impart a character-defining texture to the exterior of this important structure. The nail heads are hand-forged, and the vertical rows of nails tend to follow the wall studs behind the sheathing, thus imparting a logical and disciplined visual character to the texture of the wall surfaces. This character is seen in the nails on each side of the pulpit window in the photograph below.

In addition to early nails, as seen in the photograph above, the clapboards are also held by modern wire nails that were added to tighten the clapboards when the building was re-painted during the twentieth century.

It is important that all surviving old or original clapboards be preserved. Most are in good condition, and can be retained when the building is repainted; treatment of the clapboards and nails is discussed further under *Painting*, below.

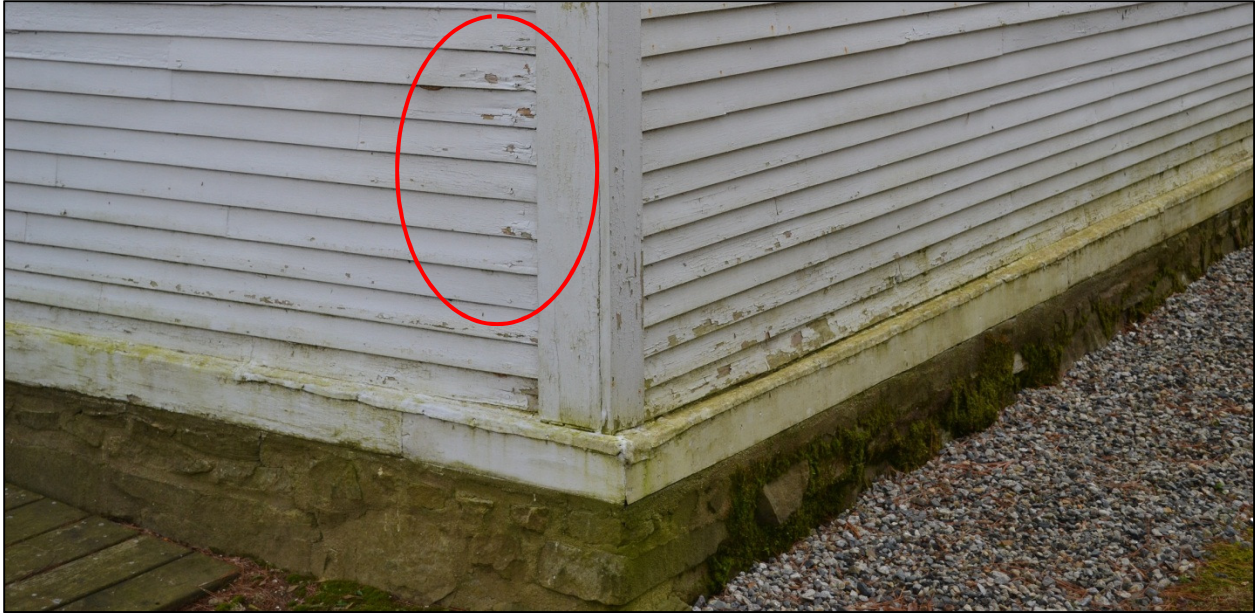
Although most areas of clapboarding appear sound and ready for preparation for future repainting, there are a few areas where deterioration needs to be explored. The area of greatest concern in the northeast corner of the building, shown in the photograph below. Here, the clapboards and the lower sections of the corner boards are softened by decay. Moisture meter readings taken in this area reveal saturated wood, with 25% to 30% moisture content, which is a symptom of advanced decay.

*Left: east side of the building, showing deteriorated clapboards at corner; right: rear (north) wall showing algae growth on water table and moss growth on foundation stones.*

The condition of the wooden lower walls, the algae film, and the moss on the foundation all point to chronic dampness and absence of direct sunlight. Much of this dampness is attributable to roof water falling from the eaves on the north side of the building. Some of the dampness, however, may be associated with the trees that overhang and shade this corner of the building. Trees transpire a surprising amount of water vapor during the summer months, often being the direct cause of lichen or moss growth on the roofs of buildings below the branches.

As noted above, metallic ions have long been regarded as inhibitors of algae, lichen, and moss growth. The addition of copper or zinc wires or strips near the ridge on the northern slope of the roof could have a beneficial effect in killing the algae and moss that are obvious at the bottom of the north wall.

Beyond that, however, the situation at the northeast corner calls for careful removal of the clapboards and the lower corner boards in this vicinity, followed by removal of the underlying sheathing if the latter is found to be deteriorated. Chronic dampness will permit the fungi that are present in the wood to propagate and affect adjacent wood, leading to ever-increasing problems. Once established, decay fungi have the ability to retain moisture and transmit it through sound wood with organic filaments, thus maintaining and distributing the dampness needed for their growth even in relatively dry conditions. It will be important to remove all affected wood at the northeast corner and to replace it with sound new wood. This must be accomplished before any re-painting is attempted in this area of the building.

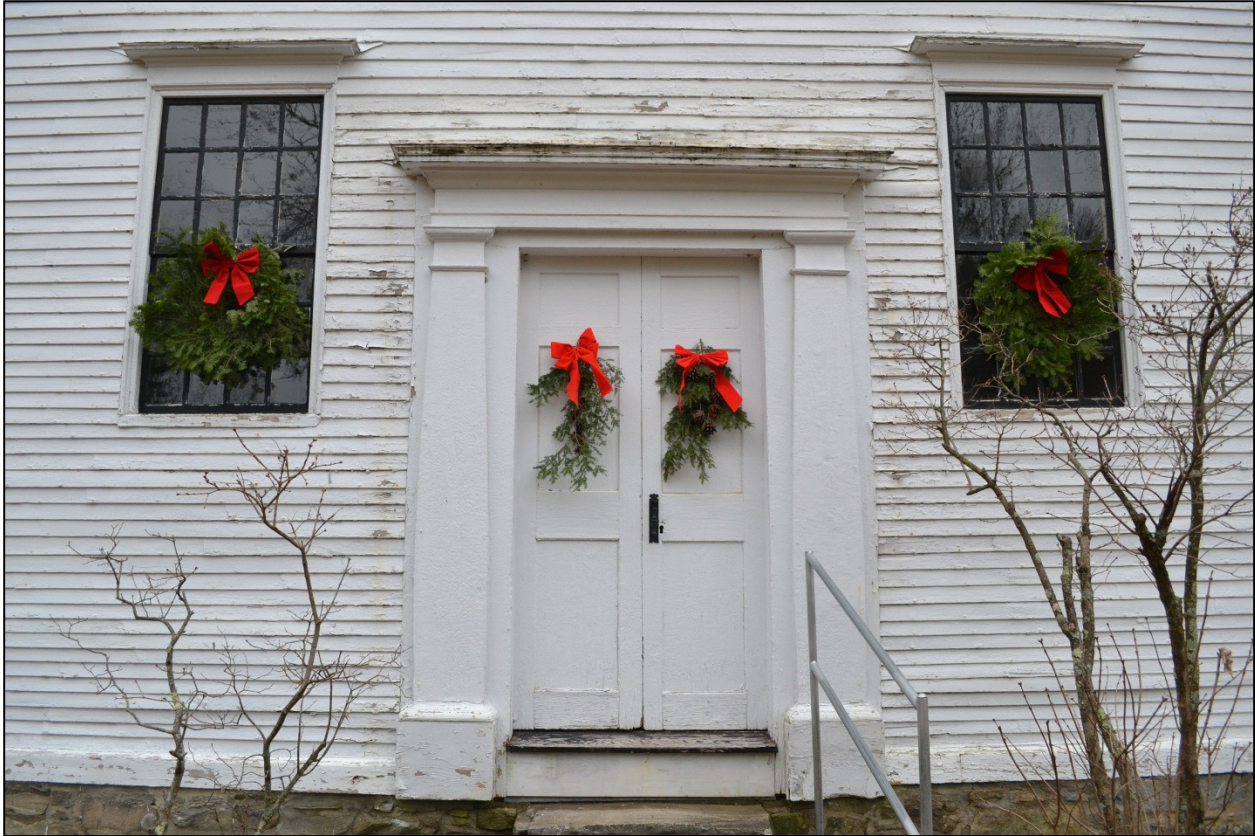
Excessive moisture, although not to the degree seen at the northeast corner of the building, is also seen around the front (south) doorway of the meeting house. As seen below, the paint is failing on both sides of this doorway.

This can largely be attributed to the failure of the flashing detail above the flat doorway cap. The lowest clapboard here has curled and pulled away from the building, allowing water that falls on the cap to find its way behind and under the flashing, and ultimately behind the clapboards on each side of the doorway. Moisture meter readings in this area range from 15% to 18%, ensuring paint failure.

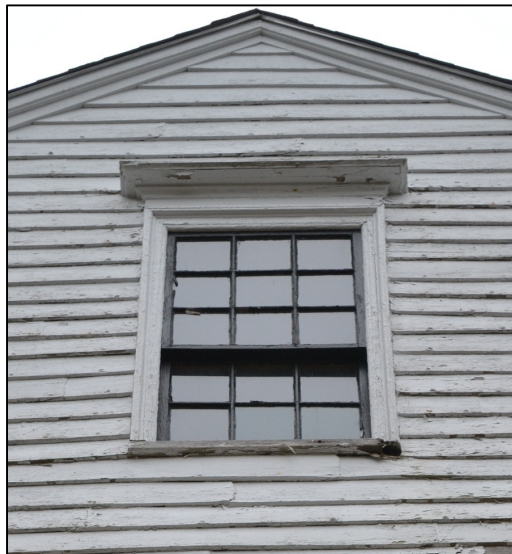
*Western gable window*

Mr. Collins pointed out that the sill of the western attic window has deteriorated, as seen below, and will require replacement. This sill, and any other replaced exterior detail, should carefully replicate the unique configuration of the original feature. The unusual design of many of the building elements at Danville contribute to the integrity and significance of the meeting house.
