JAMES L. GARVIN

**REPORT ON THE FOGG-ROLLINS BARN
44 HAMPTON ROAD, EXETER, NEW HAMPSHIRE**

JANUARY 26, 2012

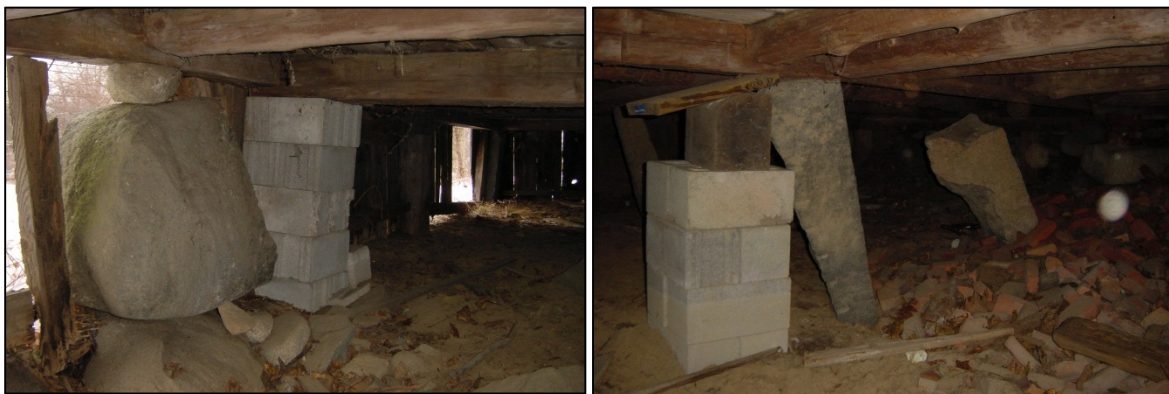
Substructure. The barn is supported on perimeter foundation walls of irregularly placed dry-laid fieldstone and boulders, and on interior piers that for the most part are posts of split granite. The splitting technology of the granite posts denotes a date after circa 1830, so it may be theorized that most of the split granite piers under the barn were added when the barn was enlarged in the mid-1800s.

In many if not most cases, these supports have shifted or subsided, often having tipped as a result of uneven freeze-thaw cycles in the soil around their feet. A number of supplementary piers of timber and/or concrete blocks have been inserted at points of lost support, as seen above. In many cases, the barn frame above these points of support had deformed and settled before supplementary piers were added. The frame of the barn, especially the newer or western portion, thus remains in distorted condition, as described below.

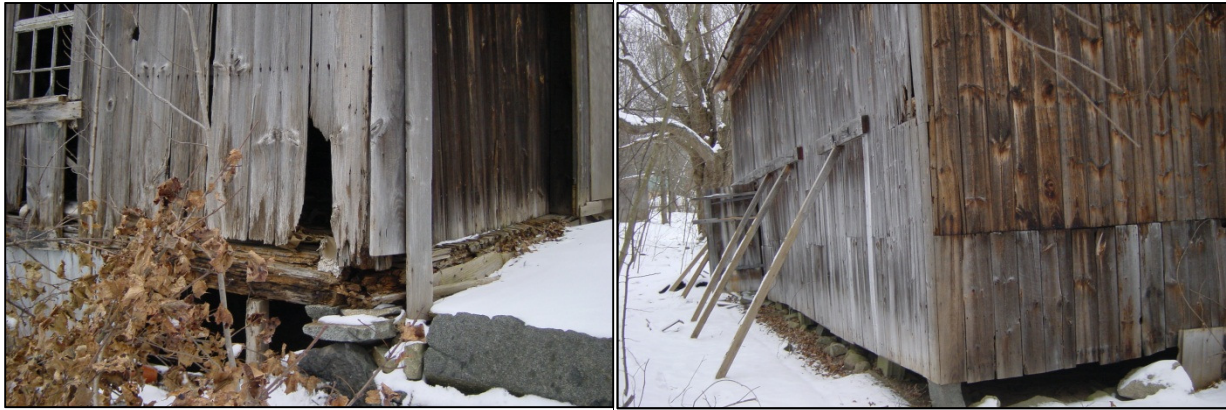
As might be expected, the perimeter sills of the barn, being close to the ground and affected by rainwater falling from the eaves of the roof, have suffered varying degrees of decay. This is especially true on the south side of the barn, facing Hampton Road. Here, as is usual with wooden buildings, the eroding effect of ultraviolet light from the sun has accelerated the deterioration of the vertical sheathing boards, leaving the southern sill of the structure especially exposed to rainwater from the roof, as seen in the photograph below, left.

The sills on the northern and western sides of the barn, though nearer to the ground, have been better protected by relatively intact sheathing, and appear to be in acceptable condition, as seen above, right.

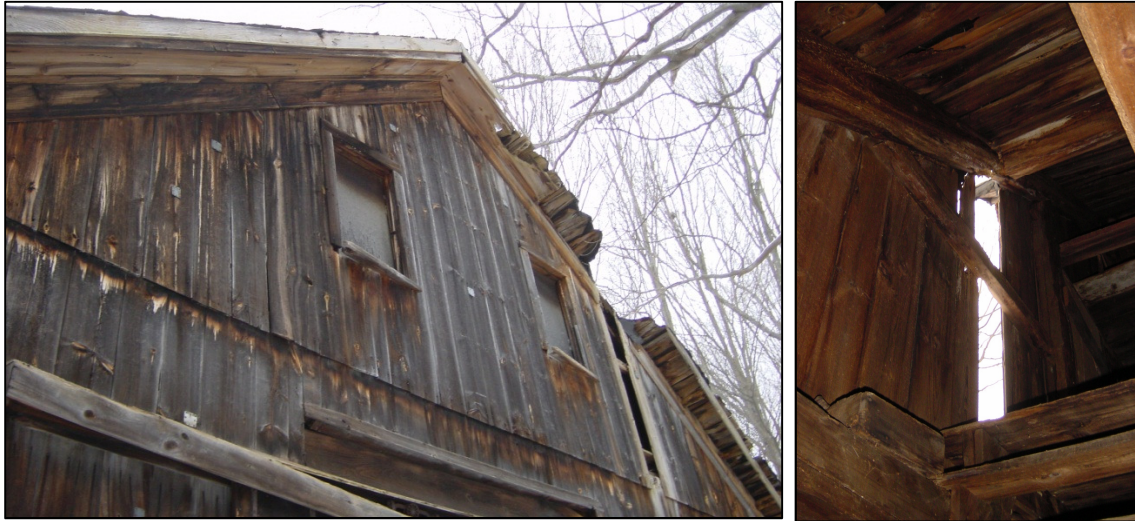
More serious than these older leaks is an active leak near the northeastern corner of the barn, shown in the photograph on page 9, left. This leak reportedly began with roof damage from a falling branch of a large sugar maple that stands just east of the barn. The branch damaged the

rake of the roof and penetrated the sheathing above the outer principal rafter, at a critical point just above the joint between the rafter and the purlin, as shown below, right. The leak was never repaired, and water penetration has progressively rotted the rafter at its center point, and the end of the purlin, threatening the integrity of a substantial portion of the northern roof plane. Continued water penetration here also threatens the original wall plate of the English barn, seen at the lower left corner of the photograph below, right.

This point of structural weakness can be temporarily supported by props extending up from the tie beam to the undersides of the rafter and purlin.

Short-term treatments must start with repair of the damage and leak near the northeast corner of the roof. Because of the crucial function of the principal rafters and purlins in this roof, and because this leak is precisely above the juncture of two such members, the leak threatens the entire slope of the roof. After the leak is repaired, it would be advisable to extend wooden props from the beam below the leak to the decaying rafter and purlin to ensure their support until the rafter can be replaced. At present, it is possible that the decayed front rafter is being supported and prevented from breaking largely by the vertical sheathing boards that are nailed to its side.

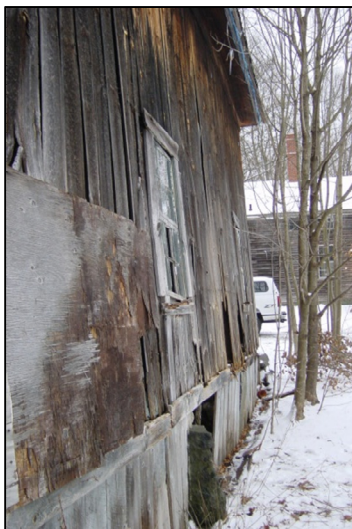
A more pervasive threat to the barn is the severe racking and twisting of the entire structural fabric, caused by the subsidence of the underpinning and piers, described on page 7. This movement has caused both localized and generalized distress, and now threatens the stability of the entire structure. Readings taken by Fred Emanuel on January 23, 2012, indicate that the barn is out of plumb by 4 inches in 48 inches from north to south, and 1¼ inches in 48 inches from east to west. As seen on page 8, an attempt has been made to prop the barn on its north side.

The degree to which the barn leans to the north can be seen by sighting along its southern wall toward the plumb walls of the dwelling beyond, as shown in the photograph at the left.

Because the modern ties of two-inch planking that were added to the roof frame do not extend continuously across the entire building, they have limited effectiveness in restraining the structure in its leaning condition. Pending the jacking of the building and its return to plumb and level condition, consideration might be given to cabling the structure from within to prevent its continued distortion, especially in the north-south direction.

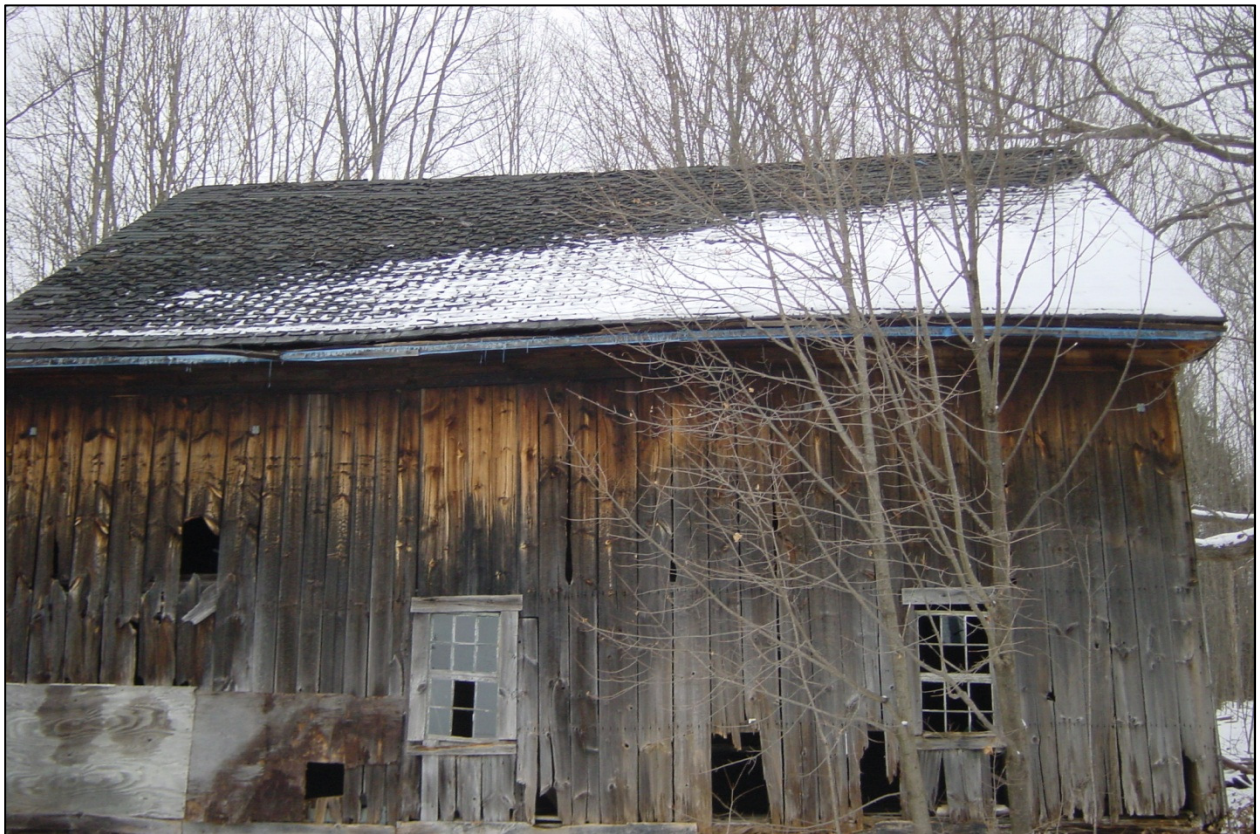
The considerable distortion of the frame through subsidence, tipping, and racking is visible on the southern elevation of the structure, as seen below. Particularly noticeable is the depression in the southwestern quadrant of the roof. This is caused by the subsidence of the former rear wall post of the English barn, mentioned above, which has telegraphed its movement to the rafter and purlin above. As seen in the diagram on page 6, the structure of the roof of the enlarged barn is not exceptionally heavy, and subsidence of a principal rafter and a purlin will be followed by subsidence of the lighter common rafters, and of the entire roof plane, as seen below.

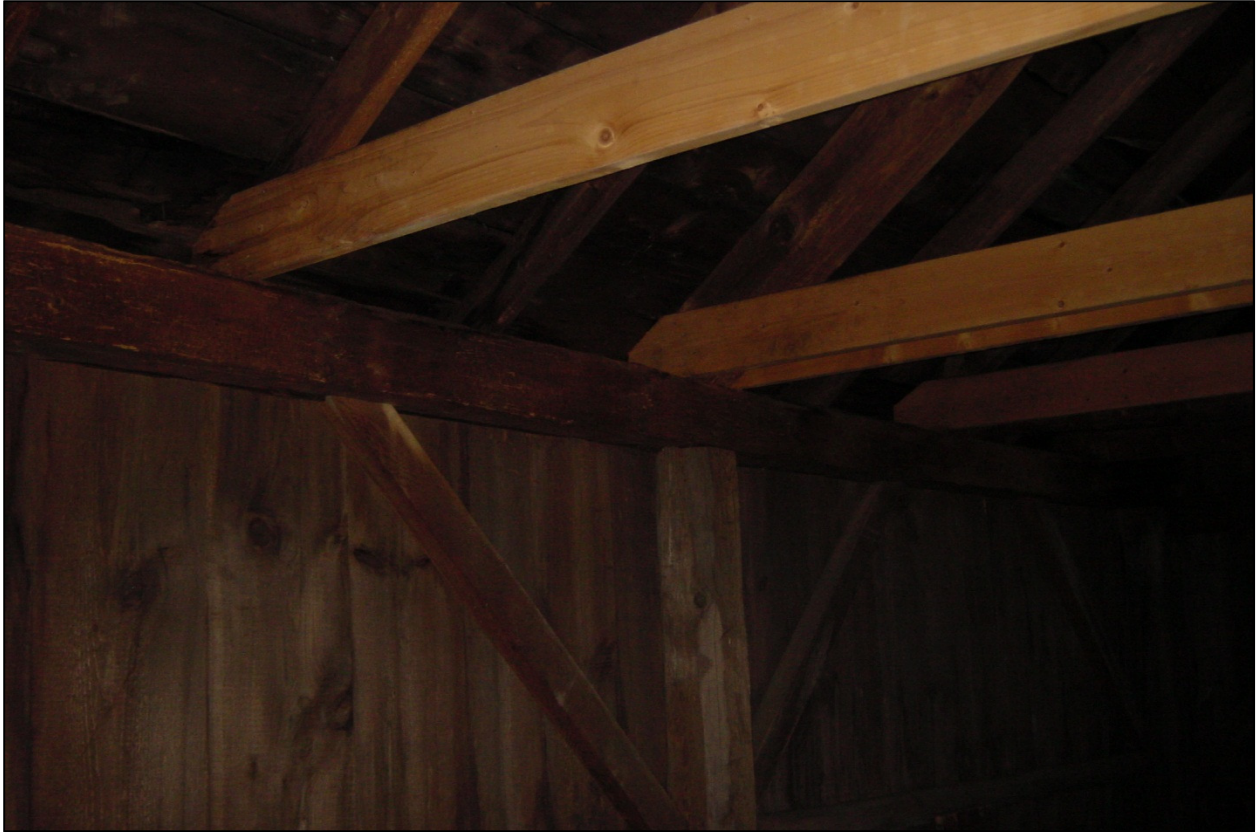
There have been attempts to restrain the movement of the upper frame of the barn. There was apparently a perception in recent years that the upper walls were spreading and the roof was flattening, probably due to snow loading. For this reason, considerable effort was made to tie the north and south walls of the structure together through the insertion of sistered ties through the barn at the level of the wall plates, as seen in the photograph on page 11. Similarly, a number of collar ties were nailed to the sides of both principal and common rafters at about the midpoint of the height of the roof frame. These new members are all two-inch planking.
