OLD PATCH HOUSE, RHODODENDRON STATE PARK EVALUATION OF EXISTING CONDITIONS AND REVIEW OF PROPOSED REHABILITATION

JAMES L. GARVIN

AUGUST 8, 1984

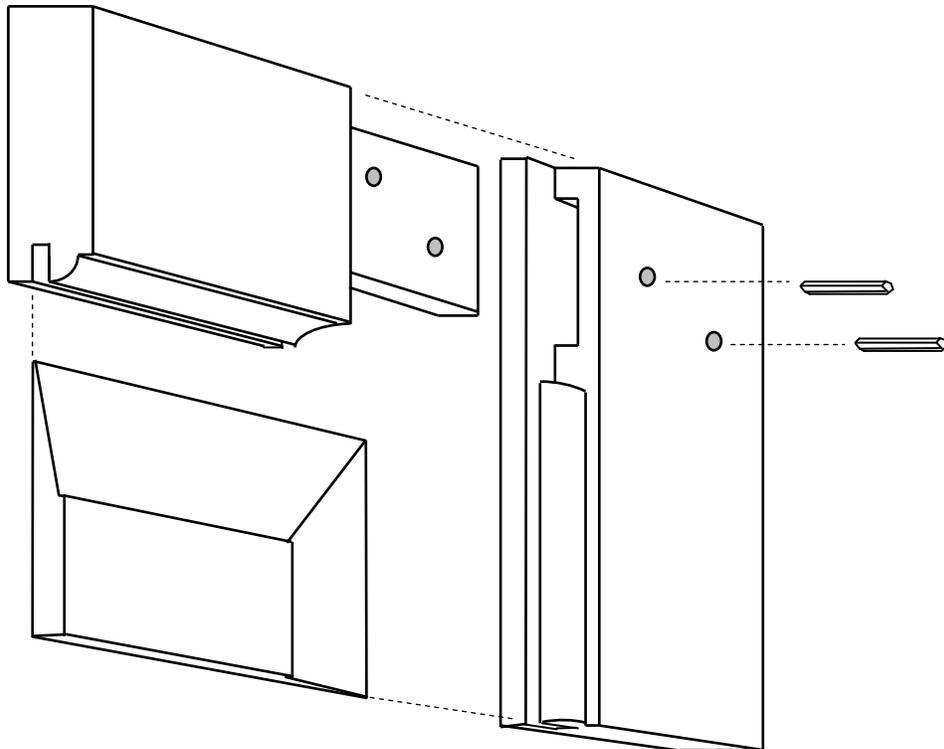
Existing Conditions: The Patch House is a one-and-a-half story dwelling which retains enough early detailing to be dated at about 1800. The style of paneling in the house is generally of the Georgian type common during the 1700s (raised panels with ovolo mouldings planed into the stiles and rails; see drawing below), yet most of the mouldings in the house

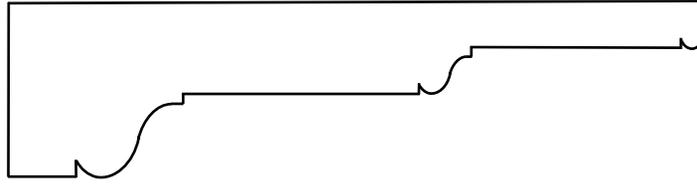
have the quirked profiles which began to be popular in New England in the 1790s (see drawing below).

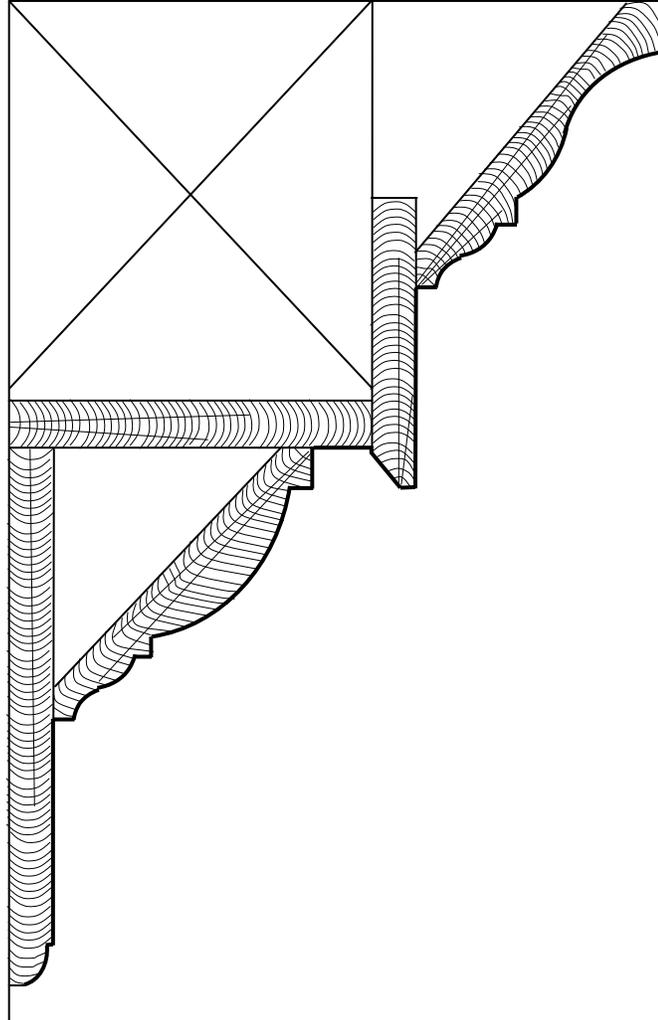
Care should be taken not to damage the roof trim during re-shingling. Of particular concern are the rake boards, which appear to be original on both ends of the house, and the eastern two-thirds of the north eaves cornice, which retains both bed and crown mouldings (the western third of the cornice was interrupted by an ell, now removed, which intersected the main house at the western third of the rear elevation).
