REPORT ON THE JOHN GREELEY HOUSE
3 SHAKER HILL ROAD
ENFIELD VILLAGE, NEW HAMPSHIRE

JAMES L. GARVIN
MAY 26, 2012
REVISED MAY 31, 2012

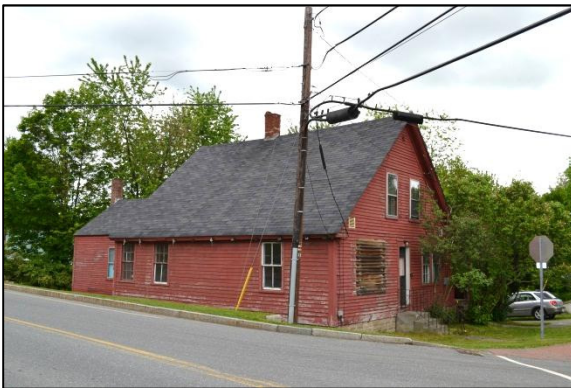
Above, left: Present front (southwest) and side elevations.

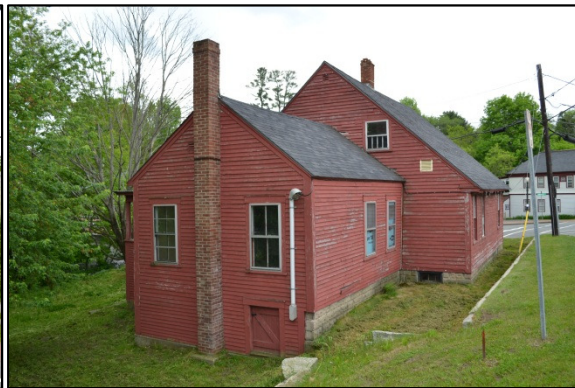
Above, right: Present rear elevation.

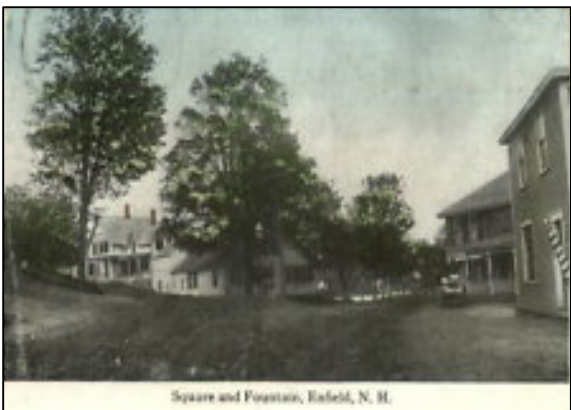
Left: Image from a post card of c. 1910, showing the location of the wing flush with the side wall of the house, and attached two-story barn.

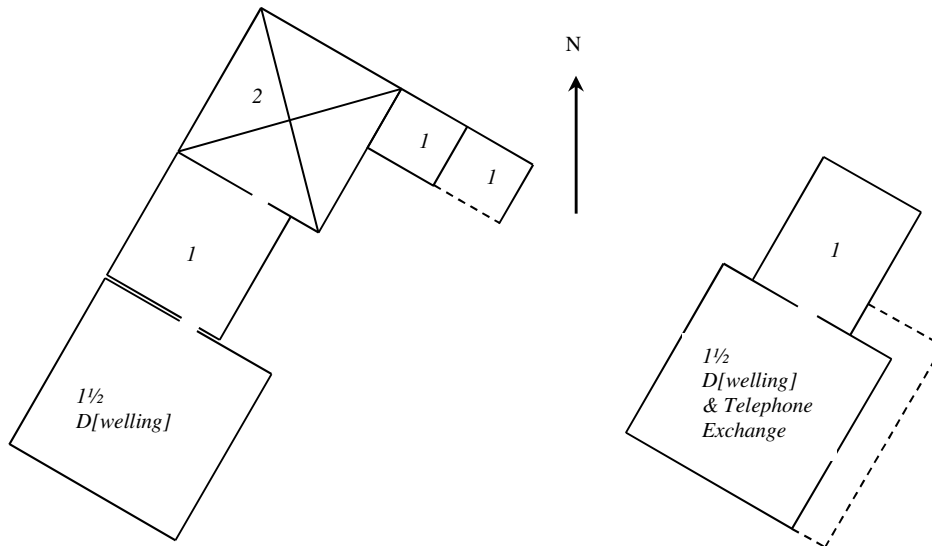
Above, left: Depiction of the Greeley House on Sanborn Fire Insurance Maps, 1893 through 1923 (with minor variations).

Above, right: Depiction of the Greeley House on Sanborn Fire Insurance Map, 1923, updated to 1935.

The depictions of the house on the maps from 1893 through 1923 suggest that the main dwelling and the one-story rear ell were not firmly attached to one another. There may have been a small gap between the two structures.

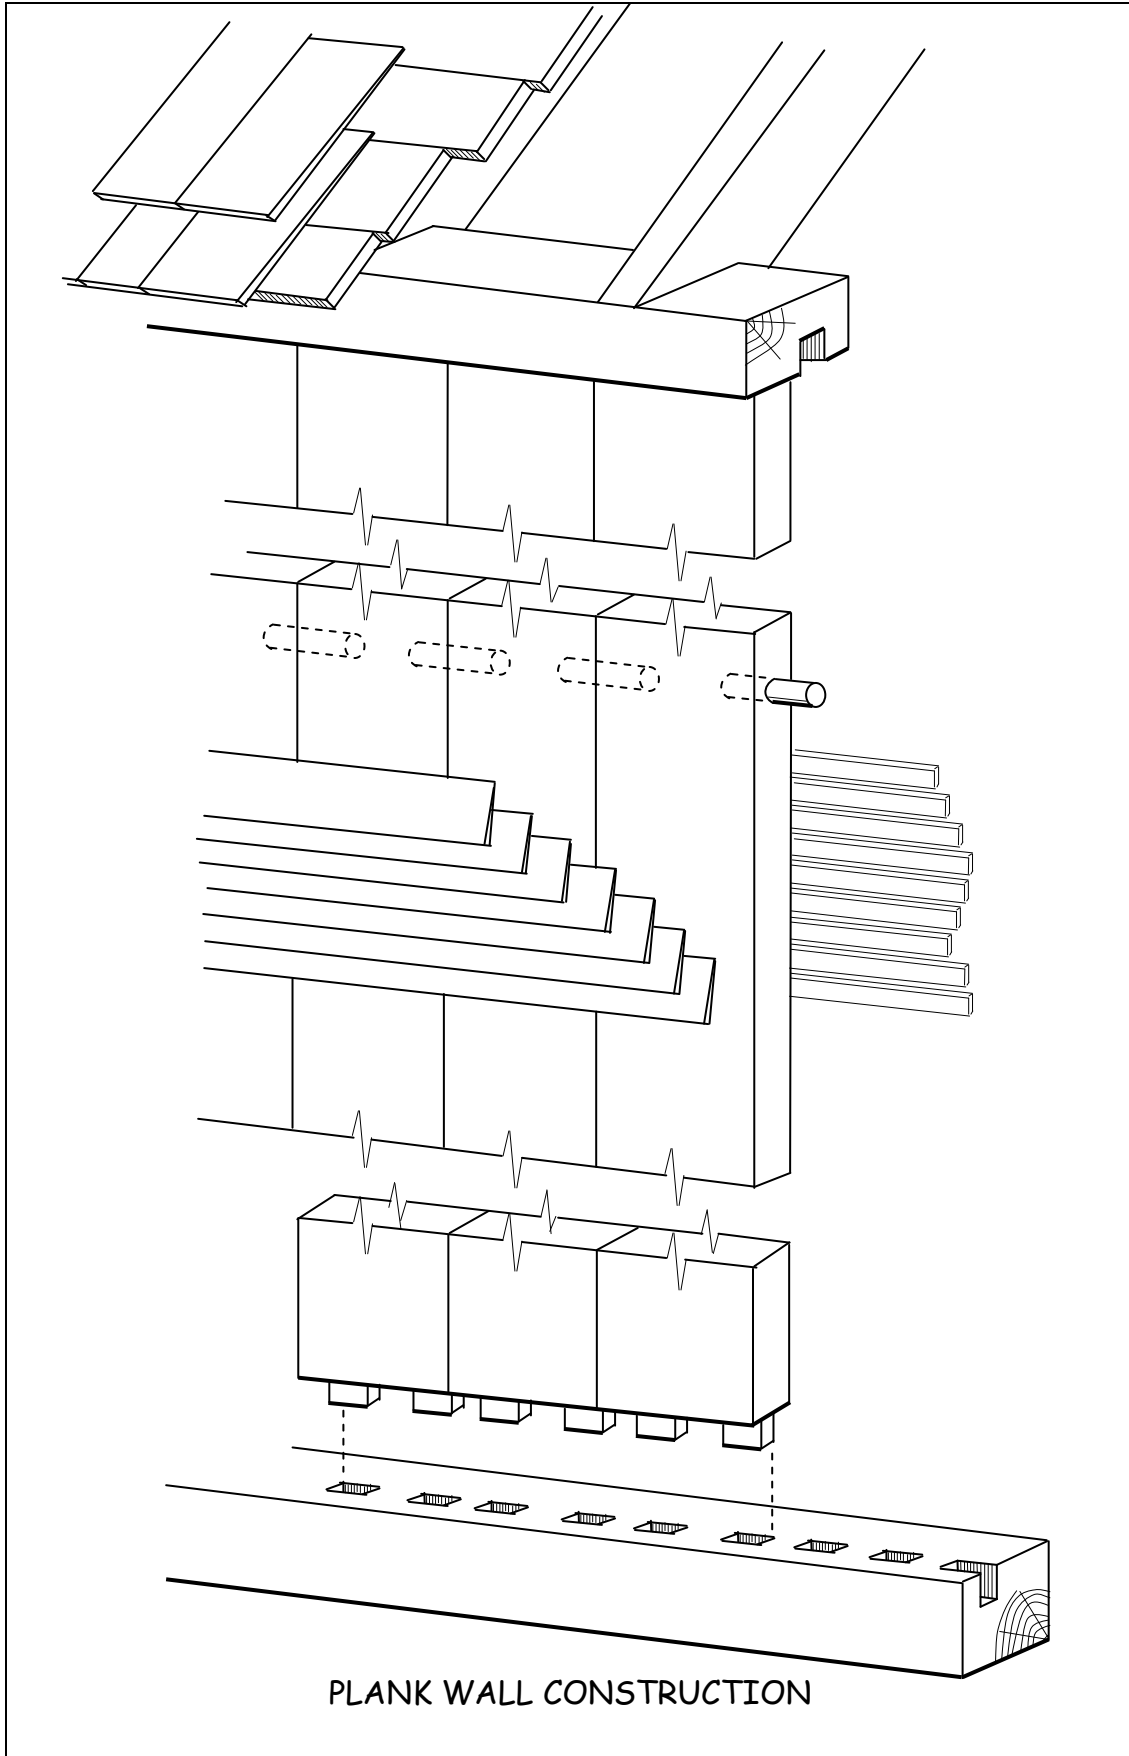
PLANK WALL CONSTRUCTION

Because the plank-wall construction is currently visible only where a partition has been partially removed between a front and a rear room on the southeastern side of the main house, it is presently impossible to know whether the construction of the older portion of the Greeley House includes corner posts and pins or dowels between adjacent planks, as shown on page 4. It is clear that the tenons on the top ends of the planks are pinned into the wall plates, using trenails driven from the outside of the plates.

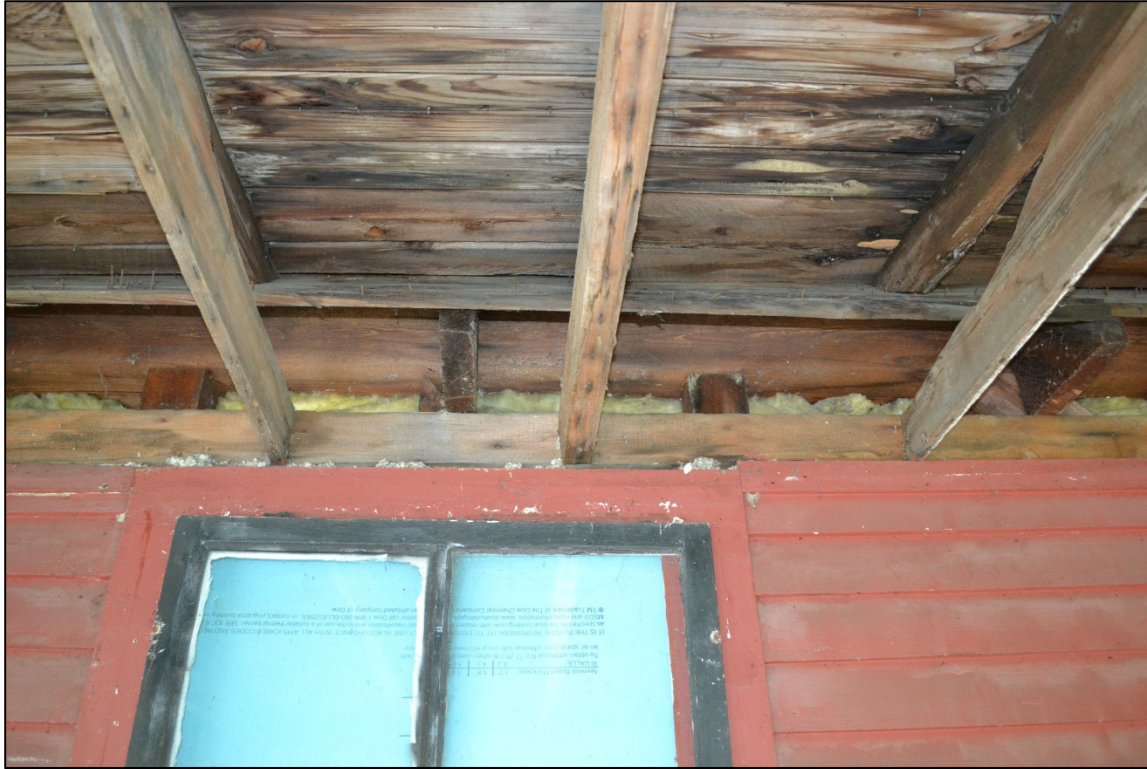
Like the plank-walled section of the building, the framed addition is presently obscured by wall and ceiling coverings so that its construction cannot be observed in detail. One of the best current vantage points for evaluating the character of the frame is found beneath the porch on the southeastern side of the building. Here, removal of a porch ceiling covering has disclosed the side wall plate of the house, the tops of studs and braces, and the projecting feet of two common rafters, which are widely spaced at about four feet on centers, as seen on the following page.

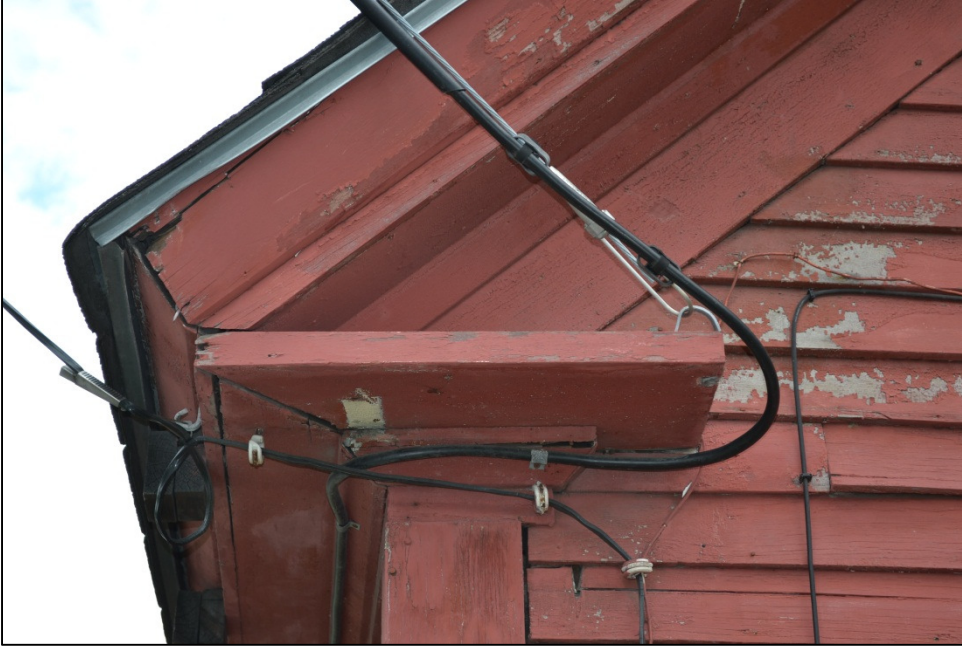
Subsequent remodeling, discussed below, has largely obliterated the interior architectural character that was given to the remodeled and enlarged Greeley House circa 1835. On the exterior, the original detailing, where it survives, is characteristic of the Greek Revival style, with plain, flat, diagonal mouldings, as seen on the exterior cornice, below:

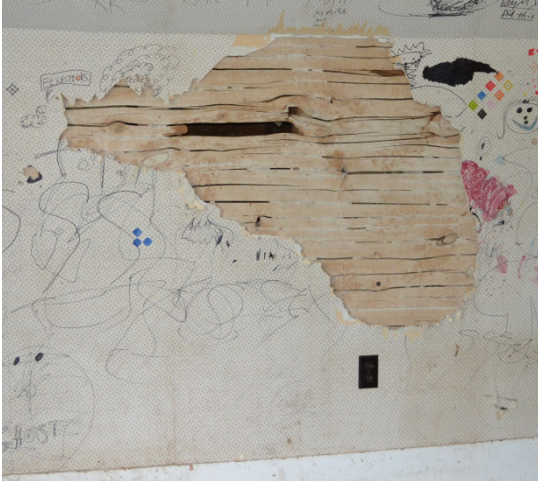
Exposed area of split-board lath

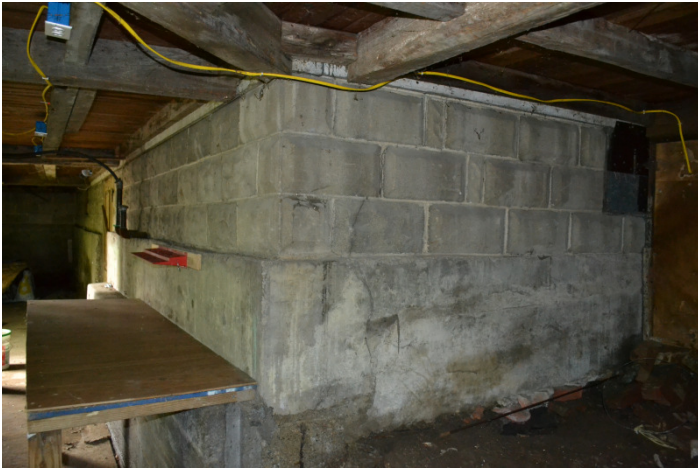
To accomplish these changes and improve the house, the Walbridge family placed a new, integrated foundation beneath the main house, probably raising the building for a second time. This foundation is composed of poured concrete up to grade level. Above grade, the foundation is built of hollow concrete blocks with rusticated faces that resemble split stone, as seen in this photograph. An underpinning wall of the same rusticated concrete blocks also supports the wing on the northwest side, toward Main Street, where the elevation of the street is considerably higher than the foundation of the wing. A full basement of the same construction was provided beneath the circa 1835 front portion of the house, which may previously have stood over a crawl space; there is no clear evidence of the substructure of 1835. As shown on the map, high porch was added along the southeast side of the house around 1930, wrapping around the northeast corner to intersect the rear wing.

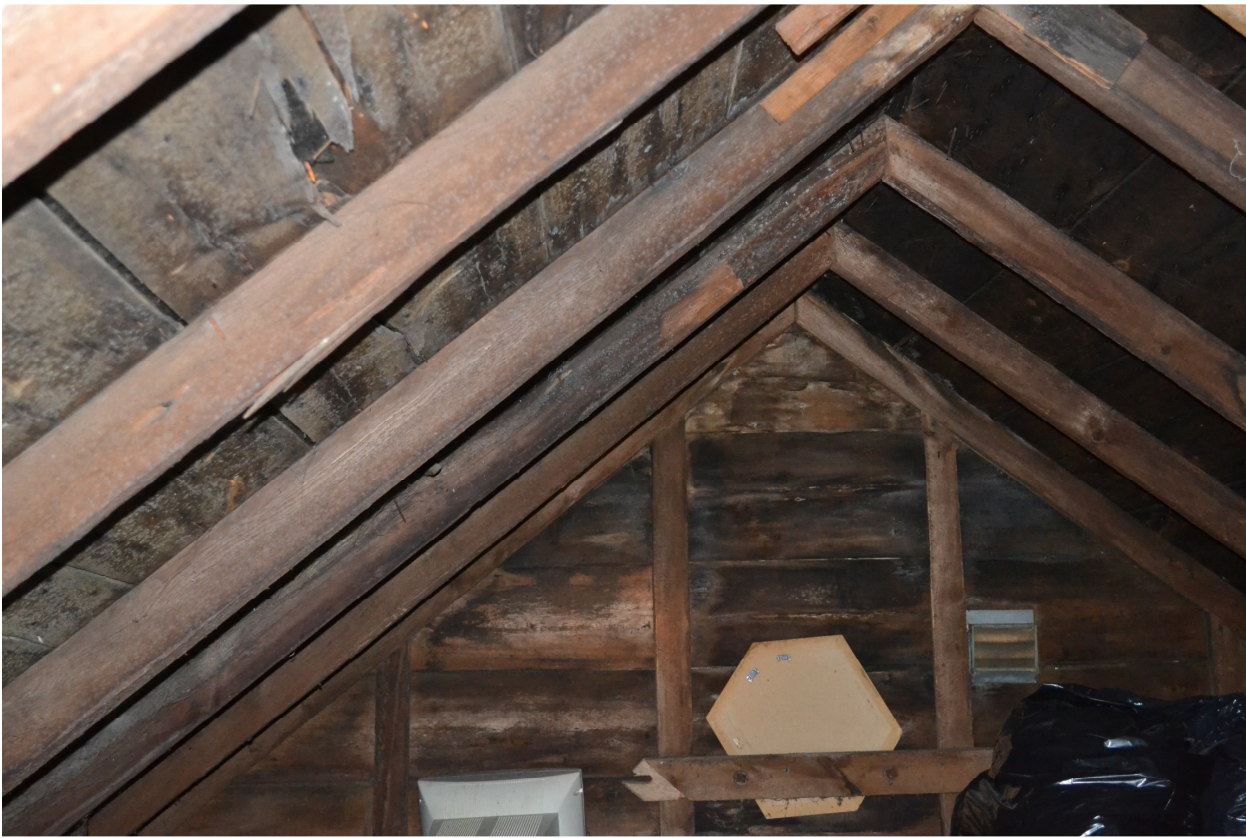
is constructed much like the front section of the main house, built circa 1835. The rafters are sawn on a reciprocating (up-and-down) sawmill, and, like those on the main roof, are spaced very widely apart. The rafters of the wing differ from those of the main roof in lacking bird's-mouth joints and deep overhangs at the eaves. Although the roof frame of the main house was not studied in detail, it seems likely that the two frames will be found to correspond closely in design, materials, and, probably, in date.

Roof frame of the wing of the Greeley House, with widely-spaced common rafters and no ridgepole.
