**REPORT ON THE UNION HOUSE TAVERN
1260 DARTMOUTH COLLEGE HIGHWAY
HAVERHILL, NEW HAMPSHIRE**

JAMES L. GARVIN
MAY 22, 2013

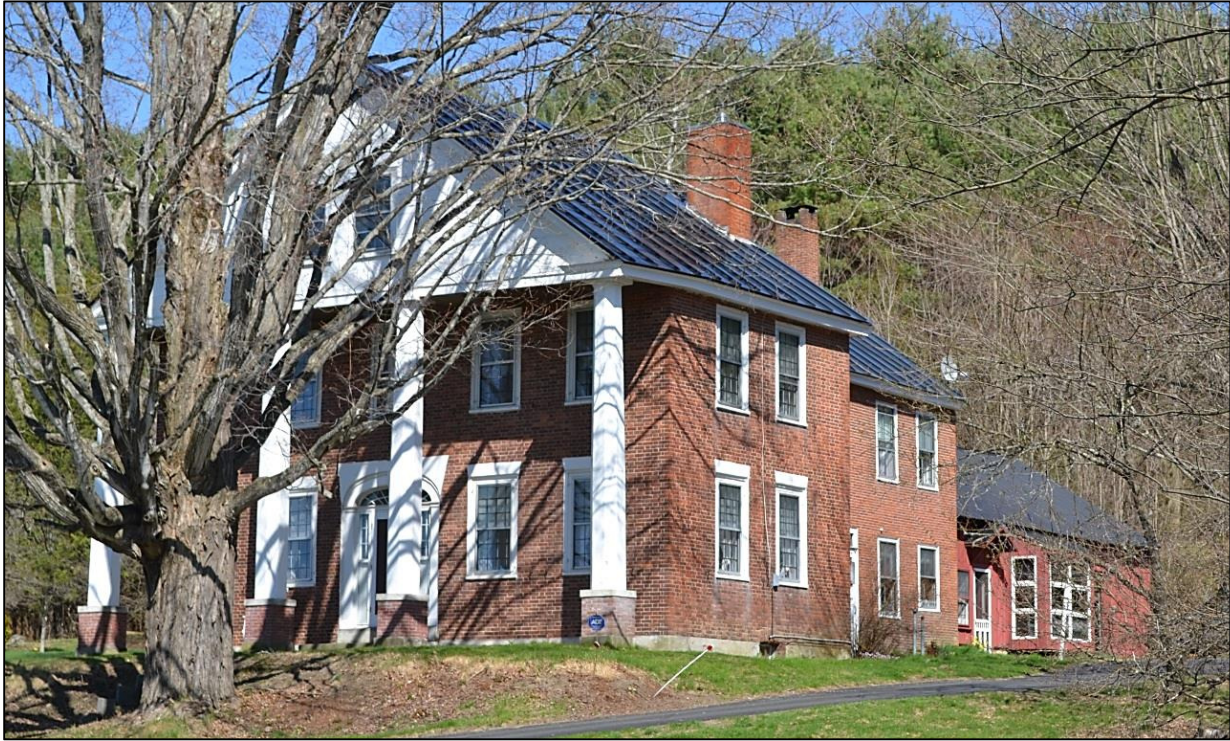
West and south elevations, Union House Tavern, Haverhill, New Hampshire, looking northeast.

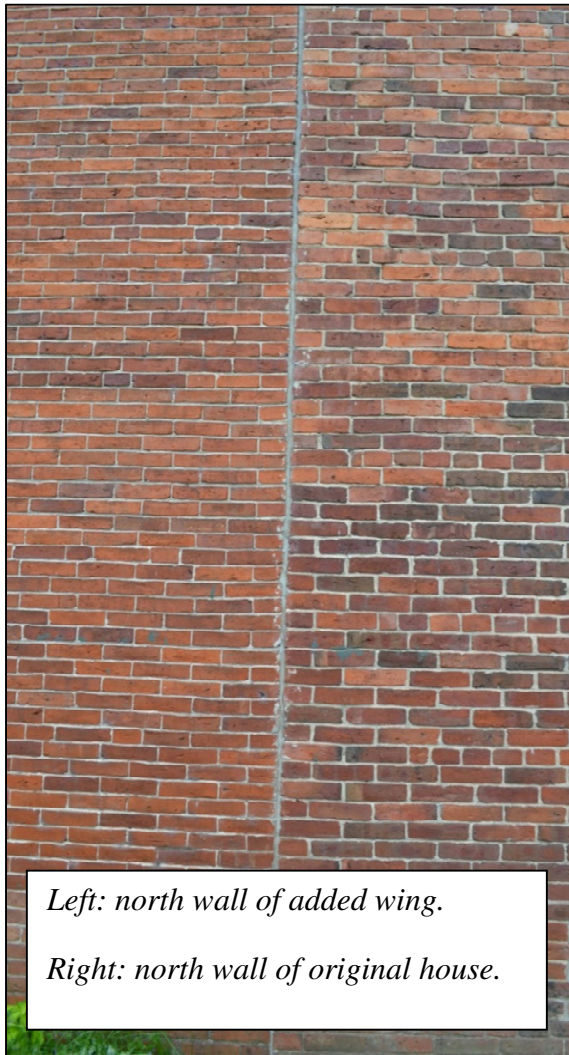
Left: north wall of added wing.

Right: north wall of original house.

height. As seen in the photograph above, these smaller bricks are not bonded with the brick courses of the original house.

As noted above, the lesser elevations of the original house were laid in common bond. On these elevations, header courses are employed, on average, every seven to twelve courses, and utilize only headers, as seen in the photograph above. The walls of the wing also employ common bond. By contrast with the walls of the original house, however, those of the ell have header or bonding courses every eleven or twelve courses, and these courses employ alternating headers and stretchers instead of all headers.

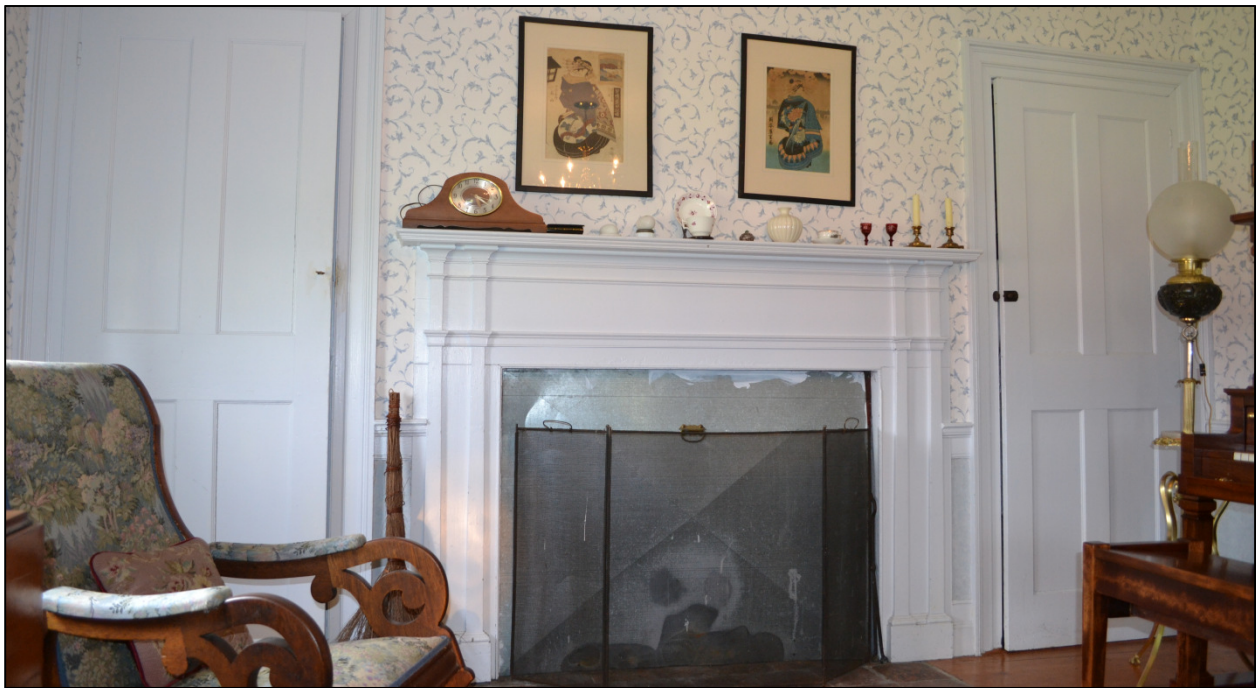
North parlor, Union House Tavern, Haverhill, New Hampshire. All doors in this room display flat panels and thus reflect a characteristic detail of the Federal style.

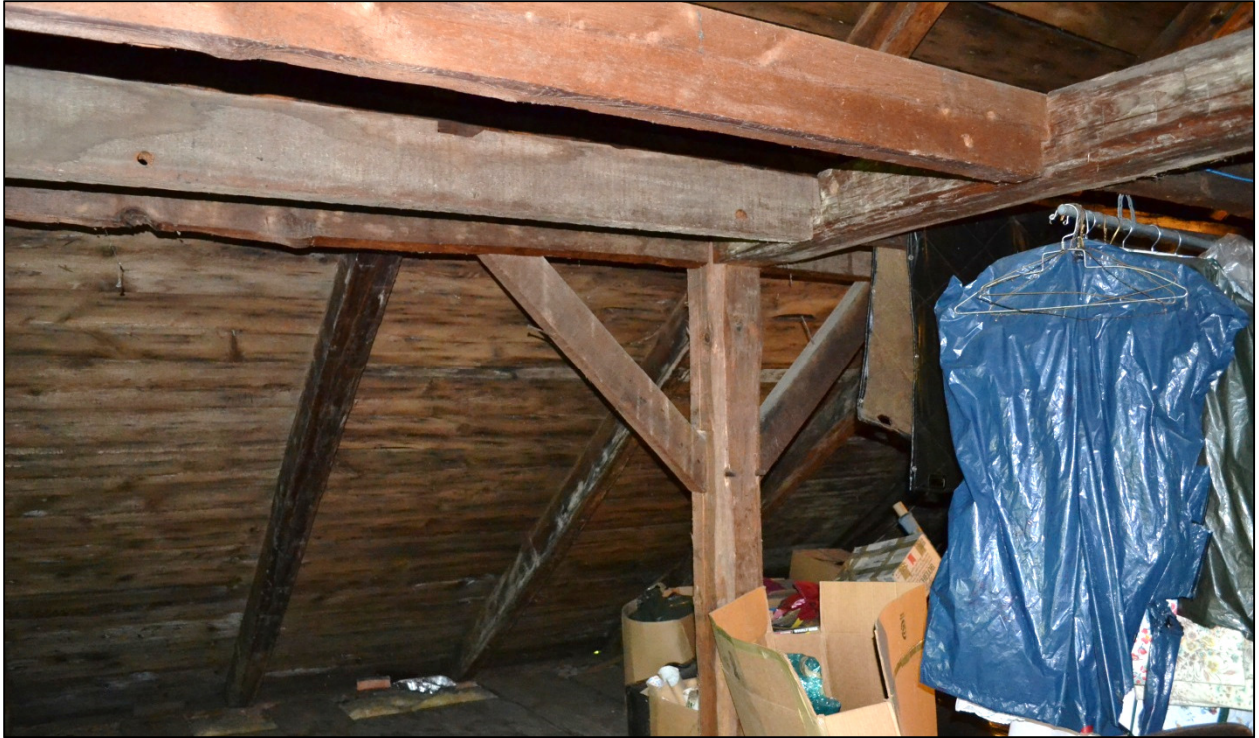
Added roof frame of the Union House Tavern, looking northeast, showing one post of the boxlike supporting framework of the broad roof.

Overhead joists, some now missing, indicate an unfulfilled intention to provide a floor, and perhaps a plastered ceiling, at the top of the added frame.

The boxlike supporting frame was employed only above the original house. It serves as a truss system to support the very long hewn rafters of the broad-gabled roof that covers the original building. The added wing, being narrower than the older house, is spanned by hewn rafters without support from below. As seen in the photograph below, the rear (east) face of the broad-gabled roof is clapboarded above the brick rear wall of the original house.

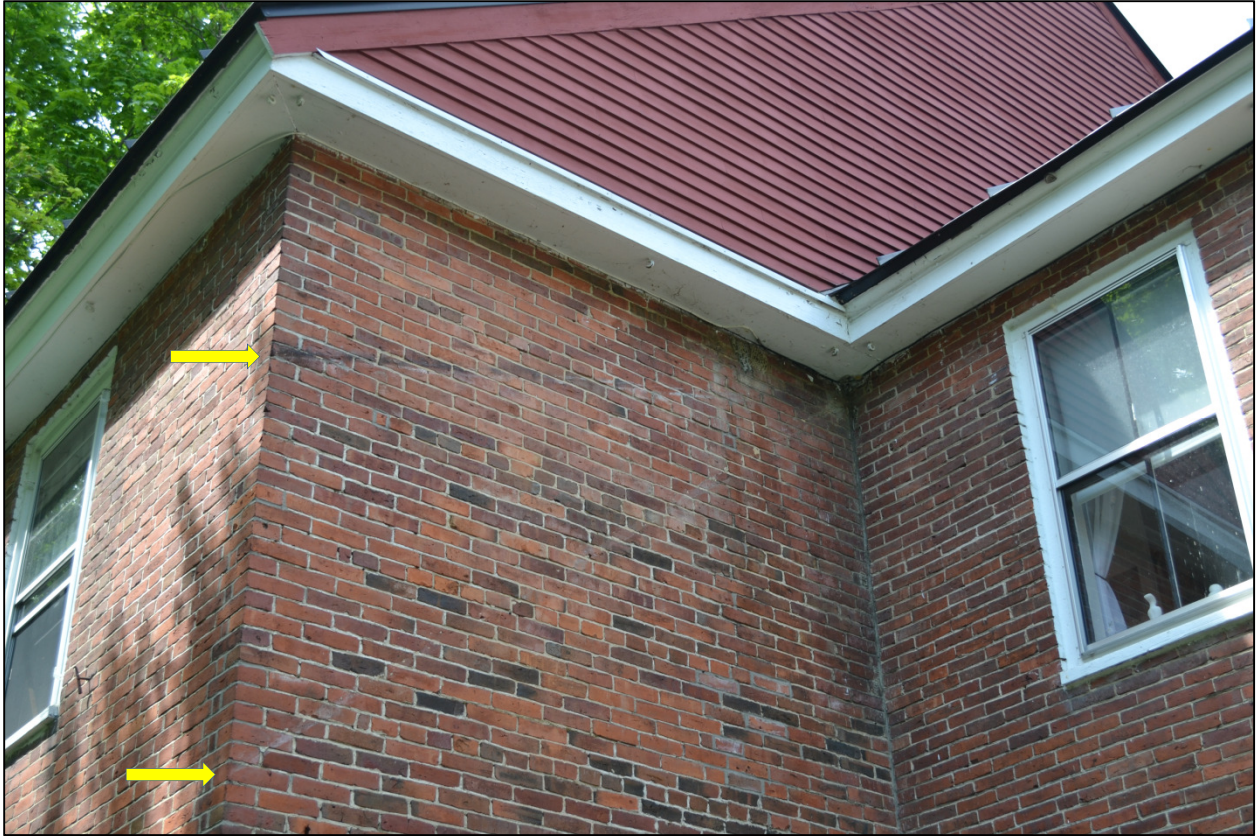
Also shown in this photograph are paint lines (see arrows) that apparently indicate the former presence of two roofs that once sheltered the upper walls of at least part of the southern wall of the wing. Since there is no indication that these roofs were flashed with lead where they intersected the brick wall of the original house, they may have been rather insubstantial in construction. The lower of these former roofs would have blocked the view, and most of the light, from the second-story windows of the ell. Possibly these roofs were associated with structures that preceded the brick wing and were removed when the existing wing was built, or possibly they mark the location of wooden leaders that once conducted rainwater from gutters at the eaves of the wing.

Rear (east) wall of the original Union House (left) and south wall of the added wing (right), looking northwest.

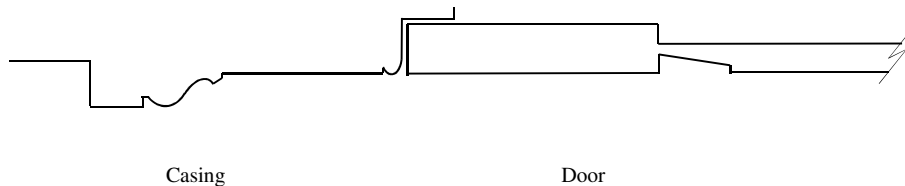
Door and door casing in dining room, Union House Tavern, Haverhill

The backband moldings of the door casings in the dining room, and the doors with unmolded stiles and rails, are characteristic of post-1830 joinery in the Greek Revival style. Nearly identical details appear in Asher Benjamin's book, *The Practical House Carpenter* (Boston, 1830), and would have been recognizable in the 1830s as modern in style. It appears that special care was taken to make this public room, essential to the operation of a good tavern, an example of a comfortable and stylish space for guests.

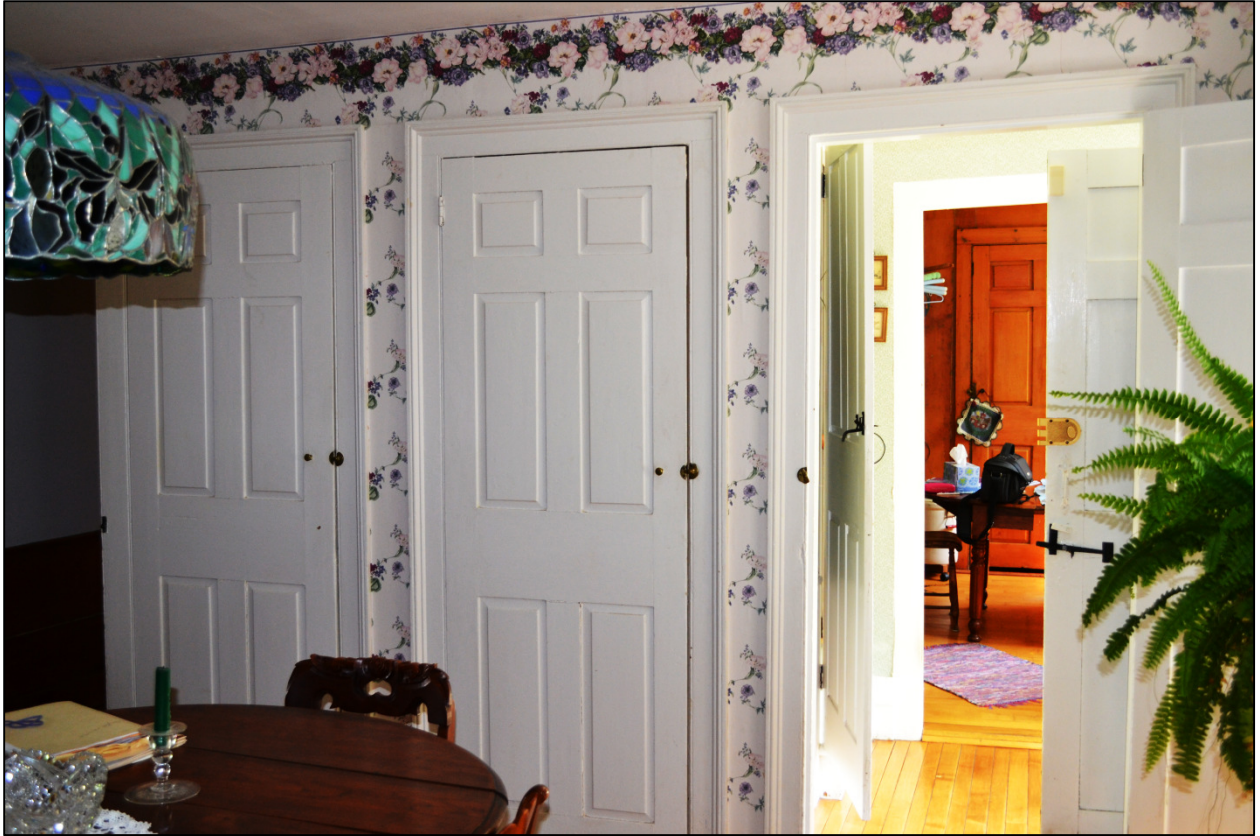
Dining room, looking east toward kitchen, Union House Tavern, Haverhill
