**REPORT ON THE OLD HAVERHILL ACADEMY BUILDING
(PEARSON HALL)
HAVERHILL CORNER, NEW HAMPSHIRE**

**JAMES L. GARVIN
NOVEMBER 30, 2008**

This report is based on an inspection of the old Haverhill Academy Building (built in 1816 and renamed Pearson Hall in 1897) on April 28, 2008. The purpose of the inspection was to address several questions about the design, evolution, and condition of the building, thereby providing a fuller context for the development of a program of rehabilitation for the structure.

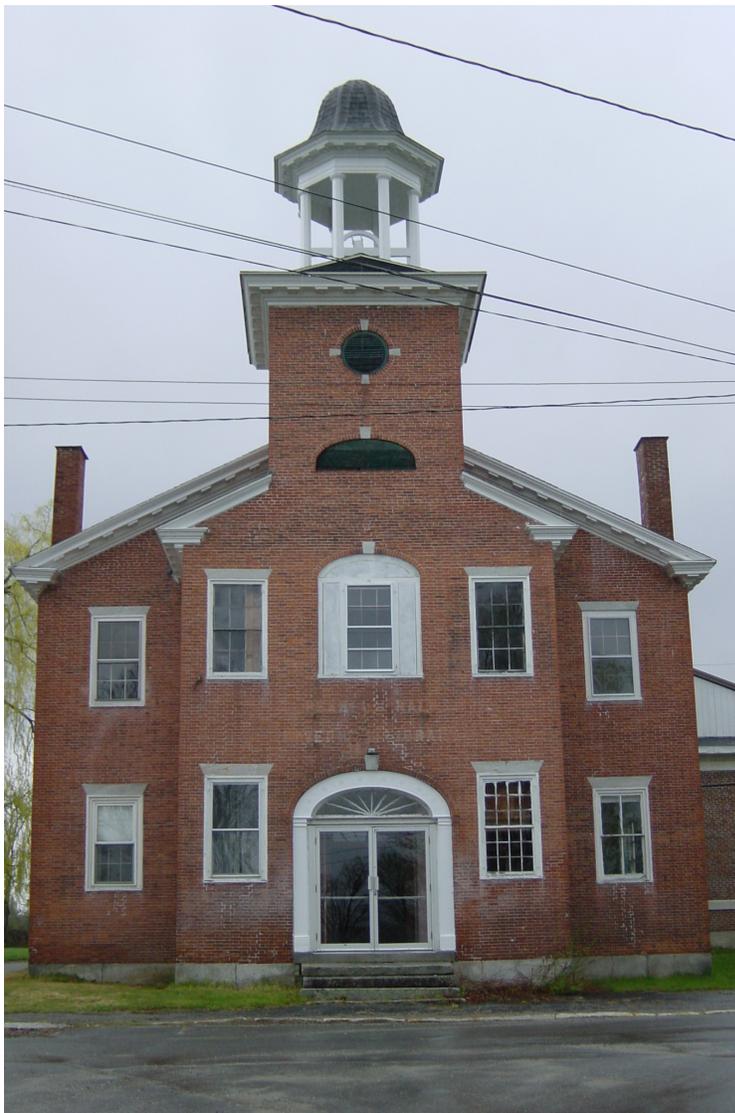
Front (west) elevation, Haverhill Academy Building (Pearson Hall), built in 1816. Photograph: April 2008.

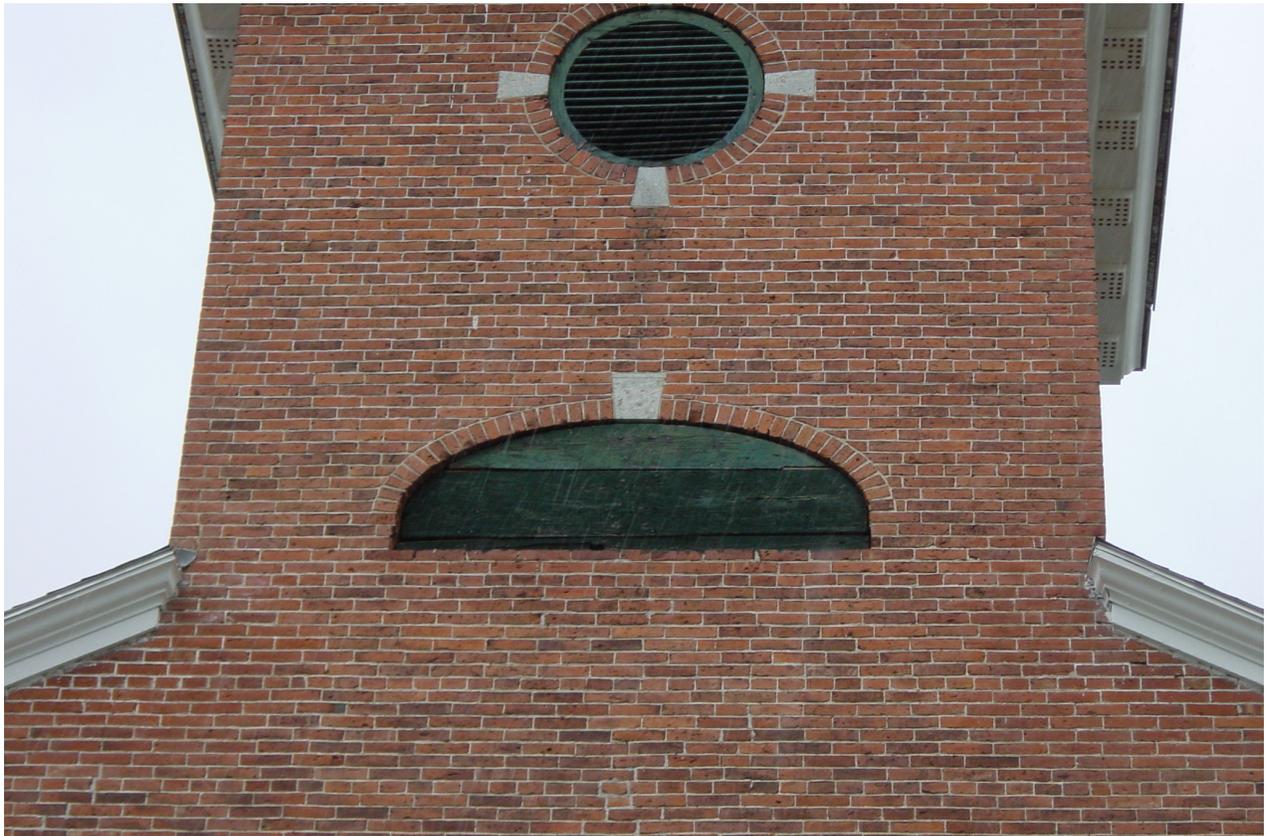
The two openings in the tower above the second story present additional puzzles. The circular aperture is treated as one might expect, with a louvered blind placed over a backing of green-painted boards. A similar treatment might be expected in the semielliptical opening. All available photographs of the building, however, show only board infill in this opening. Although these photographs are indistinct, they seem to record a full board or plank frame within this opening, having a sill, a curved to rail that follows the brick arch, and three vertical stiles. The two outer stiles appear to have been placed in vertical alignment with the window frames of the “Palladian” window below. The voids in this structure appear to be filled with boards. The current crudely-made board construction is evidently a makeshift of the twentieth century.
