REPORT ON THE HALL-DYER HOUSE
25 GREAT HILL ROAD
TAMWORTH, NEW HAMPSHIRE

JAMES L. GARVIN
OCTOBER 1, 2012

This report derives from an examination of the Hall-Dyer House on September 27, 2012. The purpose of the report is to identify the character-defining features of the dwelling as a means of ensuring the protection and preservation of those features as the Tamworth Historical Society rehabilitates the house for its headquarters.

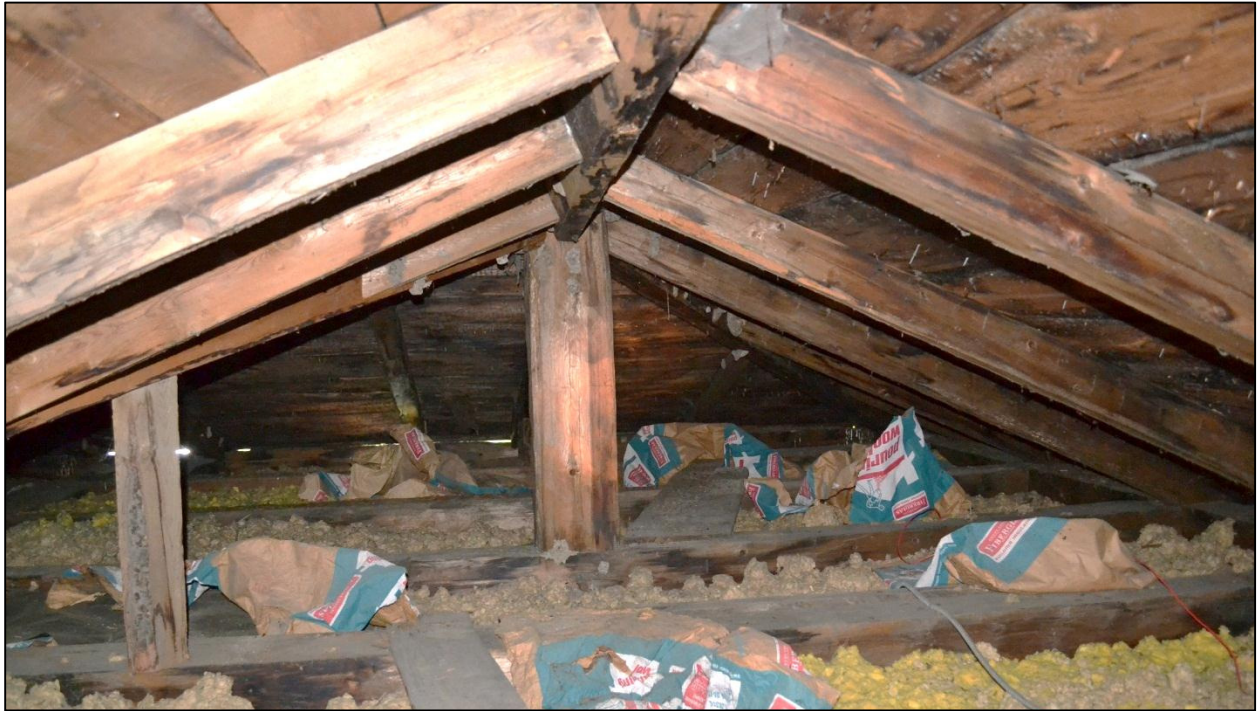
Hall-Dyer House, Tamworth, New Hampshire: Roof frame of main house, looking east

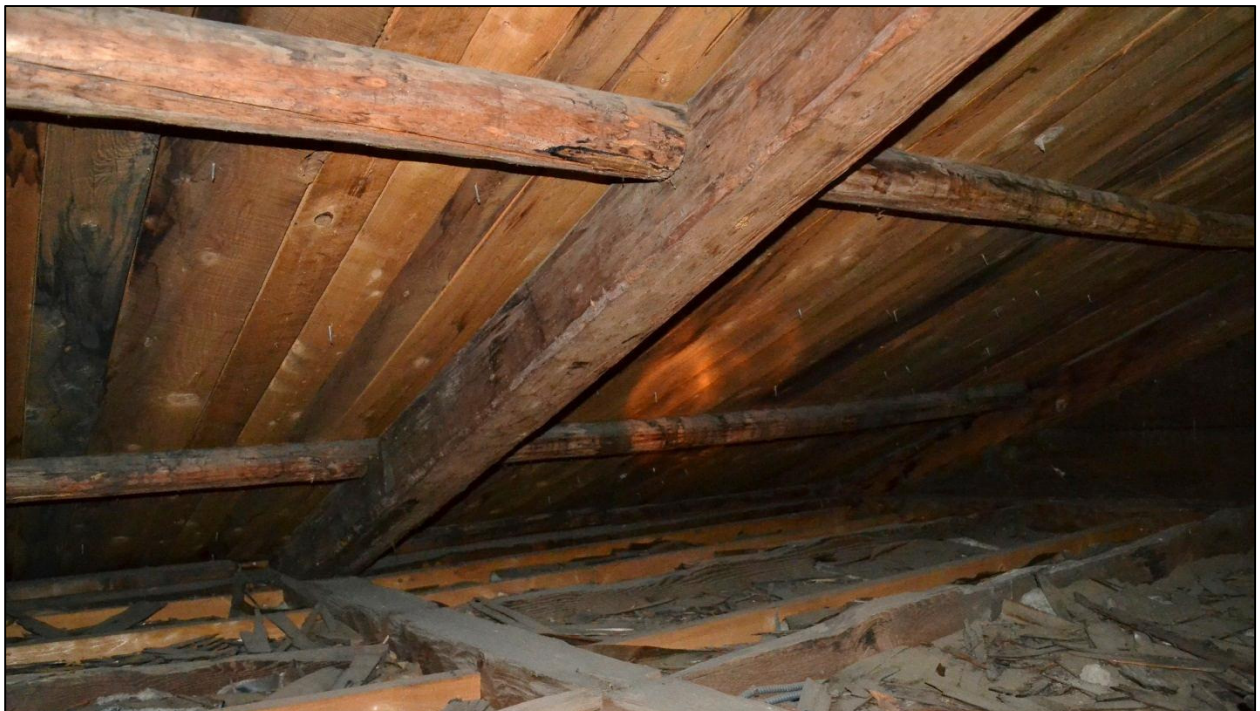
Hall-Dyer House, Tamworth, New Hampshire: Roof frame of added wing, looking northwest, showing a principal rafter and two horizontal purlins. The roof sheathing is modern.

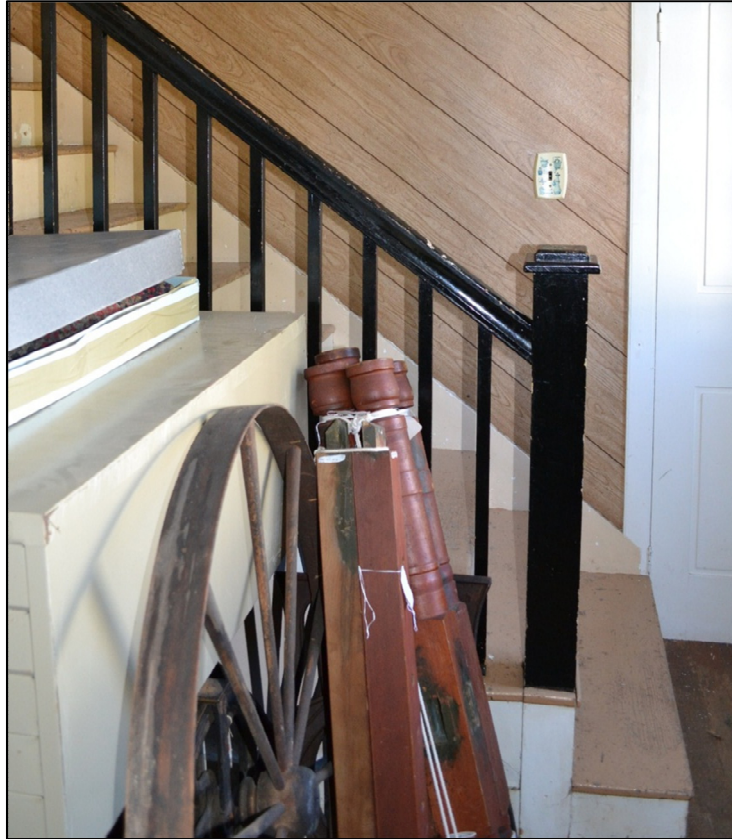
Above: Early twentieth-century balustrade in wing

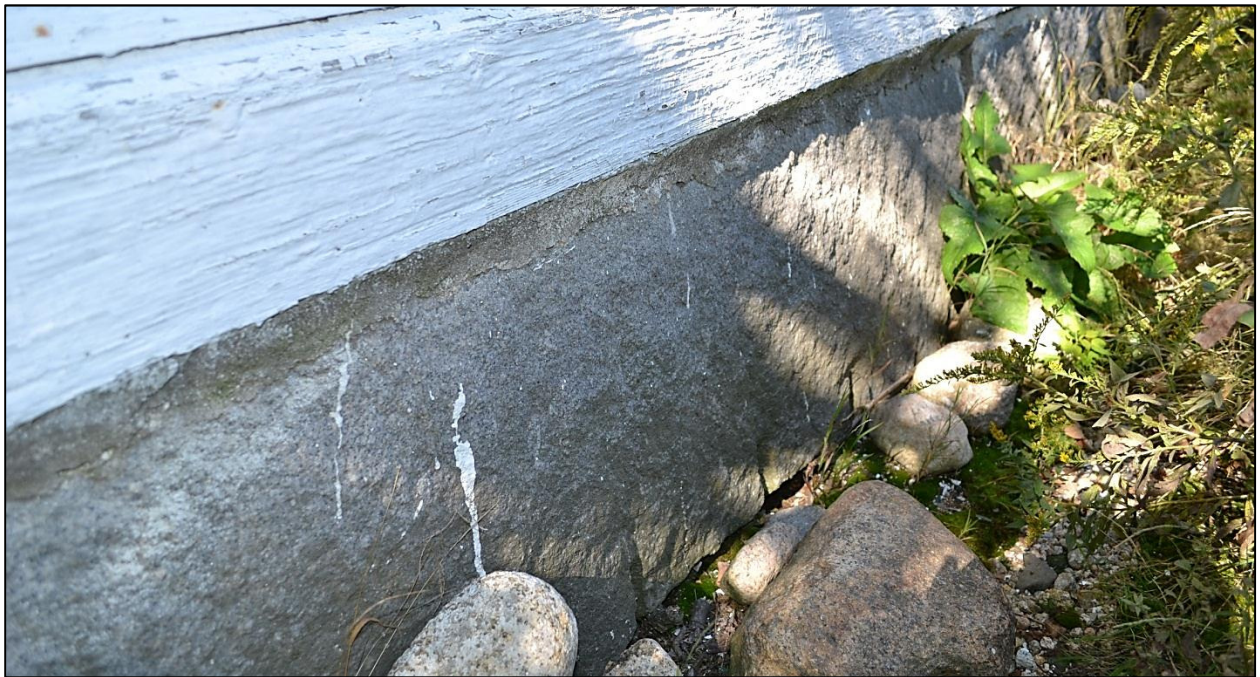
Underpinning stone on the south elevation (façade), showing plug drill holes along bottom edge

Portsmouth and Exeter, where many eighteenth-century houses were modernized during the nineteenth century. In the case of the Hall-Dyer House, however, so many other attributes point to a date after 1830 that the underpinning stones may reasonably be regarded as original.

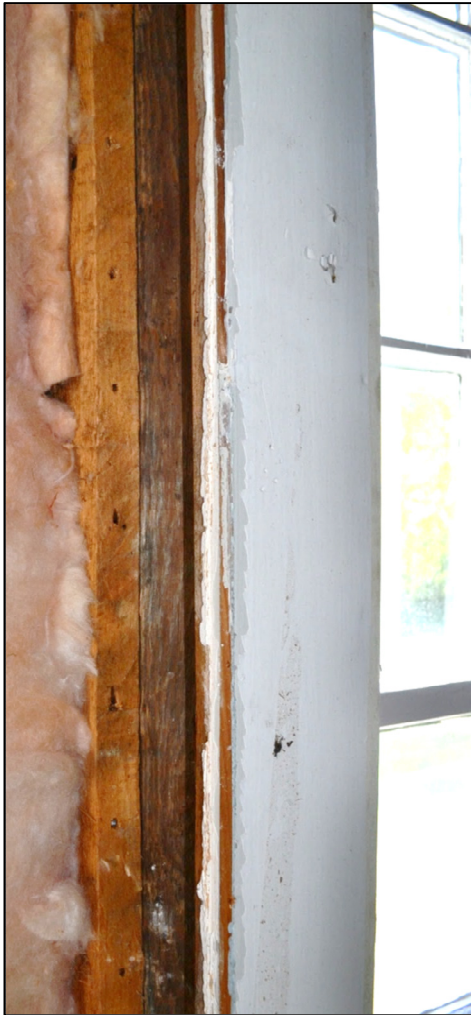
Left: Parlor window, showing a single set of nail holes on the stud for lath

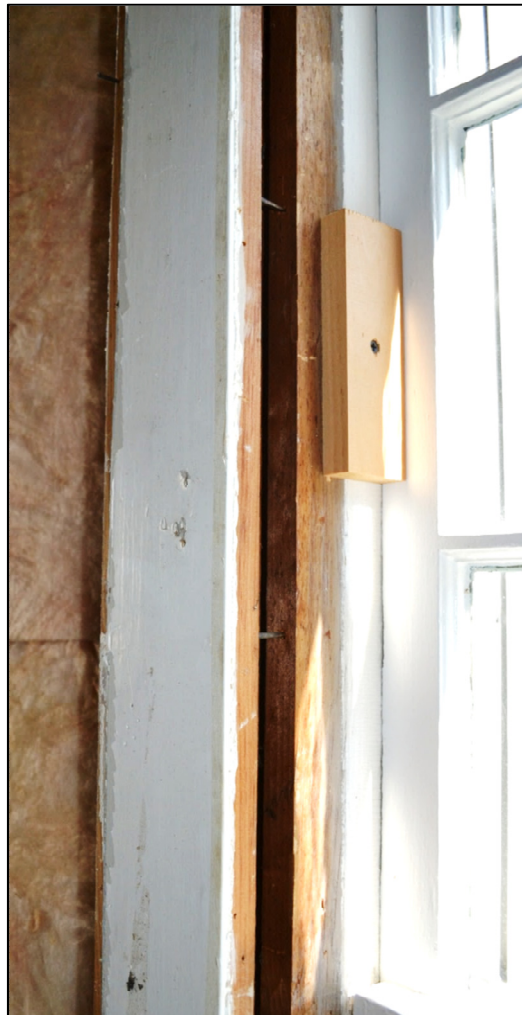
Right: Parlor window, showing a single set of nail holes for the window casing

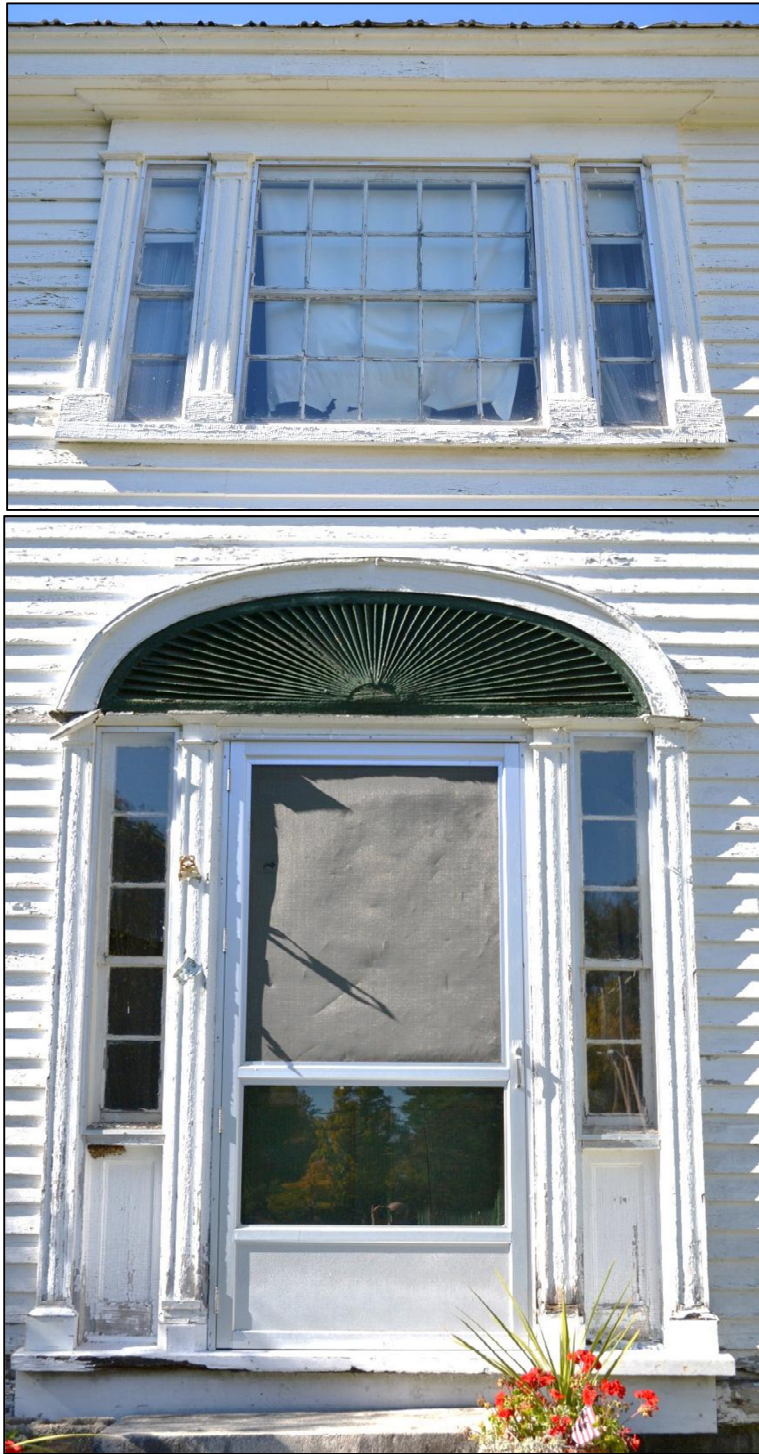
Hall-Dyer House: Front doorway and second-story stairhall window

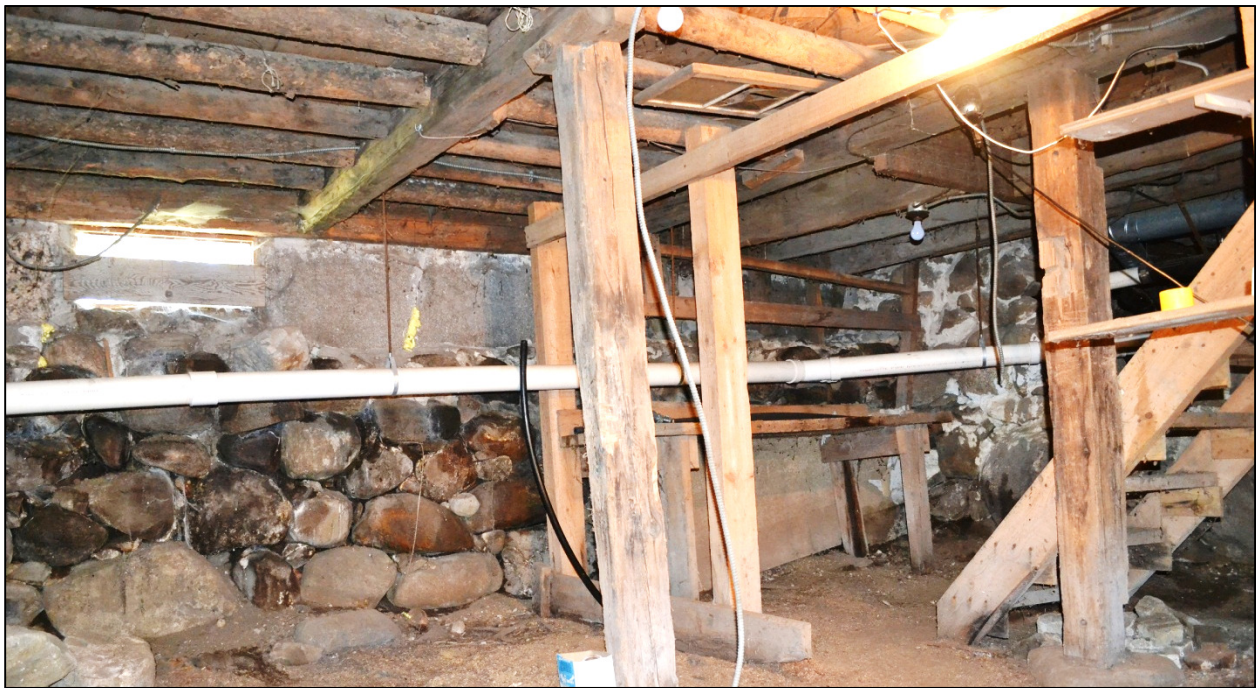
Hall-Dyer basement, looking southwest, showing fieldstone walls and split granite underpinning

Like all stone foundations, this foundation is pervious to water infiltration from the roof and from the surrounding soil outside the house. As a consequence, the basement is damp. The result of a damp basement is inevitably the suffusion of water vapor into the air in the upper zones of a building. Water vapor can result in levels of relative humidity that are too high for the proper storage of museum collections, and, under certain ambient conditions, can condense as liquid water or hoarfrost in the winter.

Since the foundation walls and the basement are character-defining features of the Hall-Dyer House, the treatment of the basement and the crawl spaces should be considered carefully and

with respect to moisture management for the entire building. The subject of moisture management in historic buildings is complex, and outside the scope of this report, but will require attention in adapting the building to the needs of the society.

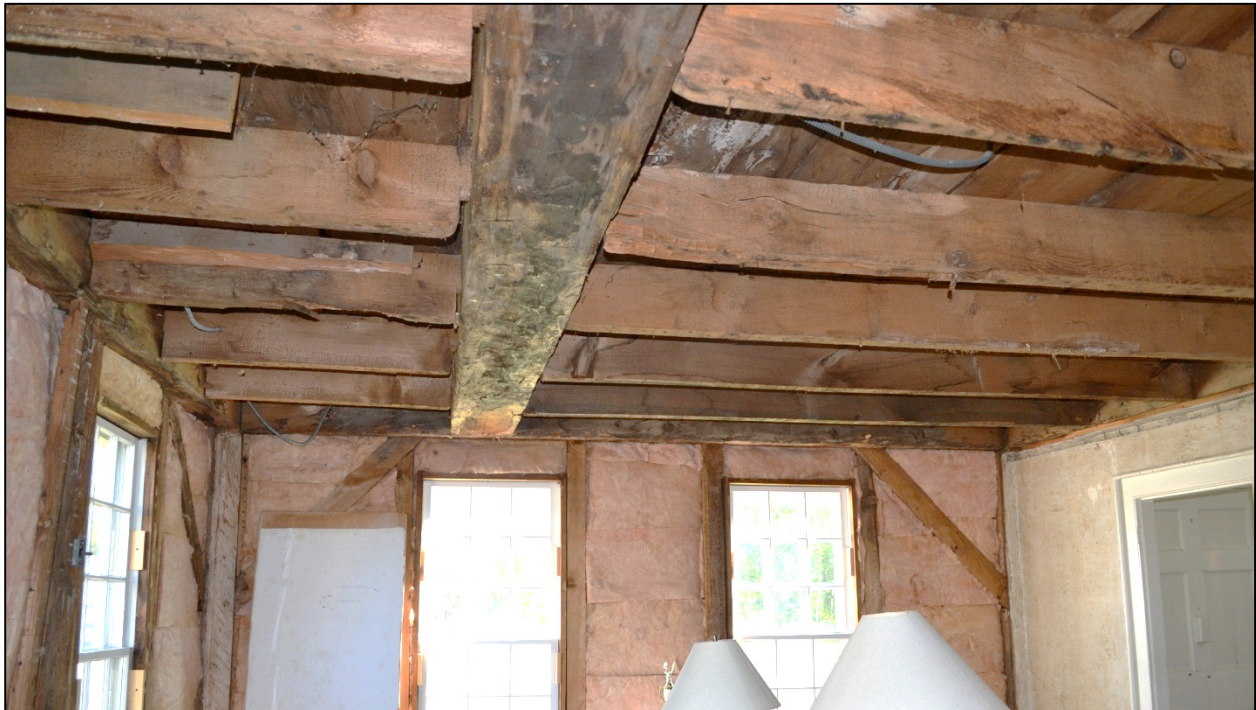
Hall-Dyer second-story frame above the parlor, looking south. Note that the wall post in the southeast corner (left) was hewn back and scarified to receive plaster and thus to be invisible from within the room.

Since this frame will probably be examined with regard to code-mandated floor loading, and since nineteenth-century carpentry is often found to be theoretically insufficient to bear code-defined loads, it will be important to devise ways of strengthening the frame, if necessary, that are additive rather than subtractive. Adding supplementary framing members, or “sistering” existing members, are often acceptable solutions. The existing ceilings in other rooms may be original, or at least retain original split-board lath if not plaster, so assessment of floor frames elsewhere in the house will need to be done carefully, and strengthening, if found necessary, may be difficult to carry out gently.

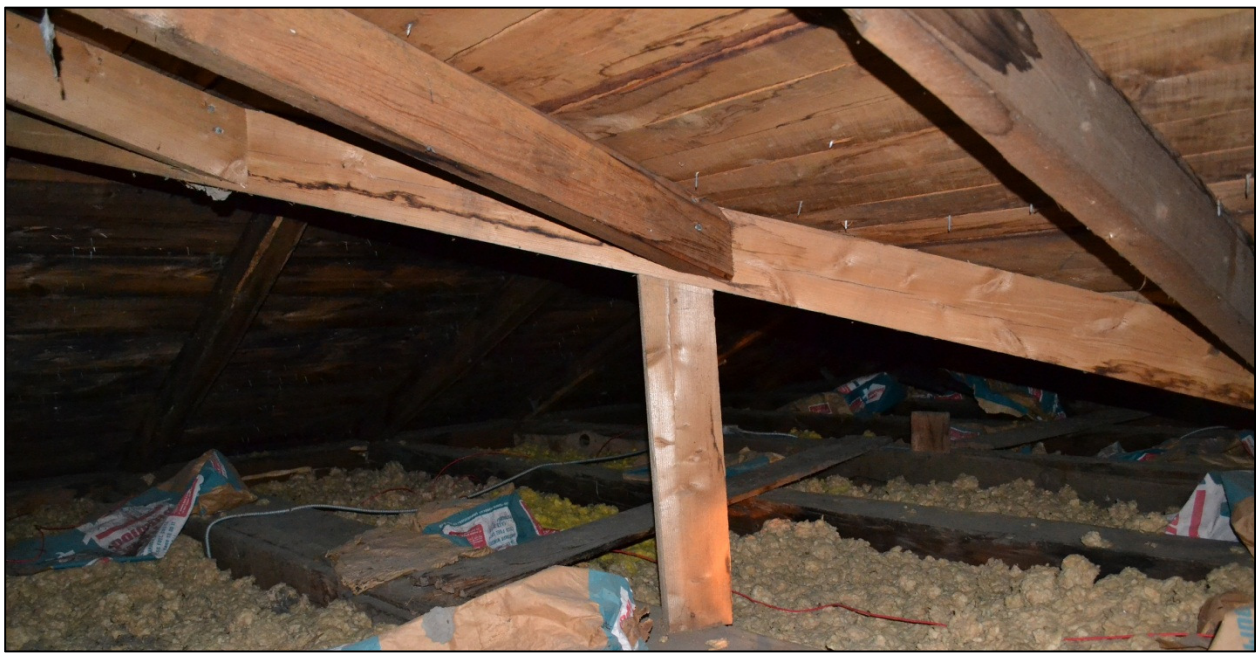
It should be noted that the roof as it stands appears to be in good repair, but also appears to have suffered neglect and damage in the past. The northern (rear) slope of the main roof and the adjoining western roof slope of the wing (both the original and the added sections of the wing) have been re-sheathed. The rafters and sheathing of part of the original roof on the northern (rear) slope of the main house and the adjoining roof of the wing have been replaced, probably reflecting prolonged former leakage that started in the valley at the intersection of the two roof slopes, as seen below.

Replaced hip and jack rafters and roof sheathing at the intersection of the roofs of the main house roof and the wing, looking southwest from the attic of the wing toward the main attic.
