### **TAMWORTH TOWN HOUSE TAMWORTH, NEW HAMPSHIRE**

**JAMES L. GARVIN**

**APRIL 15, 2003; REVISED APRIL 27, 2003**

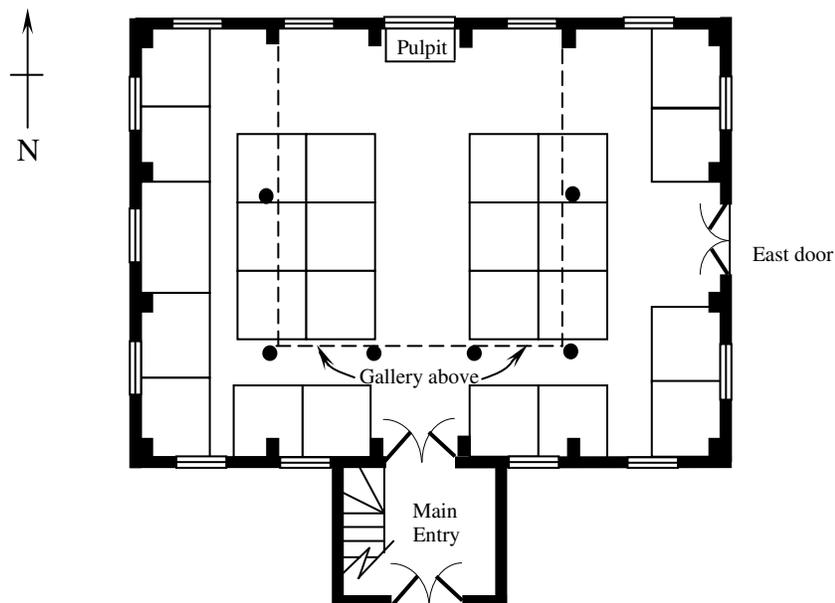
**Conjectural Original Floor Plan, Tamworth Meeting House**

Meeting house pulpits were almost invariably placed on the north walls of the buildings, accompanied by a large window located halfway between the levels of the first floor windows and the gallery windows. Dow's description suggests that this was the case with the Tamworth building. On that basis alone, it may be assumed that the present southwest side wall of the building was oriented toward the north when the structure stood in its original position, but that the building was turned nearly 180 degrees during its one-mile move to the village. Perhaps the contractor wanted to take advantage of the fact that the building had a door on the eastern end, and rotated the structure in order to convert that entrance to the front doorway of the remodeled building.

presumed original locations of these columns are indicated by circles on the floor plan, above. The general profile of these large, solid, turned columns is shown below.

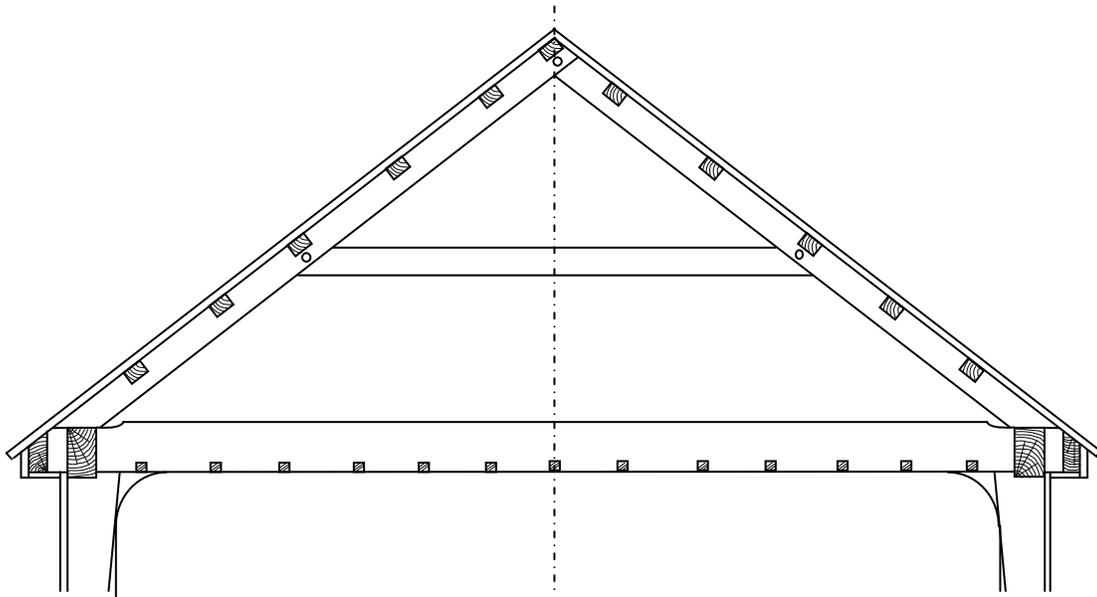
**Section through roof frame**

The roof frame of the meeting house was, and is, composed of six sets of common rafters, including the two sets at the gable ends. Each pair, including those in the gable ends of the building, is connected at about its mid-height by a heavy collar tie and at its feet by a still heavier tie beam. All these members were hewn with a broadaxe, and some were further smoothed with an adze. All these members are of massive dimensions.

Most New Hampshire meeting house frames studied thus far utilize king post or queen post trusses that are connected longitudinally through the length of the building by horizontal ties. The Tamworth frame is the first to be seen in which the pairs of rafters are stiffened by collar beams and are not connected to one another except by the purlins that support the roof sheathing. The building therefore offers important evidence of a hitherto unrecorded practice in meeting house carpentry.

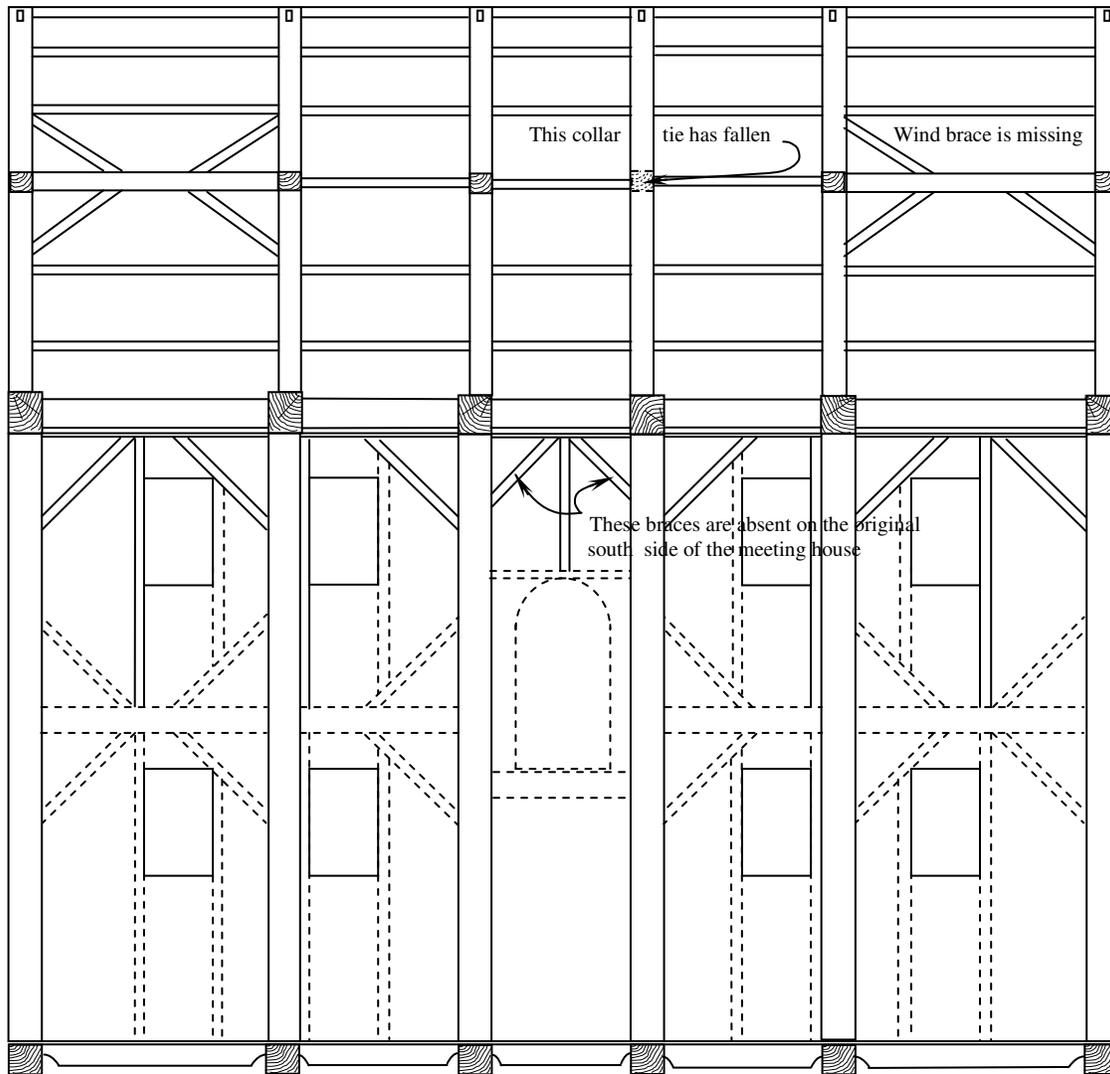
**Longitudinal section through meeting house frame, looking to original north**  
Conjectural elements are shown with dashed lines

As indicated in the cross-sectional drawing below, the presence of a pair of braces on the original northern elevation was made possible by the dropped location of the pulpit window. By contrast, the absence of these braces on the original southern elevation apparently reveals the former presence of the wide doorway that opened upon the southern gallery from the entry or stair tower that Charles H. Dow recalled in 1913.

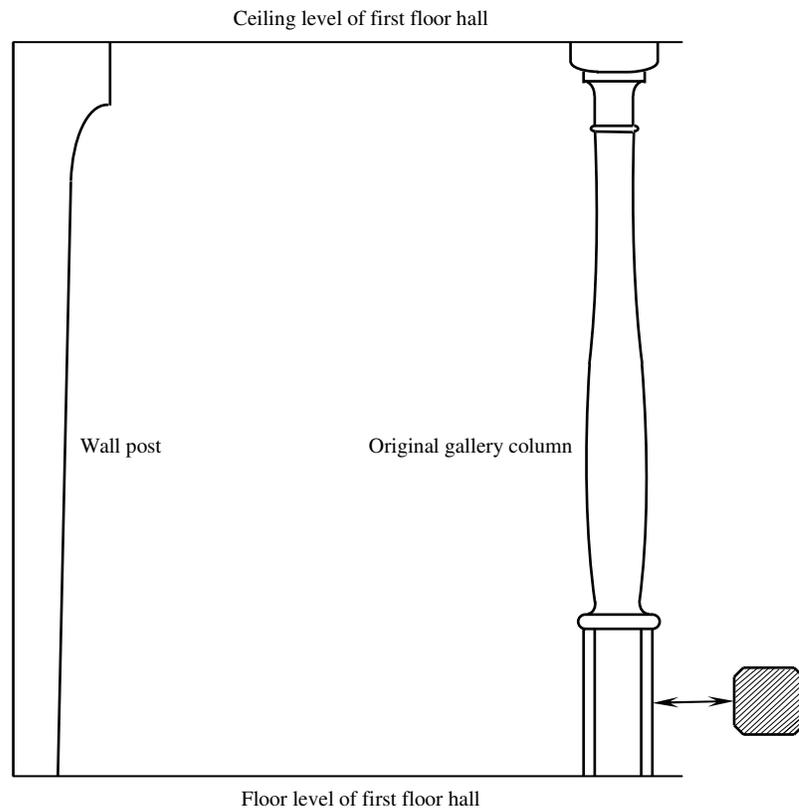
These original columns are important survivors from the original meeting house. Such columns were sometimes left unpainted, as were most of the box pews in meeting houses. Sometimes, however, gallery columns were painted in imitation of marble or exotic woods. The remaining columns in the first-floor hall may retain some evidence of the original decorative treatment of the Tamworth meeting house under their current layers of paint.

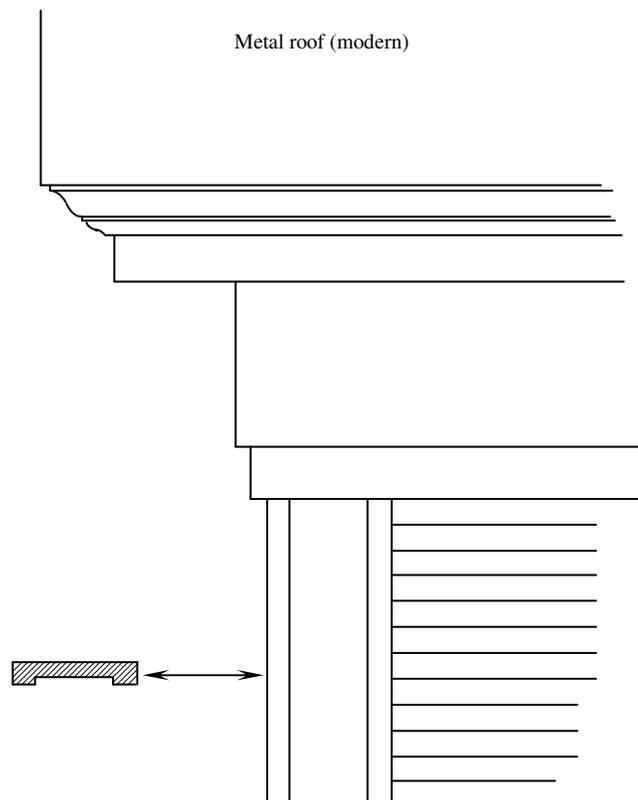
**Detail, upper front corner of Town House**  
 (The raking eaves on the rear are flush with the wall plane)

The remodeling of 1852 was intended to impart a strong Greek Revival style to the exterior of the relocated building. By placing the principal entrance in the gable end, the contractor brought the structure into conformity with one of the norms of the Grecian style. A second means by which the Town House was given a modern character was through the application of a deep entablature to its eaves, along with wide corner boards that suggest Grecian antae or columns:
