REPORT ON TRINITY CHURCH ROUTE 175 HOLDERNESS, NEW HAMPSHIRE

JAMES L. GARVIN
OCTOBER 8, 2004

Summary: The purpose of this report is to provide a brief discussion of the construction history and current condition of Trinity Church and to make recommendations for the treatment and future care of the building. By providing a baseline narrative as of October, 2004, this report may serve as documentation for further study of the building and its condition, or as a mechanism for raising funds for future treatment or care of the building. The report is based on an inspection of the building on October 6, 2004, in the company of trustee Barry Borella.

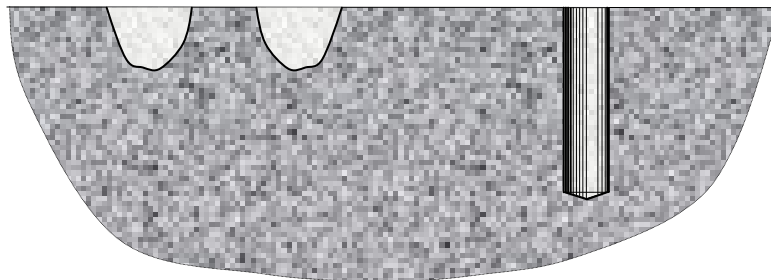
Similarly, the building was underpinned with the current granite slabs after 1830. The present underpinning stones reveal evidence of splitting with plug drills and plugs and feathers (a set of wedges of a type designed for a round hole). Prior to about 1830, granite was split with flat wedges placed in narrow, elongated slots chiseled into the face of the stone. The characteristic marks of the flat wedge splitting technique are shown at the left of the drawing below. That of the plug drill and plug-and-feathers splitting technique, dating after about 1830, is shown at the right. Where splitting marks are visible, the underpinning stones of Trinity Church display the characteristic evidence shown on the right.
