REPORT ON THE GREGOIRE BARN FORMERLY THE COLBURN BARN 239 PROSPECT HILL ROAD RUMNEY, NEW HAMPSHIRE

**JAMES L. GARVIN
ARCHITECTURAL HISTORIAN
SEPTEMBER 20, 2009**

This report is a summary of observations of the barn of the Gregoire family farm, Maple Grove Farm, at 239 Prospect Hill Road in Rumney, New Hampshire. The barn was inspected on the morning of September 19, 2009. The purposes of the inspection were to estimate the date of the barn, to assess its architectural integrity, and to identify its character-defining features as an aid to future planning for preservation of the building.

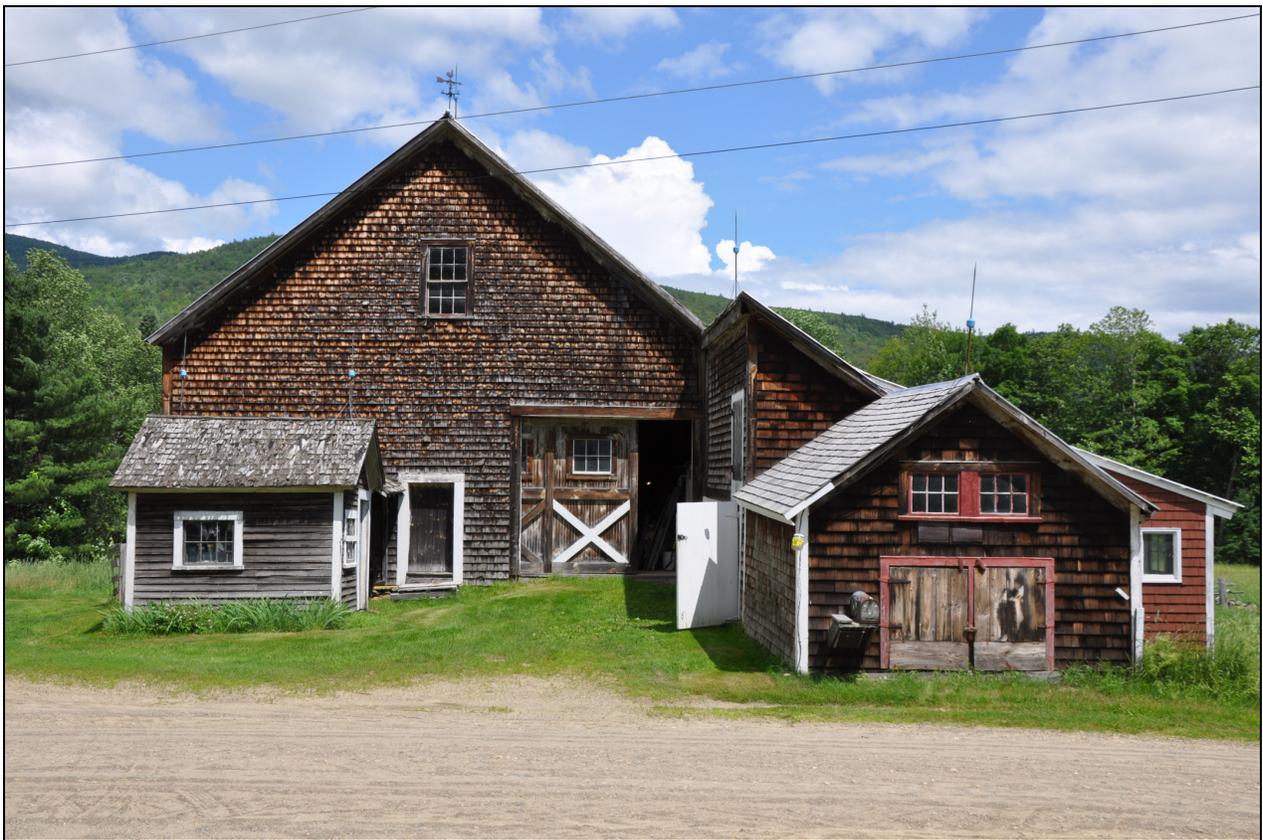
Gregoire Barn, Rumney, New Hampshire, July 3, 2009, west (front) elevation. Photograph by David Starbuck.

Description: The Gregoire Barn is a rectangular, gable-front barn measuring just over 33 feet in width and 48 feet in length. As seen in the photograph above, the front (west elevation) of the barn is covered with wooden shingles. The same wall covering is employed on the other elevations of the main barn and the stable addition on the east, except that the rear (east) gable of the barn is left un-shingled and the vertical sheathing boards of the gable are exposed to the

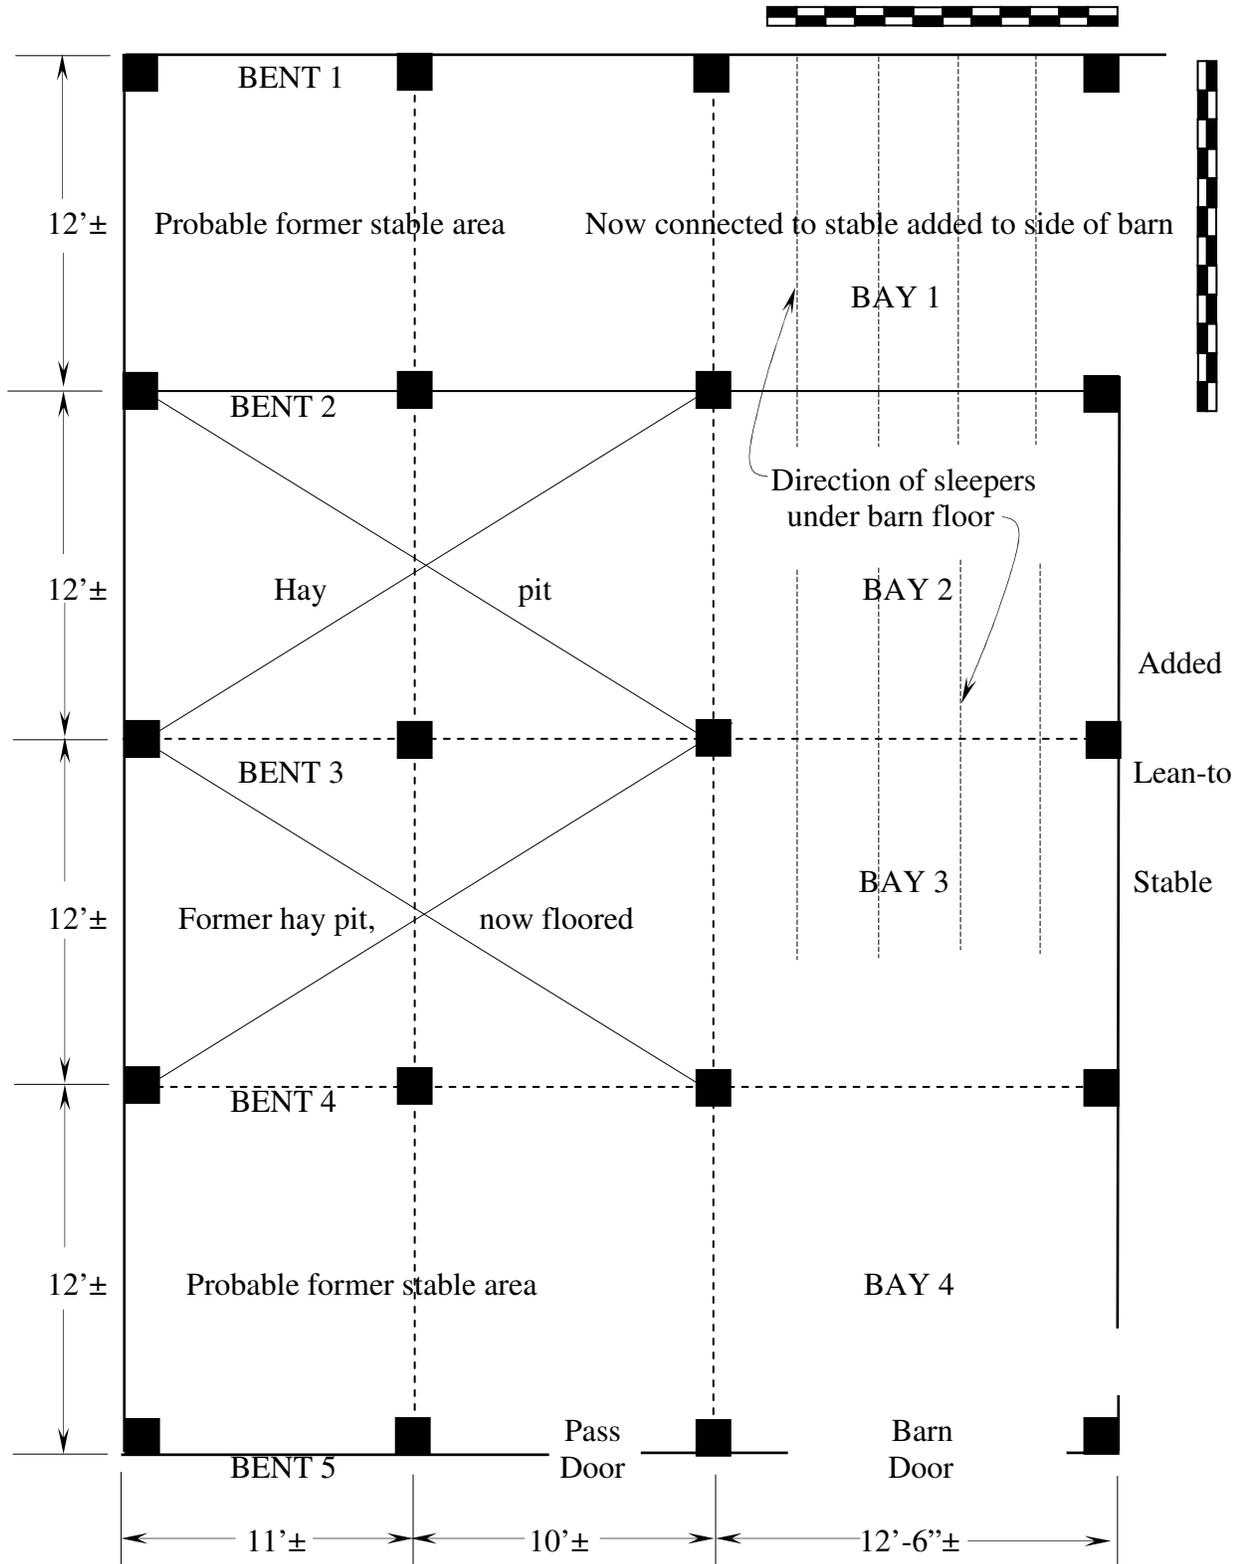
weather. The northern two-thirds of the north elevation of the barn are clapboarded rather than shingled. The barn frame was not measured carefully, but is composed of five bents placed about 12 feet on centers, for a total length of 48'-6," as shown in the schematic floor plan below:

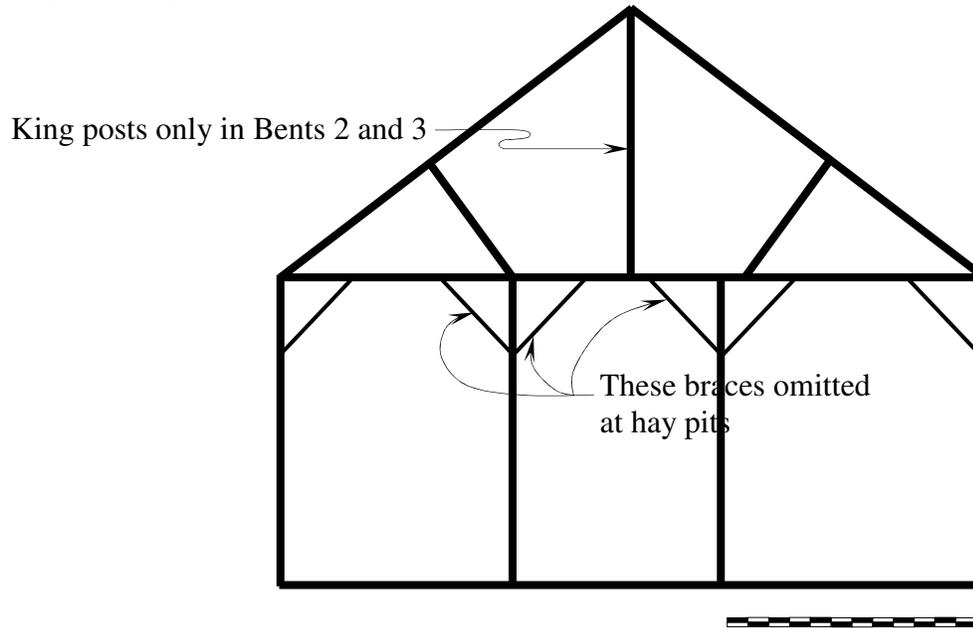
Each bent is laid out approximately as shown below. Braces were originally omitted in a few locations, and have been removed in a few other locations. The king posts are found only on Bents 2 and 3, and are linked by a truss system that stiffens the frame above one of the two original hay pits.

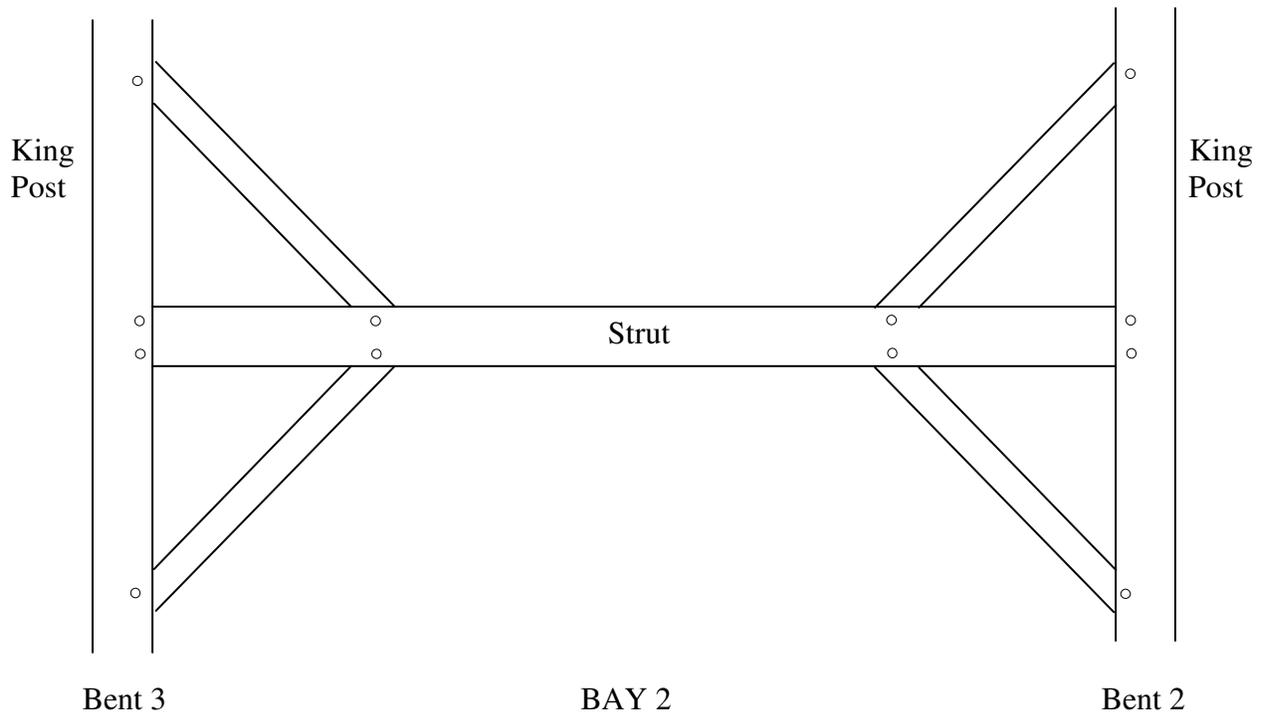
The king posts at bents 2 and 3 are linked by horizontal struts and braces in the manner usually seen in meeting house frames:

The hay pits originally extended across the both sides of Bays 2 and 3. There is no clear reason why the type of bracing shown above was not extended across both of these bays rather than being limited to Bay 2. The stiffening effect of this single strut was evidently considered sufficient to resist deformation of the entire roof frame.

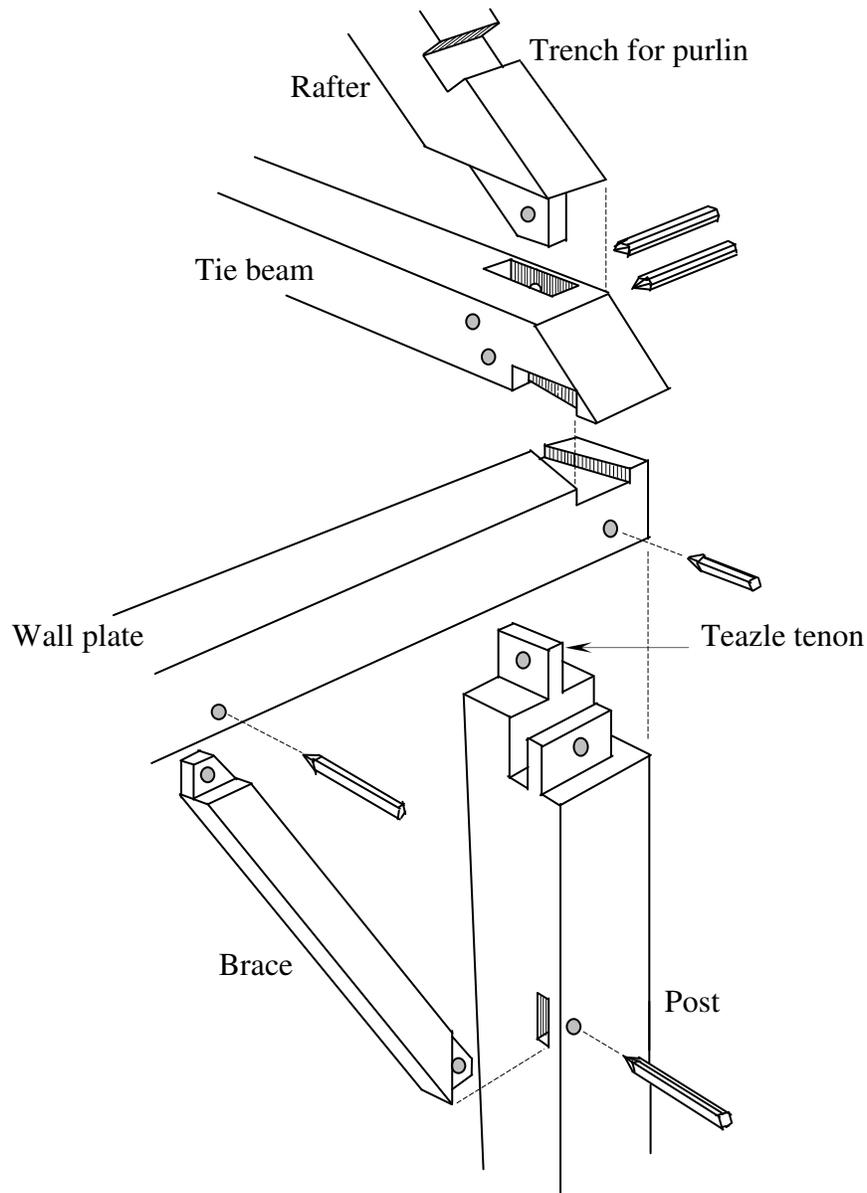
The barn has an extremely heavy frame, laid out according to the “scribe rule,” by which the members that intersect each joint are careful and individually scribed and cut to fit tightly. The frame utilizes a complex joint at the juncture of posts, wall plates, tie beams and rafters. This joint is defined by timber framers as the “English tying joint.” It is shown below, exploded to reveal some of the hidden features of this intersection.

The massive posts, dropped wall plates, and the tie beams secured by teazle tenons all replicate features seen during the seventeenth and eighteenth centuries on the New Hampshire seacoast.
