ALLENSTOWN MEETING HOUSE HISTORIC STRUCTURE REPORT

JAMES L. GARVIN

MAY 3, 2004

REVISED JUNE 21, 2007, JULY 10, 2010

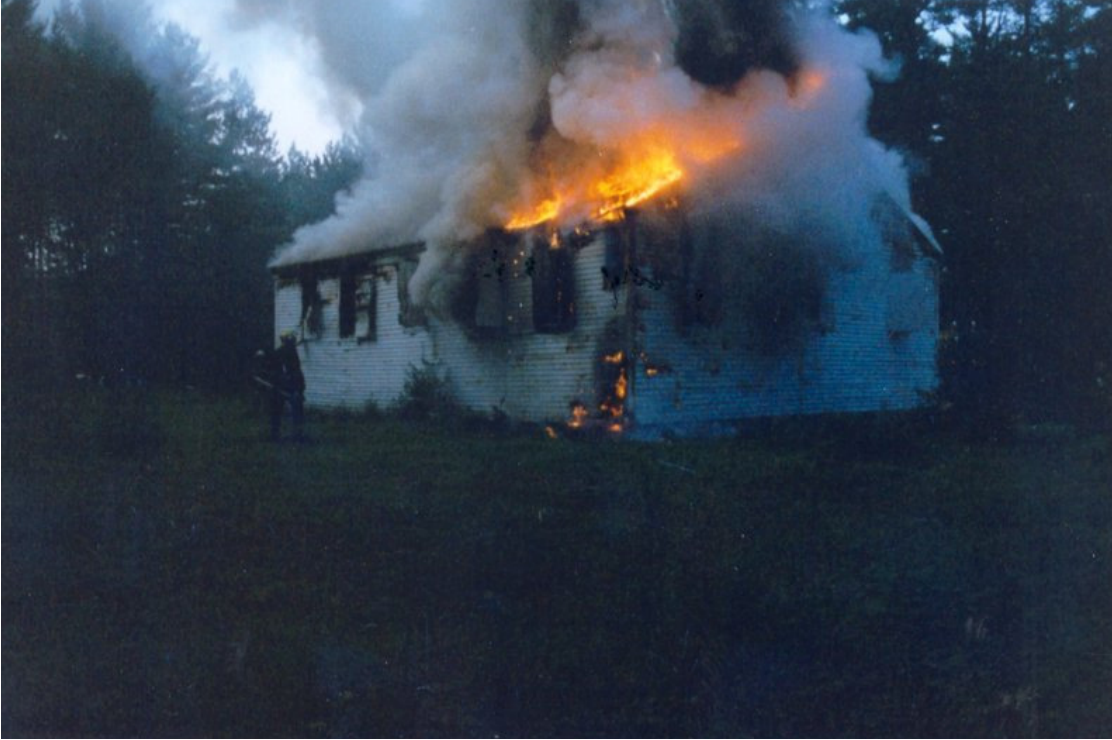
ALLENSTOWN MEETING HOUSE
Rear wall during the fire of July 15, 1985

Buntin Chapter took immediate steps to brace the walls of the structure and to provide a temporary roof over the building. The first such roof collapsed under the weight of winter snow, and a second was constructed by Roland A. Martel of Allenstown. Later, a roof of prefabricated trusses, covered by plywood sheets, was installed atop new wall plates that were fabricated from laminated two-inch planks, as shown below:

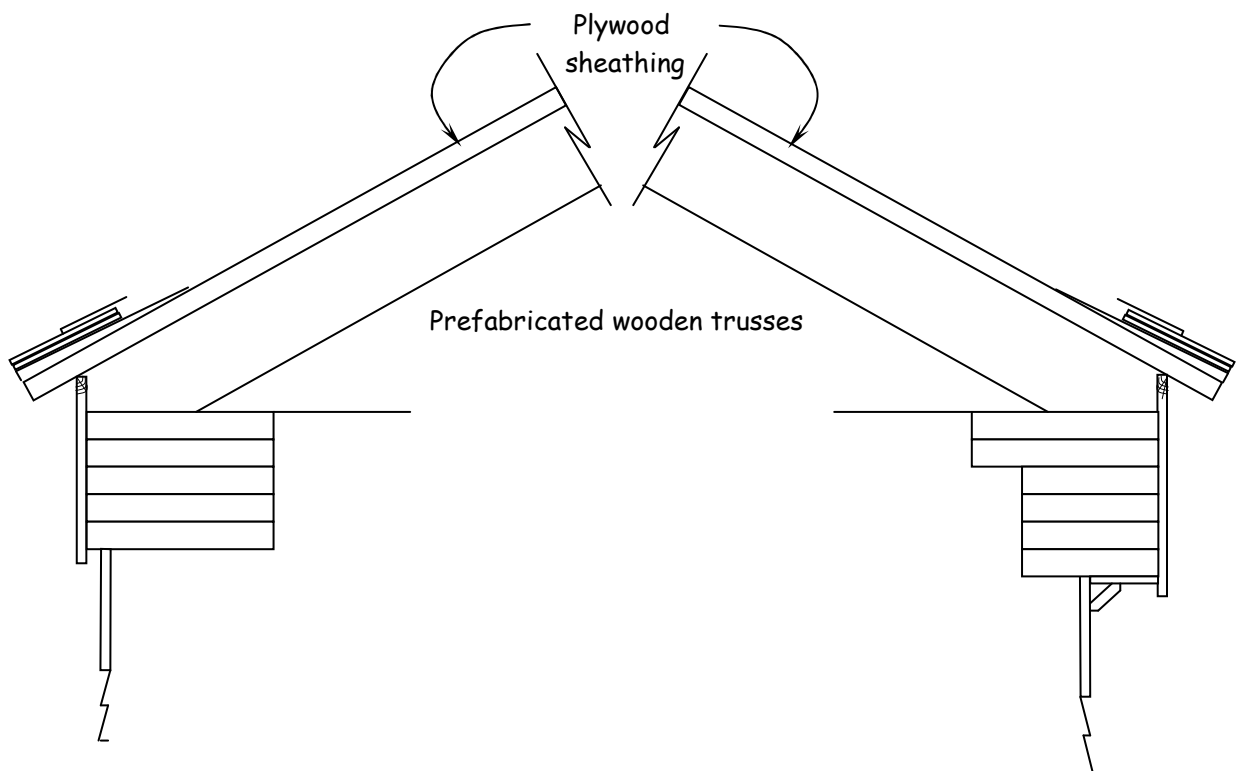
These trusses had an insufficient span to throw roof water well away from the building's walls, and water penetrated the laminations of the front and rear wall plates, causing the plates to begin to deteriorate. This roof of poorly-designed trusses was replaced by the current roof of prefabricated trusses, covered by pine sheathing boards, during the fall of 2006.

2006 The Old Allenstown Meeting House Task Force had the roof trusses of 1986 replaced with new prefabricated trusses with deeper overhangs. The laminated front and rear wall plates of 1986 were replaced with plates of solid timber.

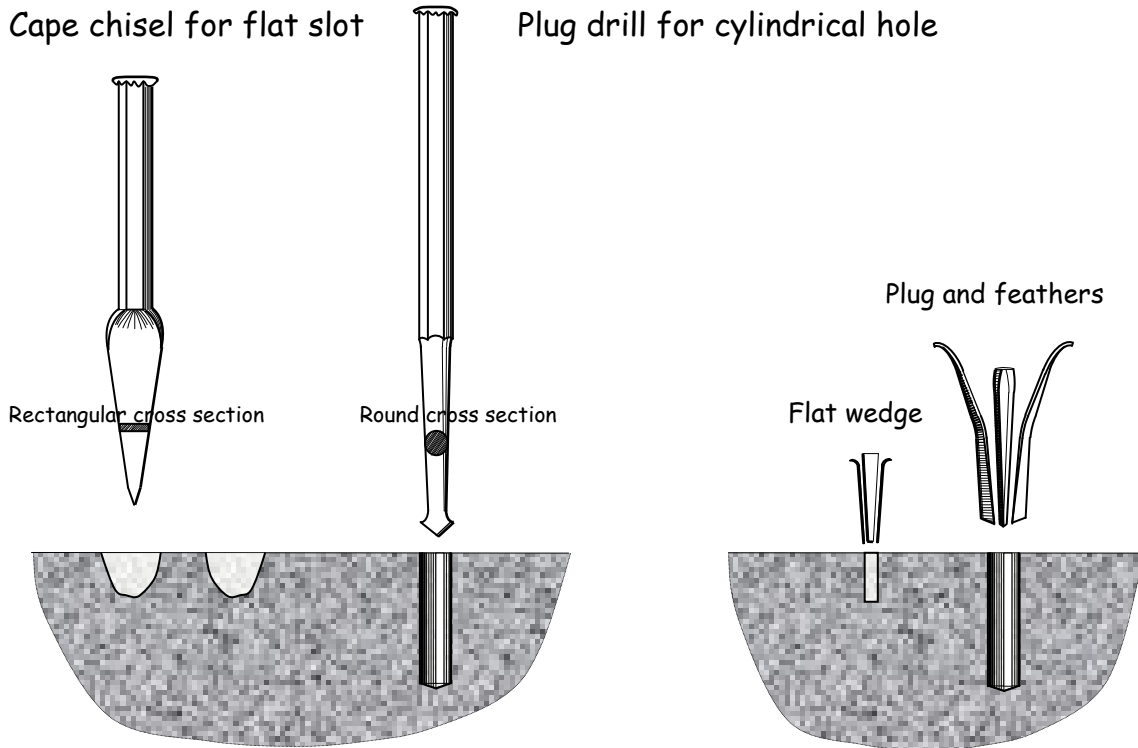
Prior to about 1830, the procedure for splitting granite entailed the cutting of a line of shallow slots in the face of the stone, using a tool called a cape chisel, struck with a heavy hammer. Small, flat steel wedges were placed between shims of sheet iron and driven into these slots, splitting the stone. The new splitting method of circa 1830 used a “plug drill,” which had a V-shaped point and was rotated slightly between each blow of the hammer, creating a round hole two or three inches deep.

Into this hole were placed a pair of half-round steel shims or “feathers,” and between these was driven a wedge or “plug” which exerted outward pressure and split the stone. The advantage of the “plug-and-feathers” method of splitting was the greater depth within the stone at which the wedges exerted their pressure, thus allowing larger pieces to be split more accurately.

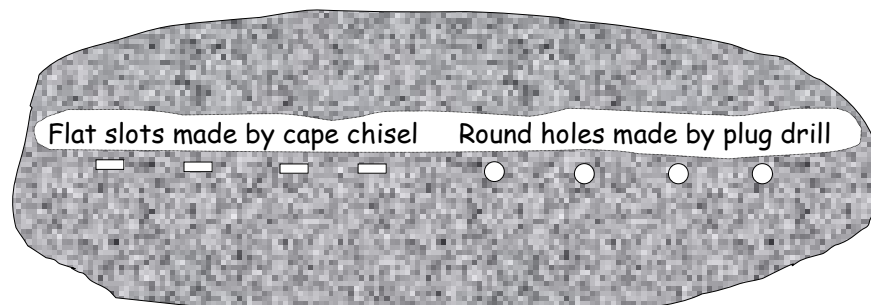
When seen on the surface of a stone that was prepared for splitting but never split, these slots or holes appear as shown below:

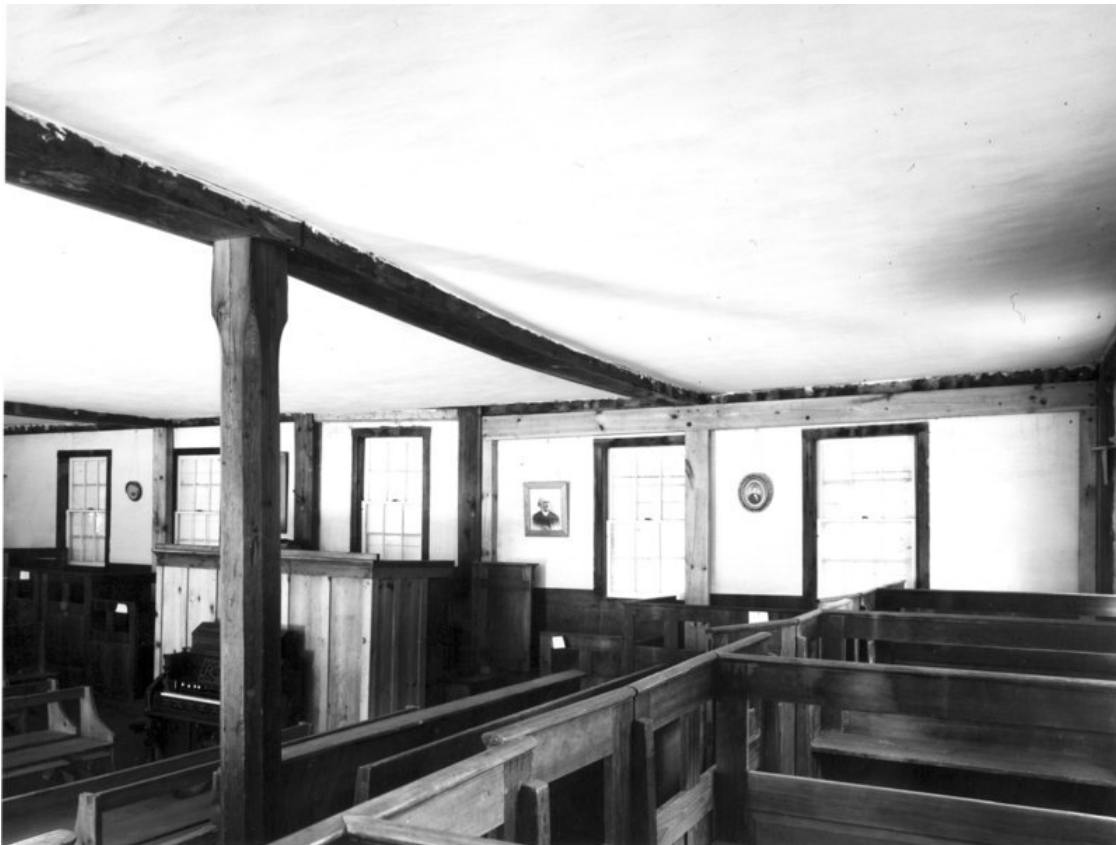
ALLENSTOWN MEETING HOUSE
As it appeared before the fire of July 15, 1985
showing the deflection of the truss tie beam from roof loading
and weight of the plaster ceiling

Workshop participant Edward Levin created a digital model of the roof. He then imposed the snow loading to be expected in Allenstown, together with the weight of the original plastered ceiling that had trapped the heat of the fire within the attic and thereby saved the old building from complete destruction. When these loads were applied, the animated computer model deflected precisely as pre-fire photographs showed that the original roof and ceiling had sagged over time.

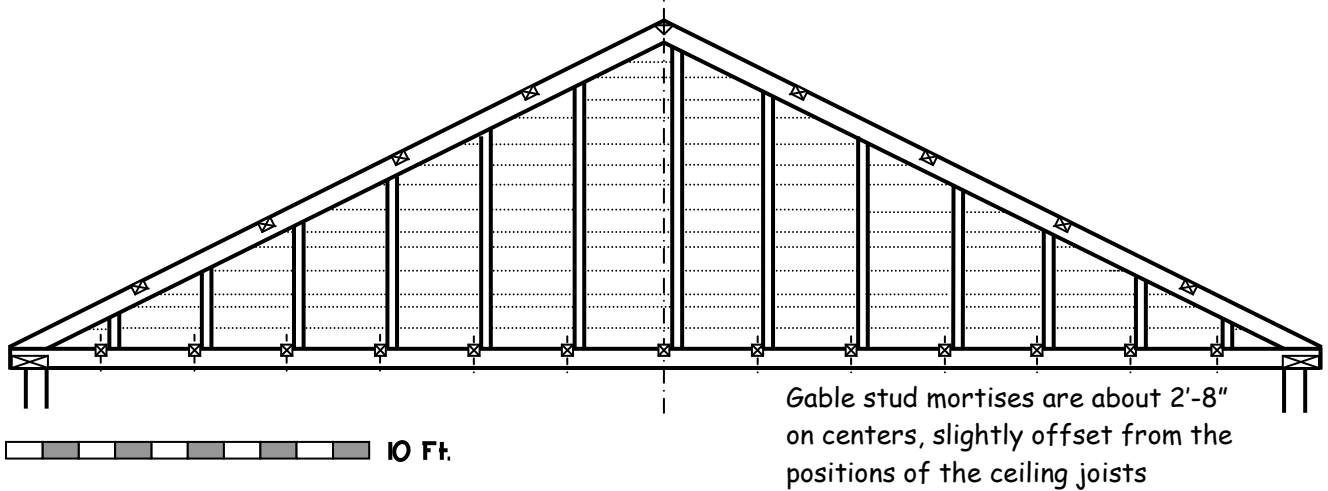
The three methods of framing the original roof of the building, as theorized following the workshop, are shown below. These diagrams detail the support of the gable ends of the building, the method of support above the two octagonal wooden columns that are shown on the floor framing plan, and the method of support above the broad expanse of ceiling in the center of the structure.

Interior elevation of gable ends

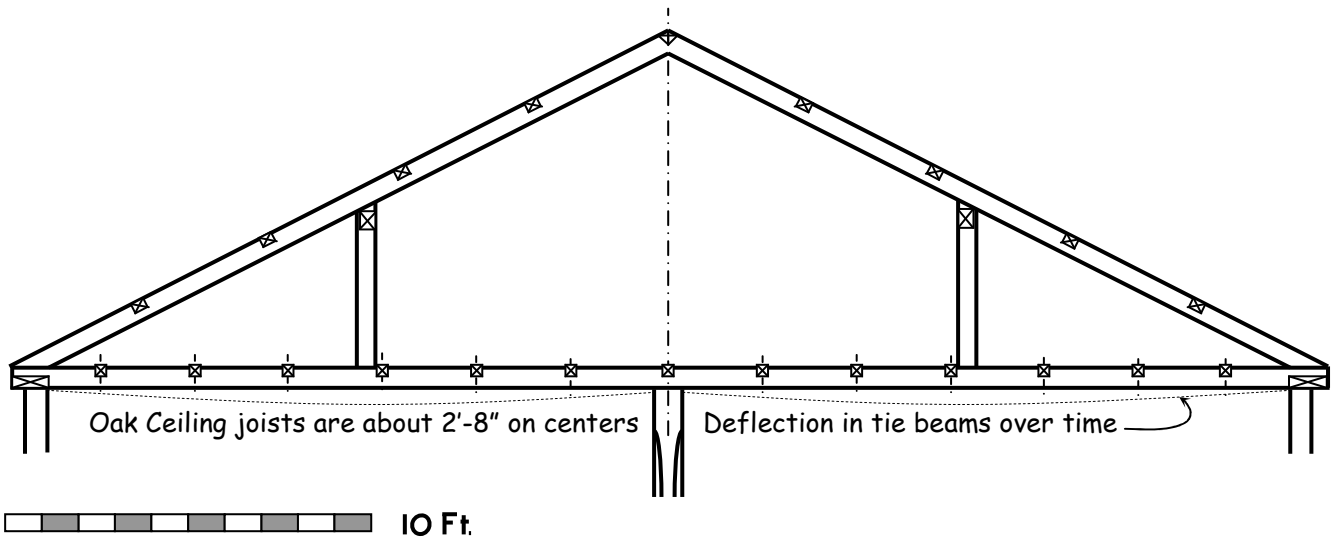
Section through roof frame above each of two wooden columns

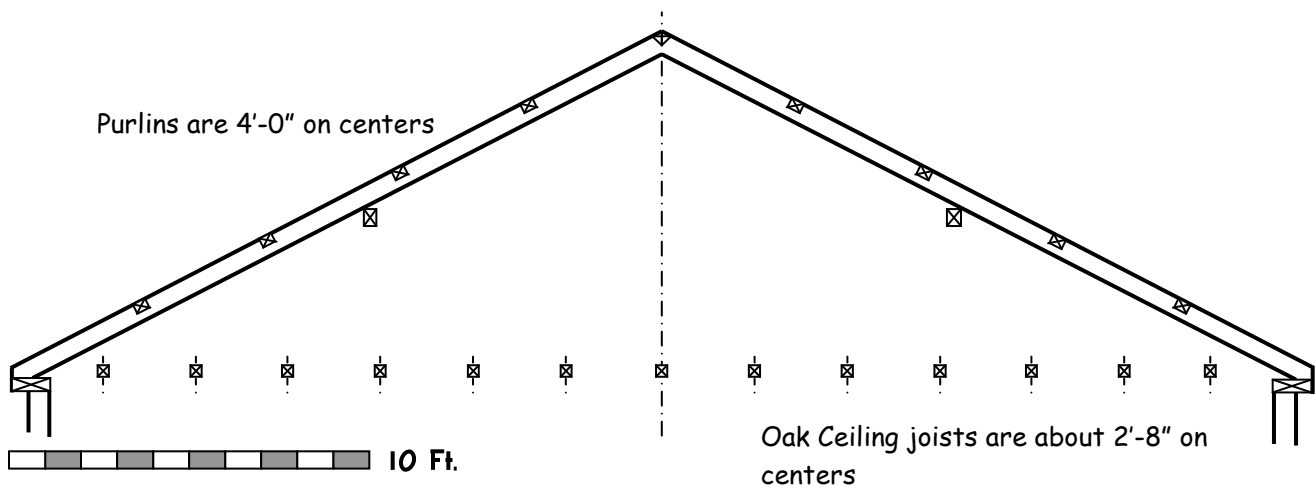
Section through roof frame
at each of two center rafter couples

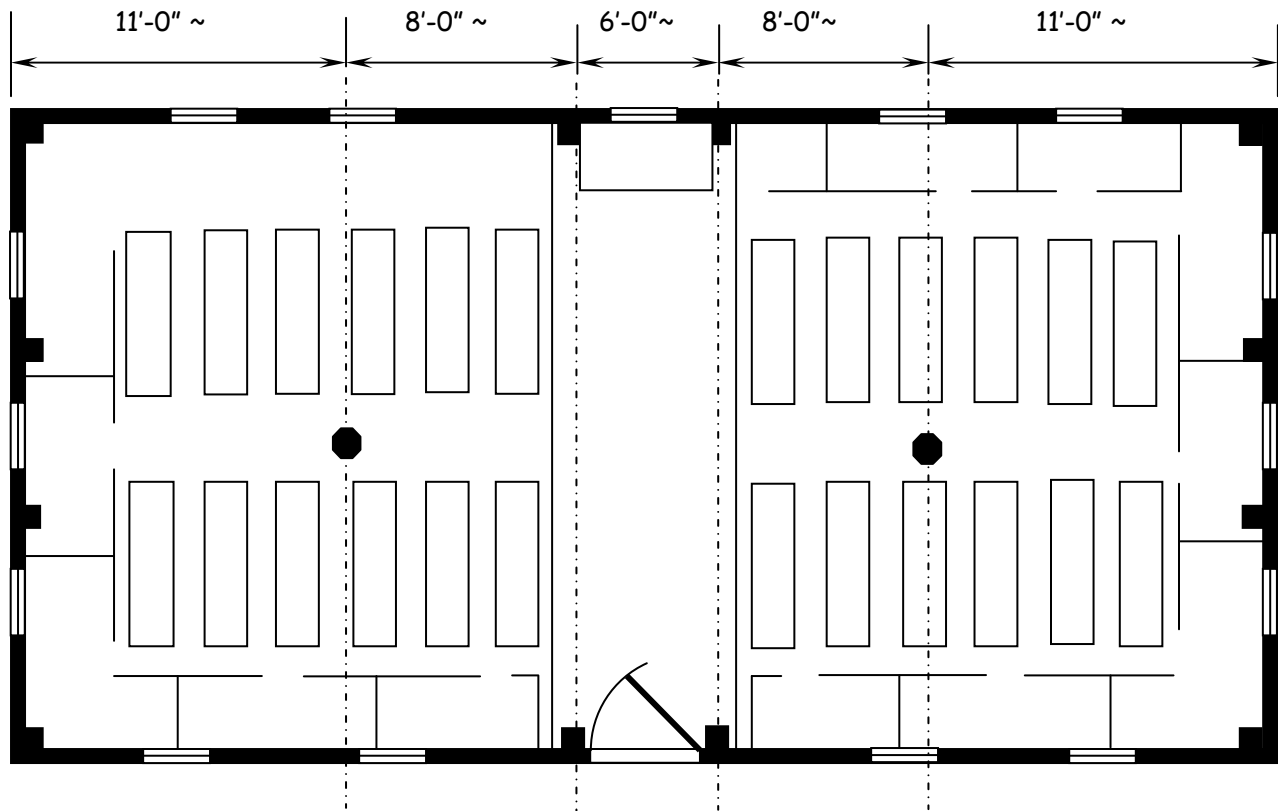
OLD ALLENSTOWN MEETING HOUSE
Floor and pew plan

A series of box pews begin at the doorway of the building and extend around the perimeter of the room to the pulpit, adjacent to the exterior walls. The building originally had twenty box pews; seventeen remain intact. The level floors of these enclosures step up from one to the next as the slanting floor rises. These privately-owned enclosures have paneled fronts, with raised panels but unmoulded stiles and rails. Above a lower range of panels, the stiles and rails of the pew walls and corresponding pew doors are left unfilled by panels. Unlike corresponding openings in more elaborate meeting houses, these areas are not filled with miniature turned balusters. Pew doors are hung on cast iron butt hinges with an adequate throw to allow the doors to be folded back against the pew walls without interference from simply moulded wooden caps that finish the tops of doors and

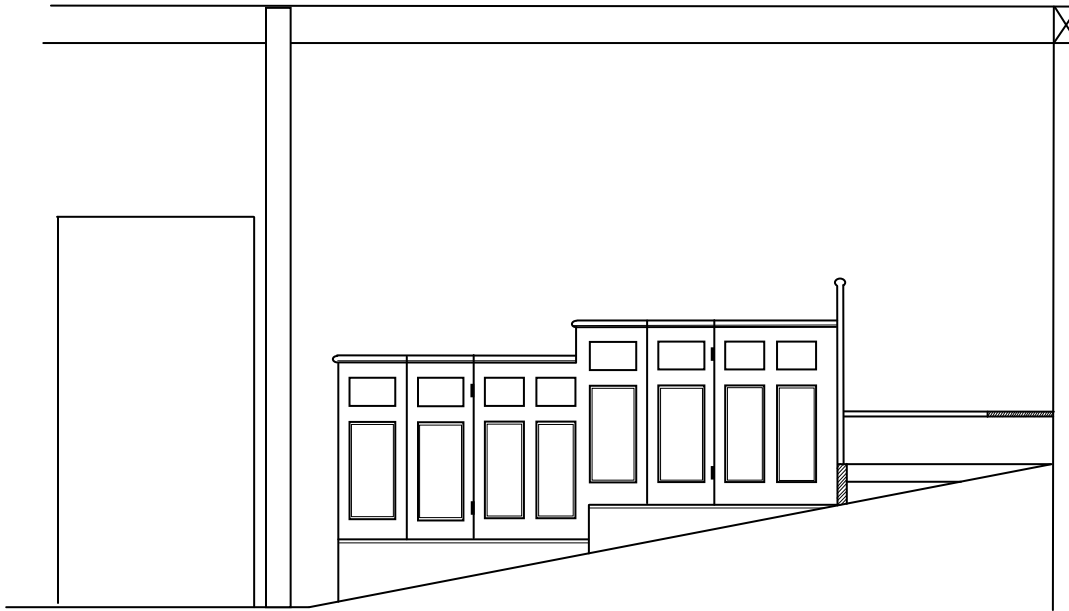
Elevation of box pews to the west of the front door

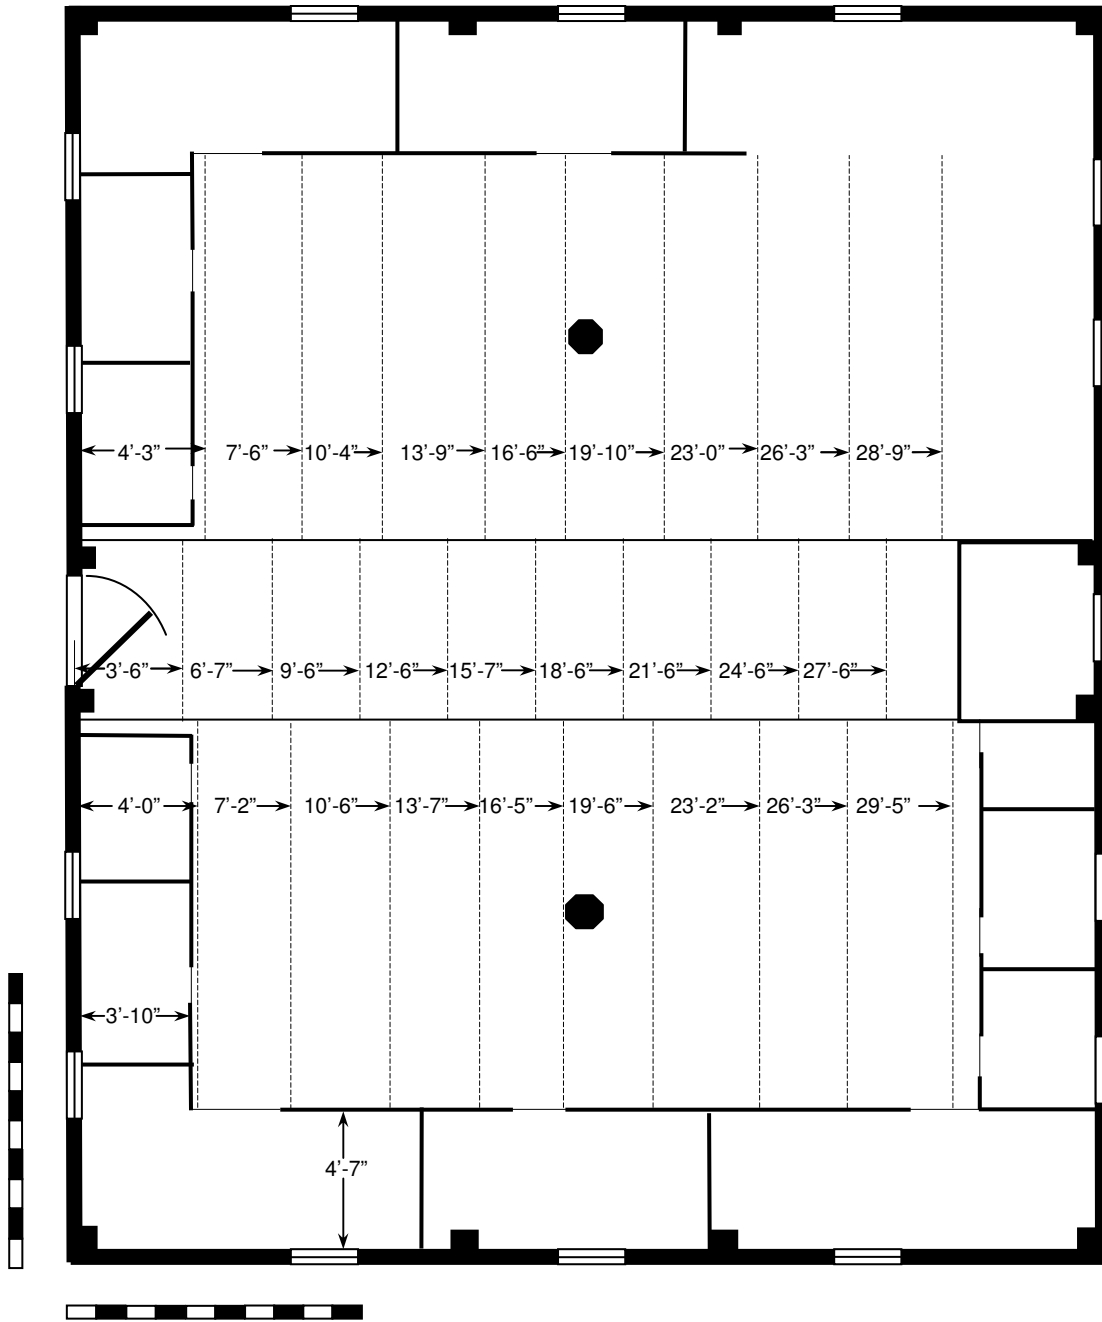
OLD ALLENSTOWN MEETING HOUSE
Floor Framing Plan as Derived from Spacing of Rows of Nails

The slanted joists that support the floors on each side of the central aisle are supported at about mid-span by irregular blocks of wood or by wooden wedges that rest on lateral girders that run from front sill to rear sill. These timbers, in turn, are supported by wooden blocks or boulders placed at intervals beneath them. In some cases, especially on the eastern side of the building, the irregular blocks or wedges that are intended to support the slanted joists have fallen out of position. They should be replaced carefully in order to prevent the bending of the floor membrane when the building is fully occupied.

Recommended treatment of lower frame: As noted above, the floor framing of the Allenstown Meeting House is structurally in good condition. As is often the case with meeting houses, the ground below the Allenstown Meeting House is still covered with the chips and shavings from the original construction of the building in 1815. This material remains in well-preserved condition except within a few feet of the front and rear perimeter foundations. There, near the drip-lines beneath the eaves of the building, enough moisture has migrated inward through the soil to cause the decay and disappearance of the debris.

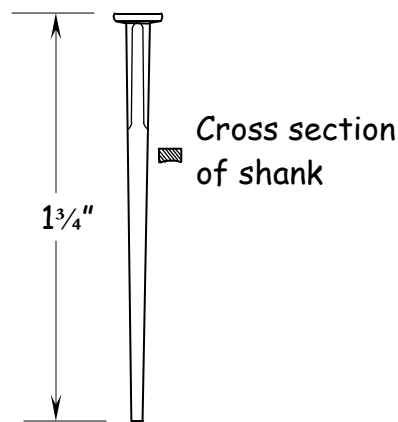
Each clapboard that was removed was found to be circular sawn. No clapboard had building paper under it. All clapboards were held by cut nails of the general pattern shown below. Although most of these nails were corroded by rust, they appear to conform to the most modern of several methods of fabrication that were employed between the advent of the cut nail in the 1790s and the decline of these nails a century later. Nails of this type have a long chamfer along the shank below the head, and burrs from shearing on the same side of the tapered shank. Research has dated the fabrication of such nails between circa 1835 and circa 1890, when the manufacture of cut nails diminished with the advent of the wire nail. Because of the wide possible date range for this type of nail, it is impossible to use the nails to ascertain a close date for the application of the clapboards. In general, however, it may be said that any wholesale re-clapboarding that might have been done in 1908, when Buntin Chapter restored the building, would most likely have utilized wire clapboard nails rather than cut nails. The wholesale use of cut nails implies that the clapboards were installed sometime in the latter nineteenth century rather than in the early twentieth century.

c. 1835 to c. 1890
Modern type of cut nail
