**NOTES ON THE BUILDING OF MOULTONBOROUGH GRANGE NO. 197
OWNED BY THE MOULTONBOROUGH HISTORICAL SOCIETY**

JAMES L. GARVIN
AUGUST 2, 2012

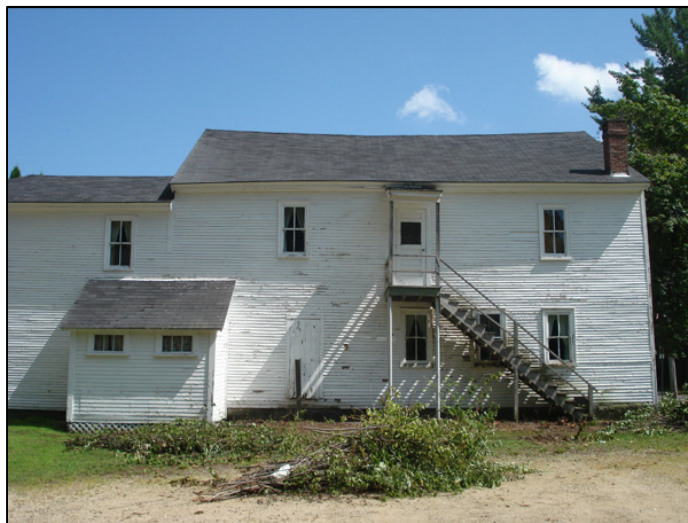
The structure is now exhibiting signs of deterioration and structural distress, notably in the visible spreading of its eaves and the sagging of its roof planes.³

Rear elevation, Moultonborough Grange building, showing distortion of the roof, August 2, 2012.
Photo courtesy of Cristina Ashjian.

The second major structural problem faced by the building is evident in the photograph on page 2 of this report. The spreading of the front and rear walls, and the subsidence of the roof planes, are serious conditions that seem to have developed, or greatly accelerated, during the recent past. As noted in the Bartlett report, this condition jeopardizes the safety of the building. It should be diagnosed and remedied, at least through temporarily stabilization, before the winter of 2012-13. Loss of the roof would make the continued preservation of the Moultonborough Grange financially difficult if not impossible, violating the intent of the perpetual preservation easement that runs with the land and is quoted, in part, on page 2 of this report.

The original support system for the roof of the original center-chimney dwelling would have been substantial and capable of resisting snow and wind loading for an indefinite span of years. The original roof would have been supported at the end walls of the building, as it still is. It would also have been supported near the center of the structure, where load-bearing partitions on both sides of the chimney would have continued throughout the first and second stories, supporting the lateral tie beams that would have linked the front and rear walls of the building at the original attic floor level. The front and rear walls would also have been tied together by additional tie beams that lay under the attic floor between each end-gable wall and the chimney bay.

All of these connections were removed when the high ceiled Grange hall was created after 1900. Two steel rods with turnbuckles were substituted for the original four internal tie beams, probably creating a structural system that was never technically adequate to resist the outward spreading tendency of the roof planes. Now, with failure of the anchorage of these steel ties, the walls have spread noticeably and the roof has distorted and subsided.

The only access to the upper roof area, above the auditorium ceiling, is a small trap door in the ceiling above the rear of the stage. Lacking a means of access to this trap door, we do not know the exact character of the existing roof system. It will be crucial to understand the nature of the present roof structure in order to design a remedy for its incipient failure.

The evenness of the roof surfaces suggests that the entire roof of the original building—rafters, purlins, and sheathing boards—was removed shortly after 1900 and replaced by a roof of sawn common sawn rafters (probably 2" by 10" or 2" by 12"), covered with horizontal sheathing boards. From the slight exposure of the rear wall plate where sheathing has pulled away at one of the steel ties, it appears that the original hewn plate and its planed board casing were retained in place but hidden behind the furred-out ceiling board wall. It will, of course, also be crucial to explore the anchorage at the ends of the two steel ties to determine how this anchorage has

It is the strong recommendation of this report that stewards of the Moultonborough Grange building make every effort to obtain the funding necessary to explore these problems thoroughly and to remedy them, at least by temporary measures, before the onset of the winter of 2012-13. To leave the building in continued jeopardy would violate the preservation clause that was inserted in the deed by which this property was transferred in 2006 from Moultonborough Grange No. 197 to the Moultonborough Historical Society.

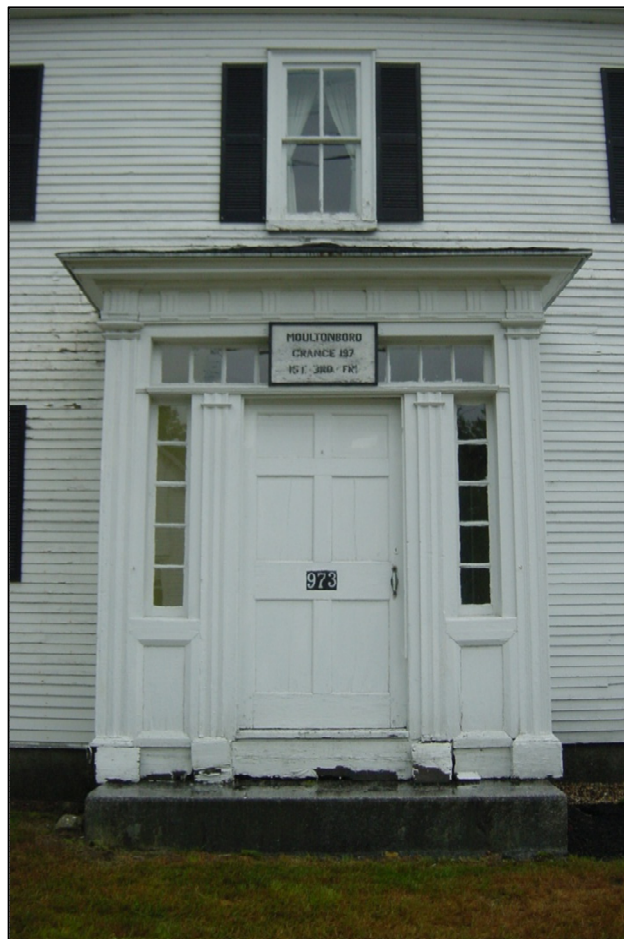
The exterior of the building retains an early or original entry “porch” with Doric detailing and features that are characteristic of the federal architectural style of the early 1800s. Much of the clapboarding of the façade, and perhaps the other elevations of the building, appears to date from the same period and to remain on good condition.

Front entry, displaying a federal-style front door and a Doric entablature.

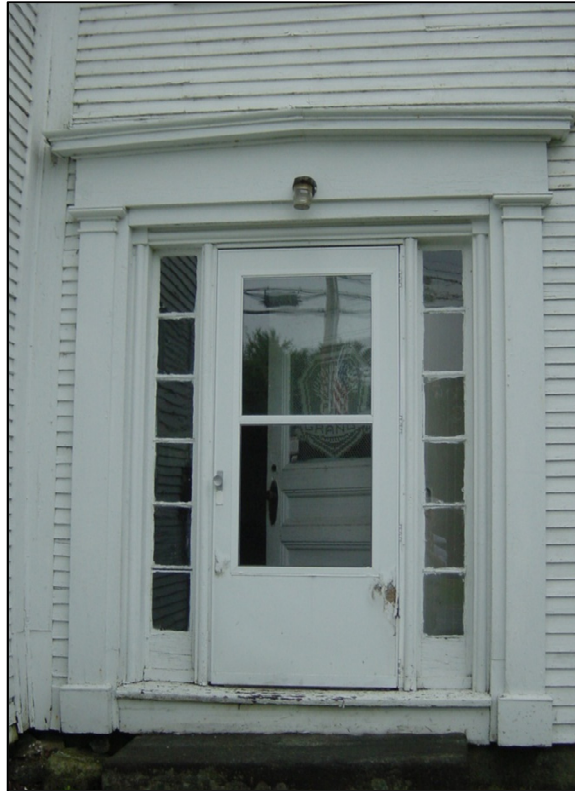
By contrast, the doorway of the added wing is an excellent and characteristic example of a frontispiece in the Greek revival style. Together with surviving interior features of the wing, this doorway denotes a mid-nineteenth-century date for this portion of the building. From the basement, the wing can be seen to have an independent frame and to have been placed adjacent to the frame of the original building.

Doorway of the added wing, displaying characteristic Greek Revival detailing.

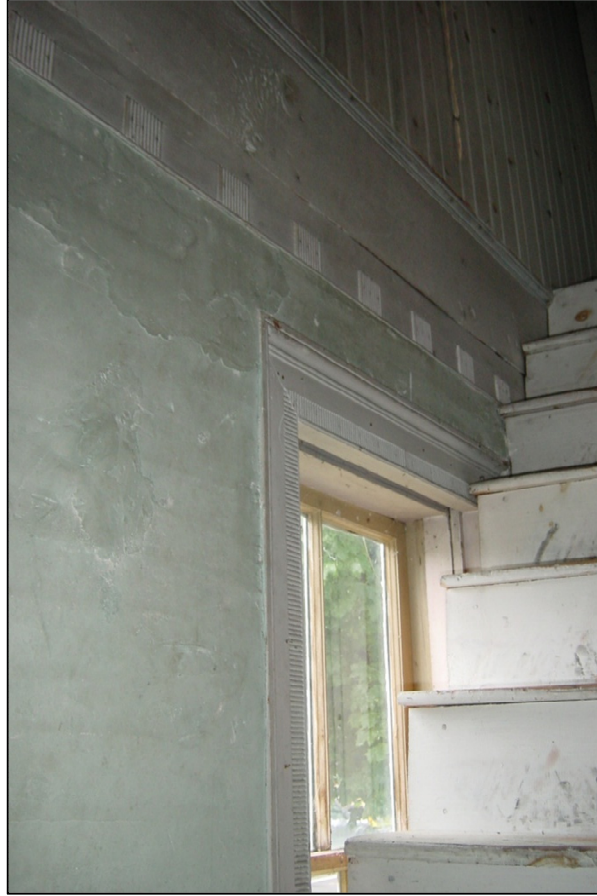
By contrast, the parlor to the left of the front doorway was finished in an elaborate and imaginative variation of the federal architectural style, employing reeded casings around the door and window openings and a room cornice having a frieze decorated with reeded triglyphs that echo those employed on the exterior of the front entrance.

Reeded window casing and entablature with reeded triglyphs in the former parlor on the southwestern side of the building, partly obscured by a staircase leading up to the back of the second-story stage.
