# **REPORT ON THE DANVILLE MEETING HOUSE DANVILLE, NEW HAMPSHIRE**

**JAMES L. GARVIN**  
**DECEMBER 8, 2012**

The following report derives from an inspection of the Danville Meeting House on December 4, 2012. The principal purpose of the report is to assess the condition of the building and to make recommendations to the Olde Meeting House Association of Danville for the future stewardship and maintenance of the property. Second, the report refines and corrects statements that were made in the National Register nomination of the property in 1982 (listed April 19, 1982; see Appendix 1). The report includes a second appendix that provides a transcript of “Notes on the Date of Construction of the Danville Meeting House” of October 7, 1995, which revised the date of erection of the body of the building from 1760, as stated in the National Register nomination, to 1755. Third, the report explores in greater depth the physical evidence of changes that occurred to the building in the early nineteenth century.

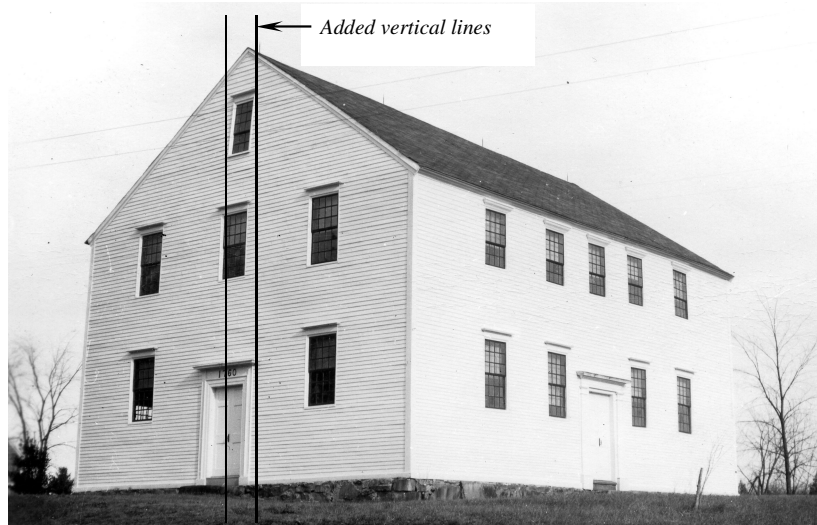
Without further measurement, it is not clear whether this distortion applies to the entire roof structure. For the moment, it appears that the lean is confined to the western gable, and that the remainder of the roof structure is relatively plumb. It also appears that this condition is of long standing, and perhaps original to the building's construction. In the photograph below, probably dating from the 1950s, the tilt of the attic window is as visible as in the 1982 photograph above.

*Photograph circa 1950 by C. Ernest Walker*

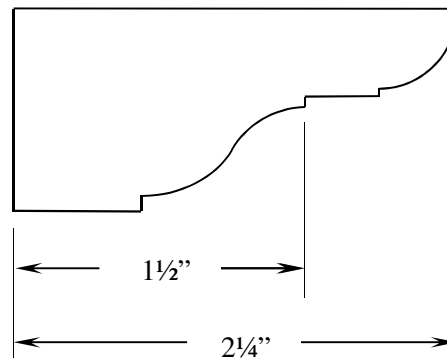
*Casing profile, front (south) gallery windows*

This configuration, with the wide backband molding measuring more than half the total width of the casing, is highly unusual and is probably an example of the work of a local joiner.

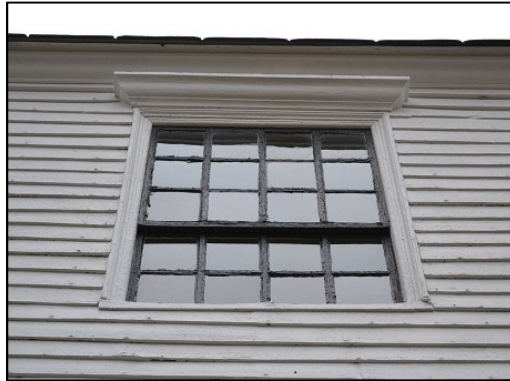
fact, they do not project as far as the backband moldings that rest upon them. This detail may be seen in the photograph of a front gallery window, below, and it is uniform around the building

*South gallery window*

Because of the rarity of all these features, it will be important to protect the window detailing during future re-painting of the building.

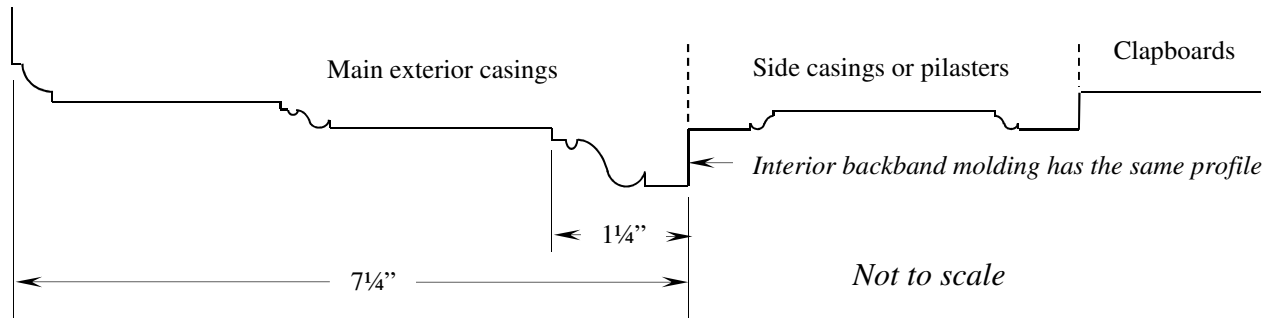
The architrave or door casing shown at the left of the sectional drawing above compares closely with a detail for an architrave given in Plate 11 of Asher Benjamin's *The American Builder's Companion* (Boston, 1806), a highly influential New England source for the new "Federal" architectural style of the early 1800s. The coherence between these two details reveals the approximate date of the western doorway.

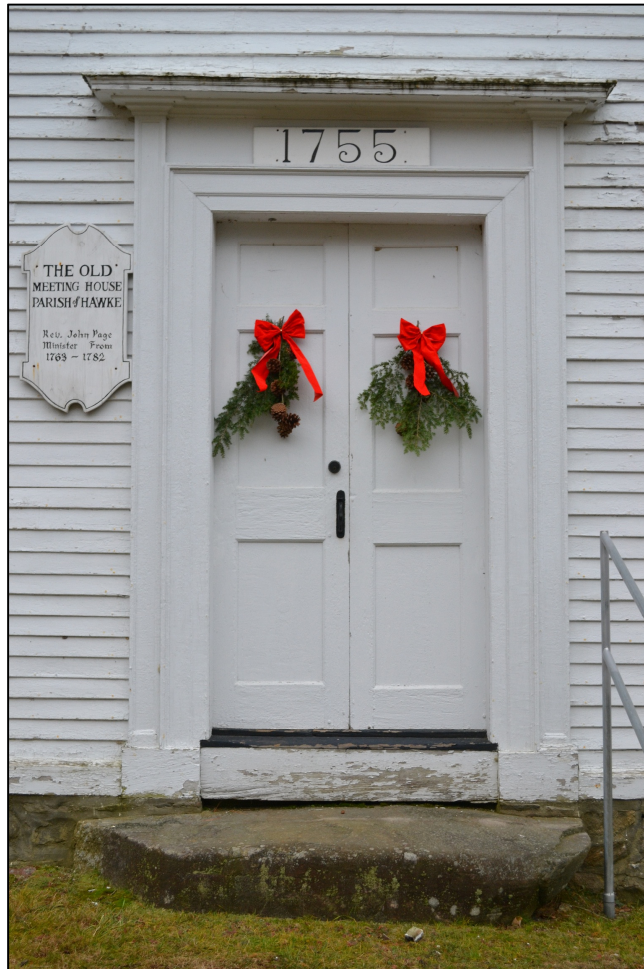
*Western (side) doorway, as remodeled in the early 1800s*

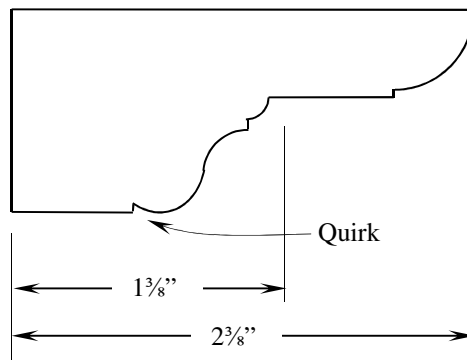
All the windows that were fitted with new projecting caps were likewise provided with new backband moldings, which in most cases were affixed to the original, narrow casings. As seen below, the backbands supplied to the rear of the building were slightly less elaborate than those applied to the front and west (road) side.

*Exterior window casings, west elevation, Danville Meeting House*

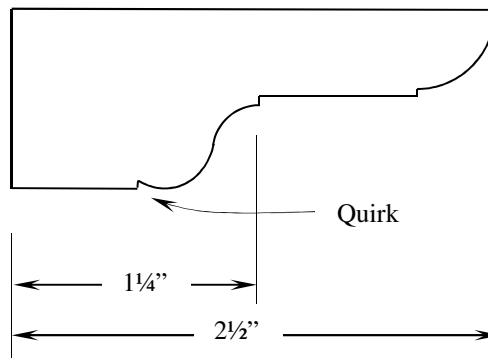
*Exterior window casings, north (rear) elevation, Danville Meeting House*

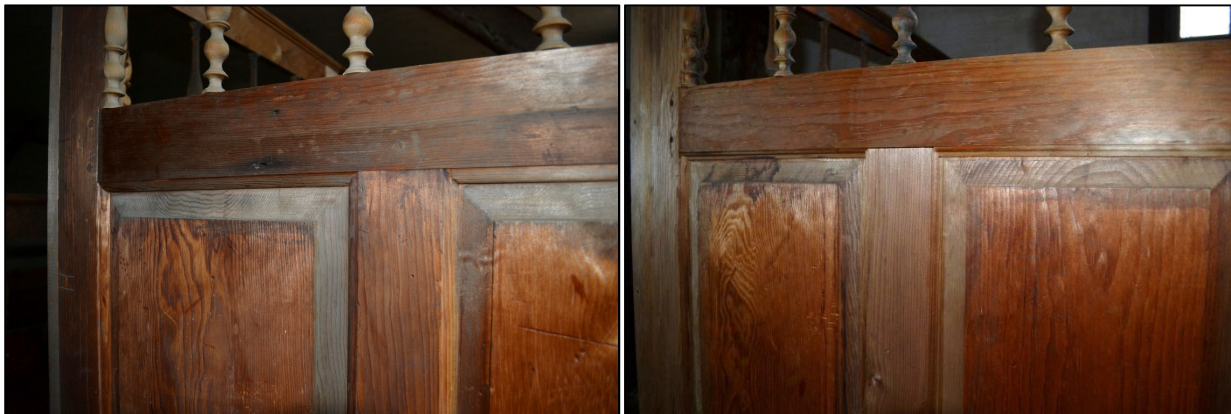
A general survey of the pews on both the main floor and the galleries indicates that at least two different styles of paneling are to be found in the pew enclosures and doors. The first of these has plain quarter-round moldings surrounding the raised panels. The second has quarter-round moldings with tiny added fillets. This small difference in detailing is diagnostic, first, of original joinery of circa 1760 (when the first “pew ground” was sold) and, second, of later joinery of 1797 (when the first gallery “pew ground” was sold, and third, of further work of the early 1800s. Although the pews do not appear to differ in other details—all share the small balusters below their top rails, for example—there is a clear stylistic difference that appears to denote the original construction and sale of pews, followed quite a bit later by the construction and sale of additional pews in parts of the galleries. The differences in detailing are shown below.

*Left: pew paneling of eighteenth-century style*

*Right: pew paneling of late eighteenth- or early nineteenth-century style*
