**REPORT ON THE OLD HAVERHILL ACADEMY BUILDING
(PEARSON HALL)
HAVERHILL CORNER, NEW HAMPSHIRE**

**JAMES L. GARVIN
NOVEMBER 30, 2008**

This report is based on an inspection of the old Haverhill Academy Building (built in 1816 and renamed Pearson Hall in 1897) on April 28, 2008. The purpose of the inspection was to address several questions about the design, evolution, and condition of the building, thereby providing a fuller context for the development of a program of rehabilitation for the structure.

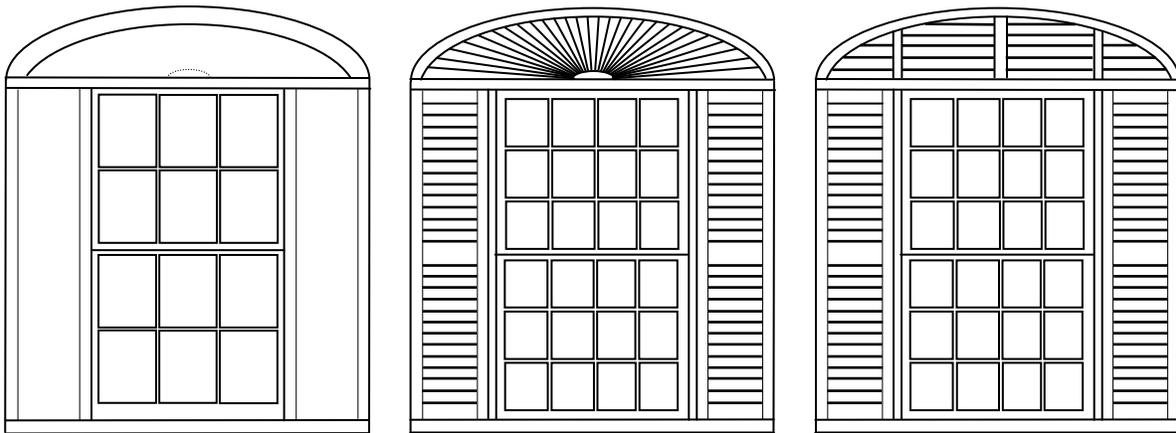
[current treatment]

Given the inconclusive evidence provided by available photographs, it will be important to search the attic of the building thoroughly for fragments of blinds or other pieces of evidence that may supplement the incomplete photographic record of the treatment of the façade over time.
