REPORT ON THE HALL-DYER HOUSE
25 GREAT HILL ROAD
TAMWORTH, NEW HAMPSHIRE

JAMES L. GARVIN
OCTOBER 1, 2012

This report derives from an examination of the Hall-Dyer House on September 27, 2012. The purpose of the report is to identify the character-defining features of the dwelling as a means of ensuring the protection and preservation of those features as the Tamworth Historical Society rehabilitates the house for its headquarters.

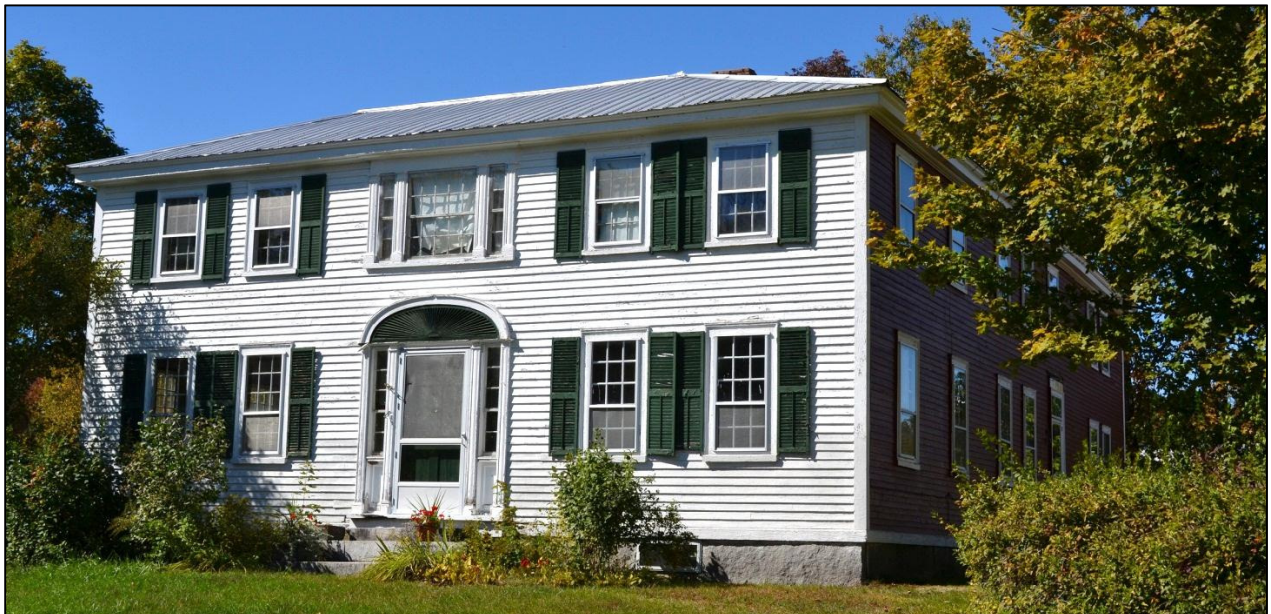
Hall-Dyer House, Tamworth, New Hampshire: Front (south) and East Elevations

The façade or south elevation of the building, shown above, is distinguished by an entrance doorway or frontispiece with three-over-two double-hung sidelight windows and a false fanlight

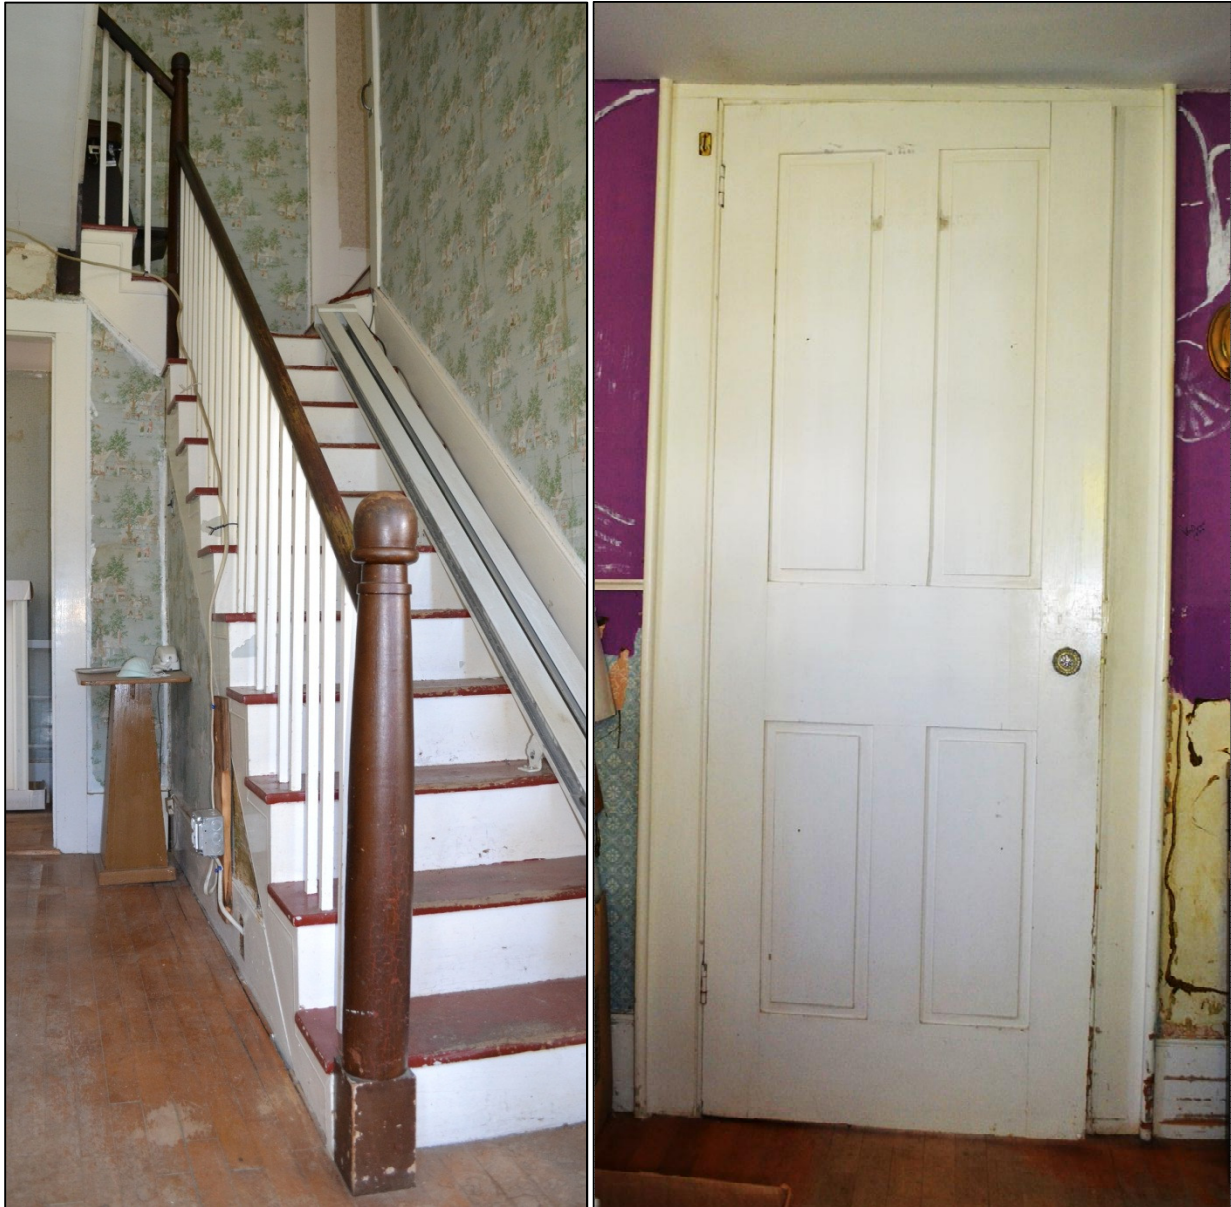
Left: Balustrade in front entry, showing heavy, turned newel and angle posts

Right: Doorway from parlor chamber to upper stairhall, showing simple torus backband moldings

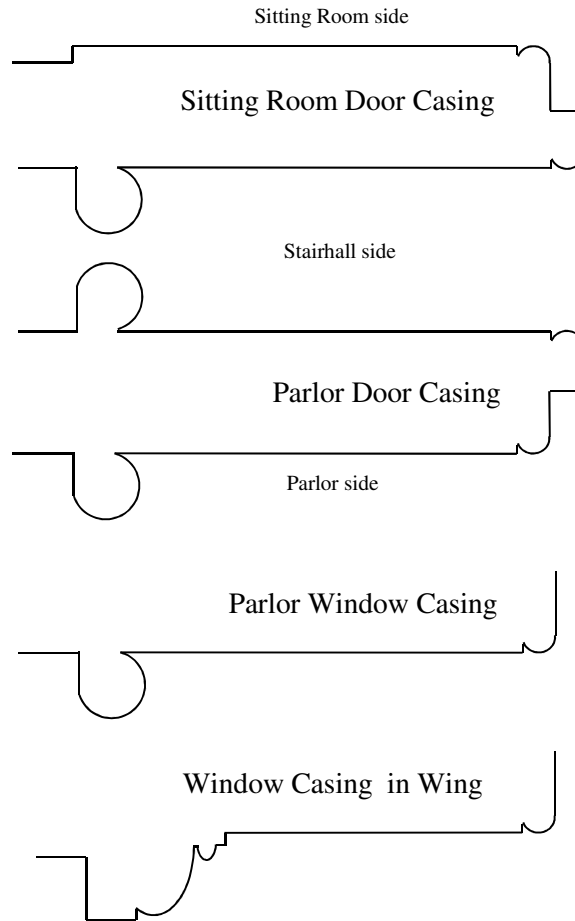
As noted above, the Hall-Dyer House exhibits a stylistic hierarchy, with its front rooms displaying joinery of an unorthodox but recognizably Grecian character, and with the rooms in the wing displaying minimal but traditional joinery that looks back to the 1820s. The interior finish suggests the hand of a joiner who was aware of the characteristics of the incoming Greek Revival style but lacked contact with contemporary urban examples of that style and thus produced a vernacular interpretation. The craftsman distinguished the front rooms of the house with his interpretation of the new style but, as was typical of many houses at many periods, reverted to simpler and more traditional detailing in the subordinate rooms in the wing. The difference in interpretation can be seen by comparing door and window casings from the front of the house to those in the rooms of the wing, as shown below:

The casings or architraves shown above relate in an elementary way to casings that were being introduced in urban buildings during the early 1830s. While the Hall-Dyer House casings are extremely simple, their distinctive backband—a plain round or torus molding—would have been a recognizable reflection of a similar feature that was appearing in more elaborate houses, as seen below.

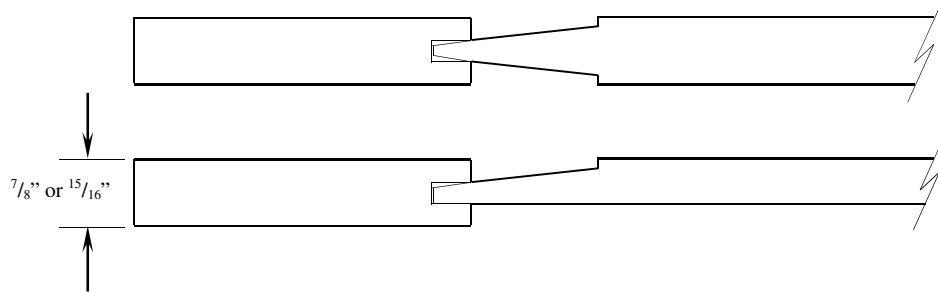
Doors throughout the house display a simple, four-panel design that dispenses with the moldings that ordinarily border the panels of Federal-style doors. The Hall-Dyer doors have raised panels on both sides when they connect two principal areas such as the stairhall and a front room; they have raised panels on one side only when they connect spaces of lesser stature, or closets:

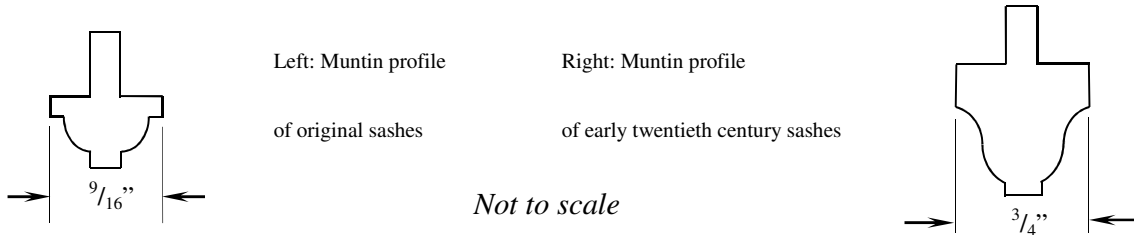
Replacement of the sashes was done carefully, with new units replicating the presumed original configurations of nine-over-six on the first story and six-over-six on the second. The sidelights of the front door, the three-part double-hung units above, and the transom over the side door of

the wing, being specially fabricated for unique openings, were not replaced during this remodeling. The contrasting muntin profiles of the original sashes and those of the early twentieth century are shown above.

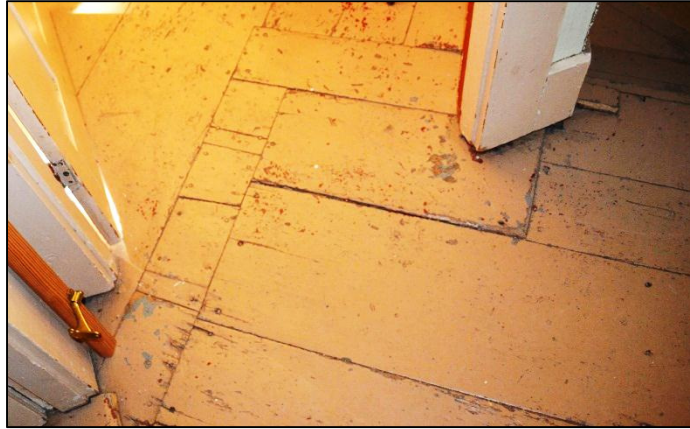
The early twentieth-century features of the Hall-Dyer House represent a conscious adaptation of the house. An element of this adaptation may have been for comfort and style, as in the installation of maple flooring. An element may have been practical, as in the presumed modernization of a kitchen in the wing. But on the second floor of the wing, a series of small chambers were created near the head of the staircase shown above. These small rooms have the appearance of chambers for boarders or possibly servants. The fact that these rooms (some of them having diagonal partitions) reflect a change to an earlier floor plan is indicated by evidence in the floorboards of former partitions, as seen below.

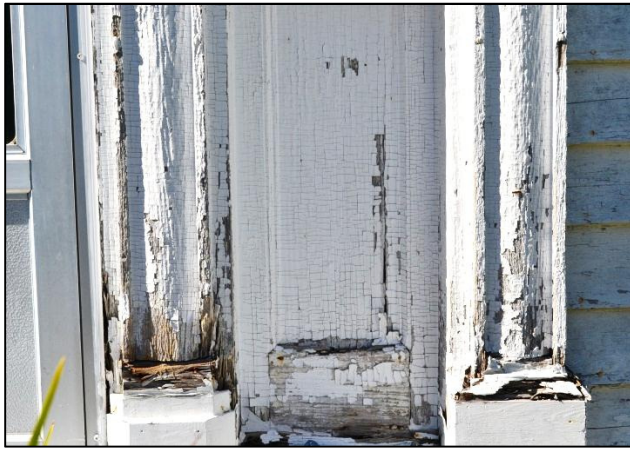
A closer examination of the principal casings that serve as mullions between the major openings of this composition, however, reveals that these features are uniform throughout both the doorway and the window, and have the profile shown below:

This profile—a broad convex molding embraced by two fillets—is not characteristic of the Federal architectural style, even though the overall composition of doorway and three-part window derives directly from that era. Rather, this symmetrical casing profile is a Greek Revival form. Similar profiles first became familiar to New England craftsmen with the publication of Asher Benjamin’s builder’s guidebook, *The Practical House Carpenter*, in Boston in 1830. This was the first New England text that delineated the attributes of the new style, signaling the end of the long-familiar forms of the Federal era and the advent of new and bolder details, as well as new floor plans and building shapes.
